Assessment of 3 *Eucalyptus camaldulensis*
located at
End of Curragh Moor Rd Carisbook

Condition Report
completed for

Prepared by
WM Environmental
Wesley Martin
Certificate IV Horticulture (Arboriculture)
Dip. Ap. Sci. Forestry

Tree Inspection: 25 November 2018
Report Date: 30 November 2018

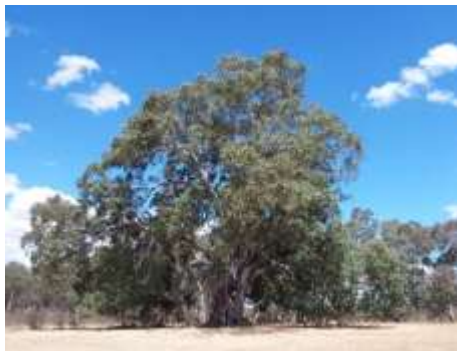
Figure 1: Tree 1 *Eucalyptus camaldulensis*

Tree #	Species	DBH (cm)	Height metres	Age (aprox years)	Canopy Dimension radius	Health	Structure	Landscape Contribution	TPZ in metres	SRZ in metres
1	<i>Eucalyptus camaldulensis</i>	267	35	300+	15.5m	Very Good	Very Good	Very High	15	4.97
2	<i>Eucalyptus camaldulensis</i>	84;73	28	65+	8m	VG	G	Very High	9.12	2.95
3	<i>Eucalyptus camaldulensis</i> var. <i>obtus</i>	138	25	100+	12m	VG	VG	Very High	15	3.79

A visual inspection from the ground perspective revealed expected signs of age ie: previous storm damage, habitat hollows. At the time of inspection, all damage or wounds had grown over adequately in all three trees and have not compromised tree structure and health moving forward.

These trees are highly recommended for retention.

- Mulch the ground area within the TPZ.
- Exclude all activities from the TPZ has indicated in *AS4970-2009 Protection of Trees on Development Sites Section 4.2* (See Appendix B).
- Maintain TPZ with temporary fencing.
- Mulch the TPZ.
- Consider exclusion of TPZ during and after development to reduce the inherent risk of limb drop or any tree failure due to any future decline in health.
