central Goldfields Shire

Heritage Study 1992

BOOK 3 - Havelock - High

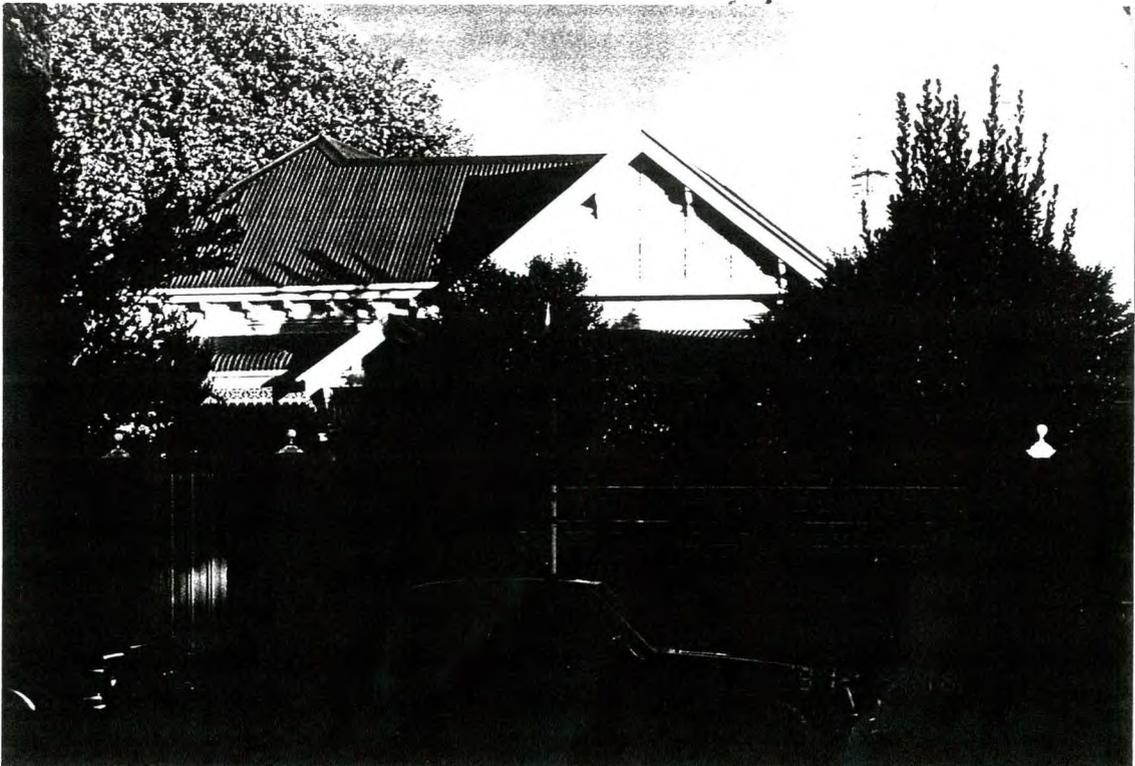
In architectural terms the second best of Maryborough's small number of 1900s houses, this building is also a significant part of the streetscape despite the high front wall. Maryborough is characterised by a lack of affluence throughout its history and while most of its pre 1960 dwellings were built during the 1900s, virtually all are standard design late Victorian period weatherboard dwellings. The heavily rusticated gable ends and large eaves consoles are unusual details which give this house prominence. The affluent nature of this dwelling is a reflection of the shopkeeper occupation of its first owner, most of Maryborough's residences and better houses having been constructed for those in the same occupation. Number 55 Victoria Street is Maryborough's only proper Edwardian era house and no.25-27 Park Road the only residence.

Regular maintenance as required.
When repainting use original/period paint colours.
Removal and replacement of the front fence with an appropriate period one is desirable, though presumably it keeps out some of the traffic noise.
Reconstruct demolished chimneys.

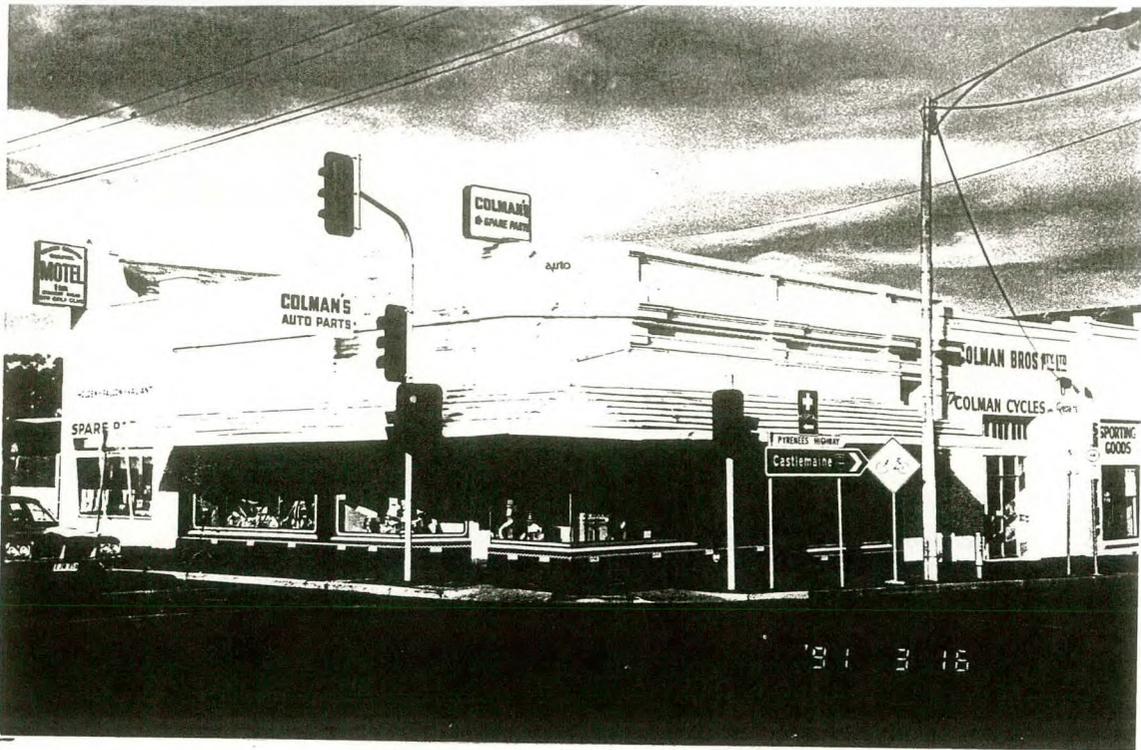
THE CORNER OF THIS BUILDING HAS BEEN CUT OFF FOR THE SERVICE STATION AREA; THIS END OF THE FACADE POSTDATES THE MAIN BODY ON THE STREET CORNER
