central Goldfields Shire
(Former city of Maryborough)
Maryborough
Heritage Study 1992

BOOK 4 - Majorca - Palmerston

HERITAGE STUDY

BOOK 4

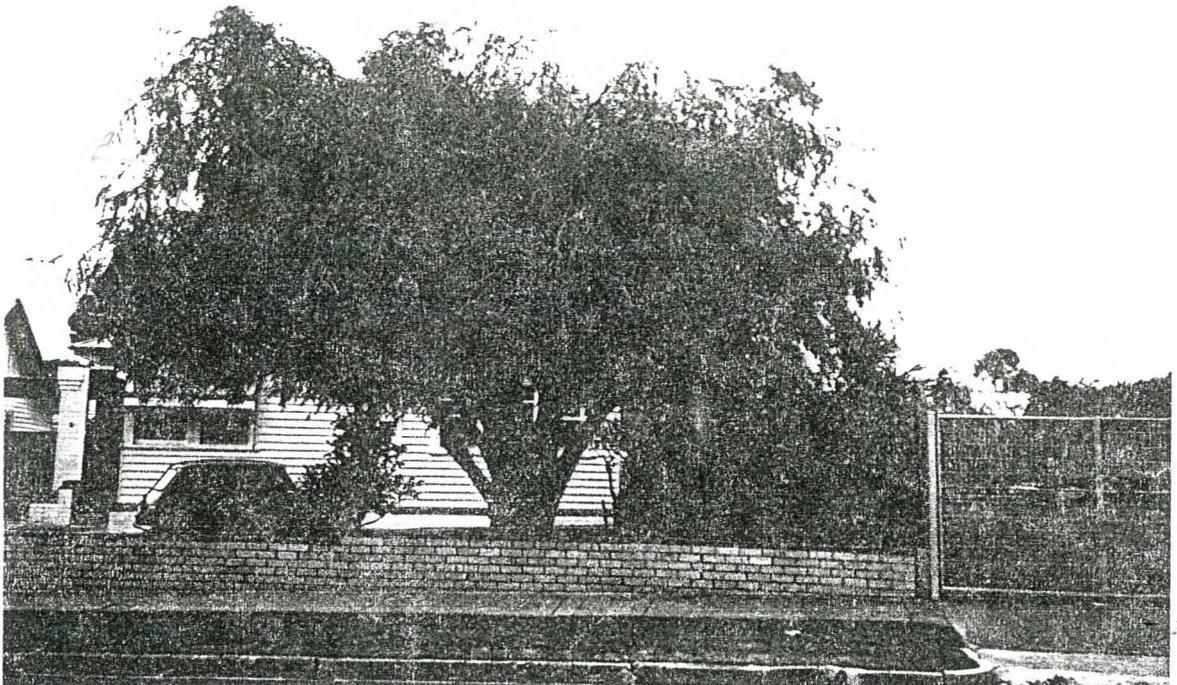
Agonis flexuosa - WILLOW MYRTLE,
3 MAJORCA STREET,
MARYBOROUGH.

PLANTED:	CIRCA 1960
DEGREE OF SIGNIFICANCE:	OF LOCAL SIGNIFICANCE
RECOMMENDATIONS:	LOCAL PLANNING PROTECTION

A good specimen of a native tree used as a garden ornamental.

No perceived threat. Inform owners of value of tree.

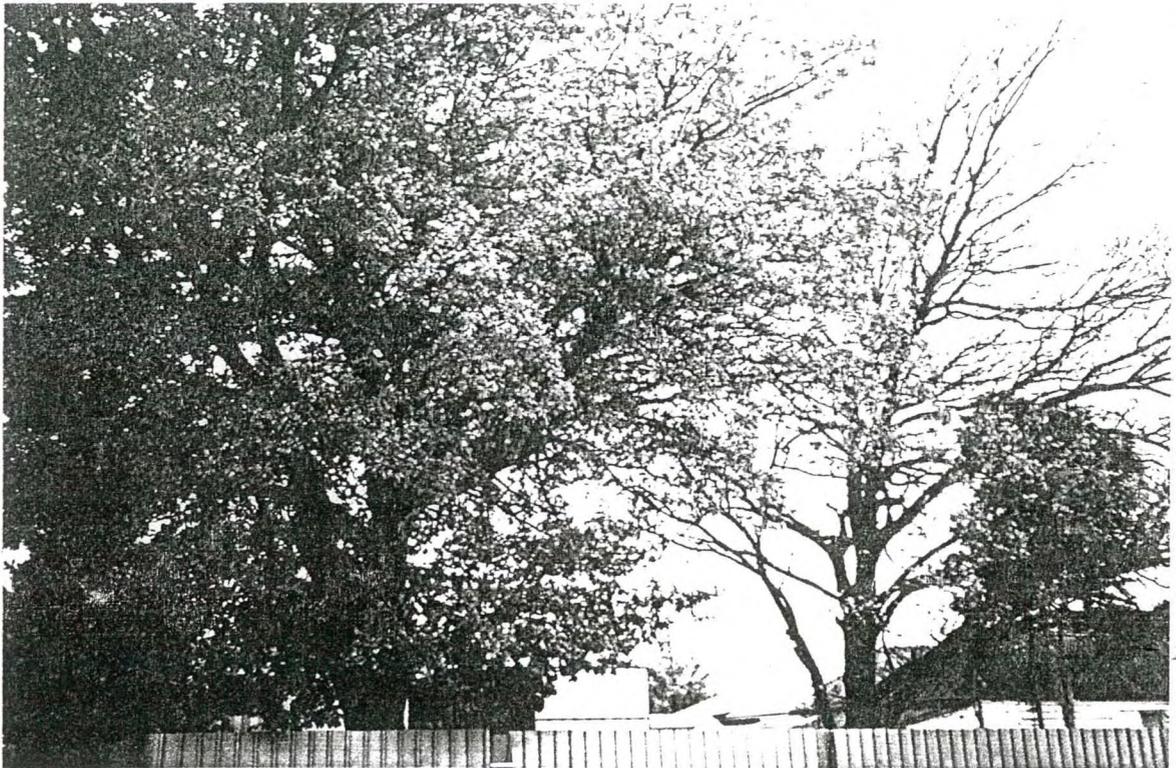
Quercus robur (x2) - ENGLISH OAK,
CNR. LOCH STREET AND 31 MAJORCA ROAD,
MARYBOROUGH.

PLANTED: CIRCA 1930
DEGREE OF SIGNIFICANCE: OF LOCAL SIGNIFICANCE
RECOMMENDATIONS: LOCAL PLANNING PROTECTION

Fine specimens of exotic tree, of good form, health and vigour.

No perceived threat. Inform owners of value of trees.

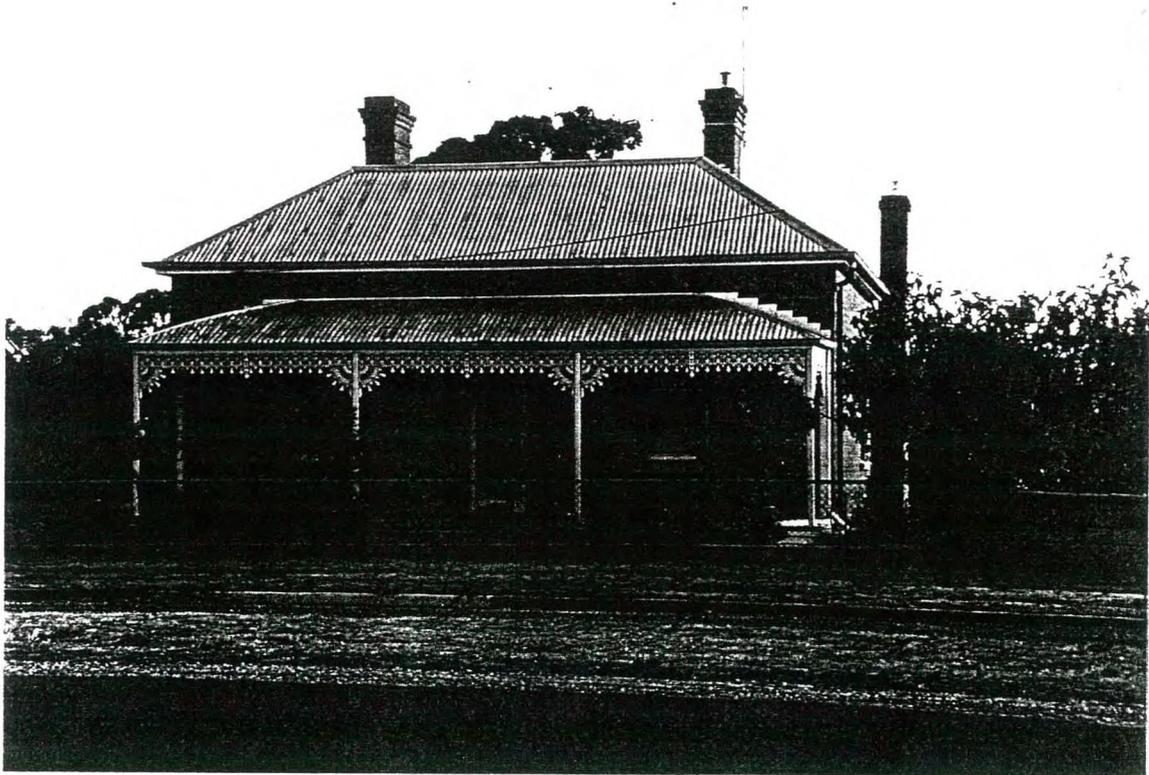
BUILT:	1900S
THEMES ILLUSTRATED BY THIS PLACE:	SOCIO ECONOMIC MIX IN THE TOWN
	PRIVATE BUILDING - EDWARDIAN
DEGREE OF SIGNIFICANCE:	LOCAL SIGNIFICANCE
EXTENT OF SIGNIFICANCE:	ENTIRE BUILDING AND SITE
RECOMMENDATIONS:	LOCAL PLANNING PROTECTION

Regular maintenance as necessary.
Ensure all roof and ground-water is collected and carried well away from the building.
When repainting use original/period/appropriate paint colours and placement.
When replacing spouting use ogee profile gutters and round downpipes.
Replace present front fence with a replica of the original, or another appropriate period fence or plant a hedge to mask the existing mid 20th century front fence.

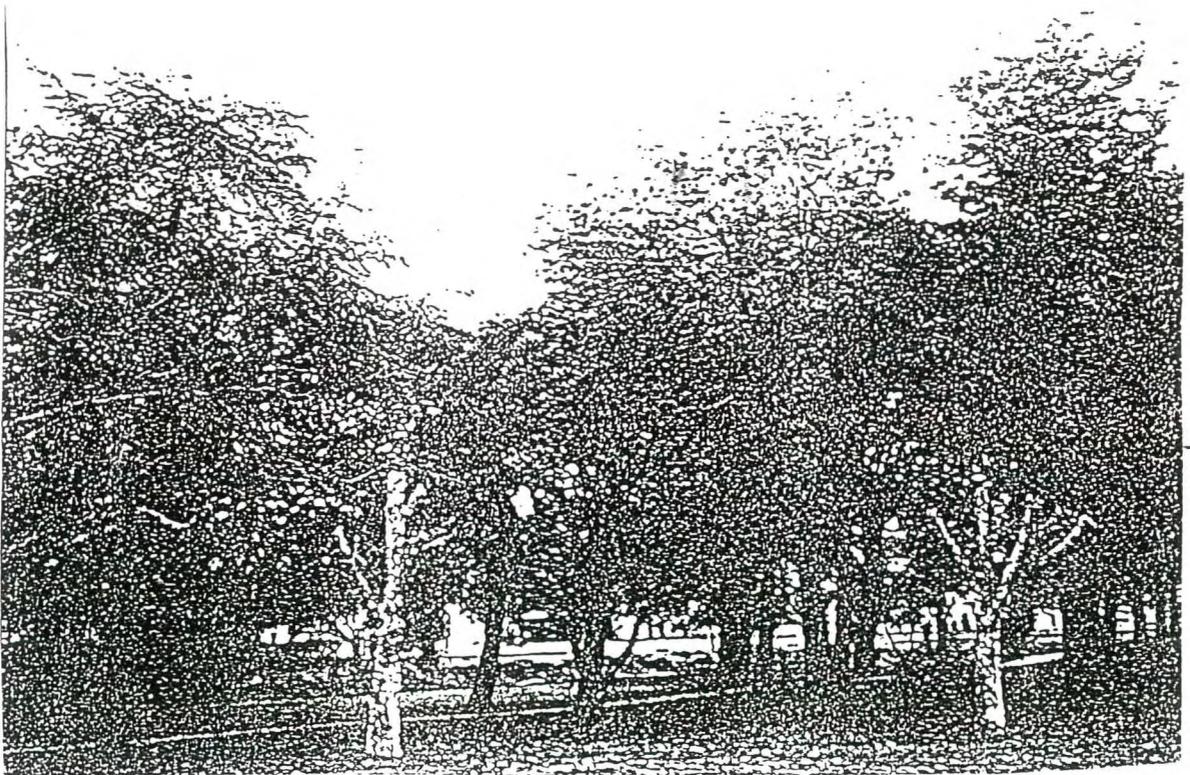
An interesting group of trees providing an effective block of mature planting on the street corner. The treatment of the Planes detracts from the quality of the site.

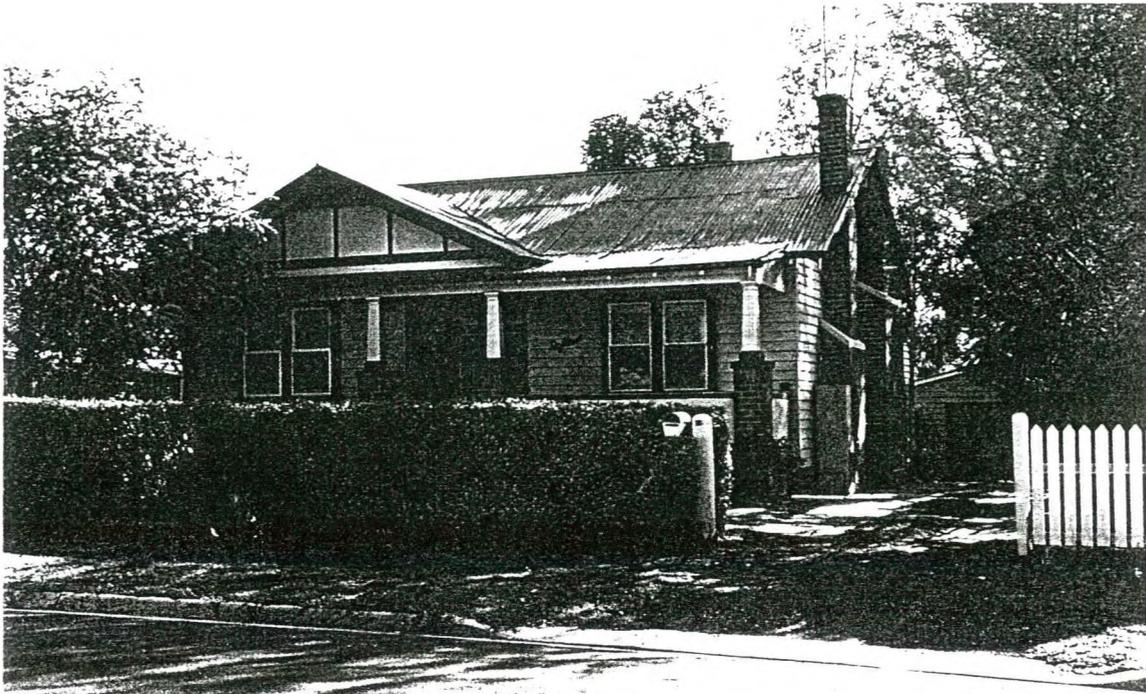
CREAM FACE BRICK AND TIMBER HOUSE,

42 MARINERS REEF ROAD,
MARYBOROUGH.

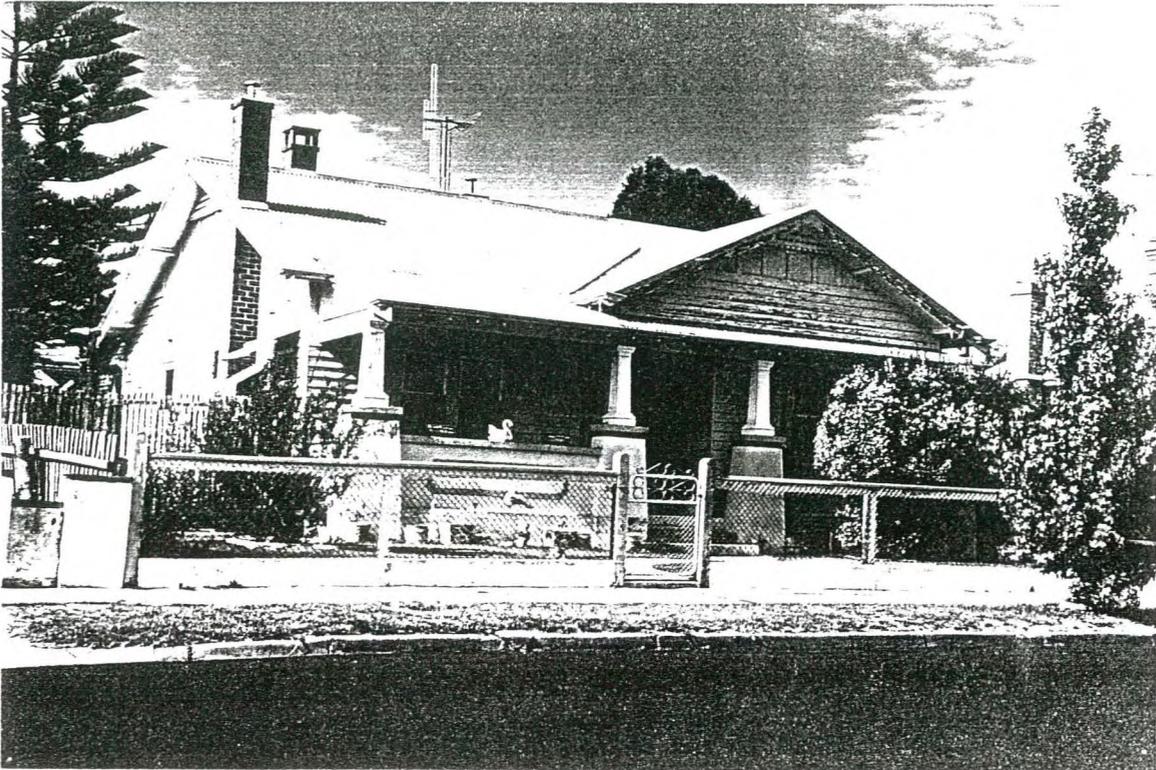
FACE BRICK HOUSE,

52 NAPIER STREET,

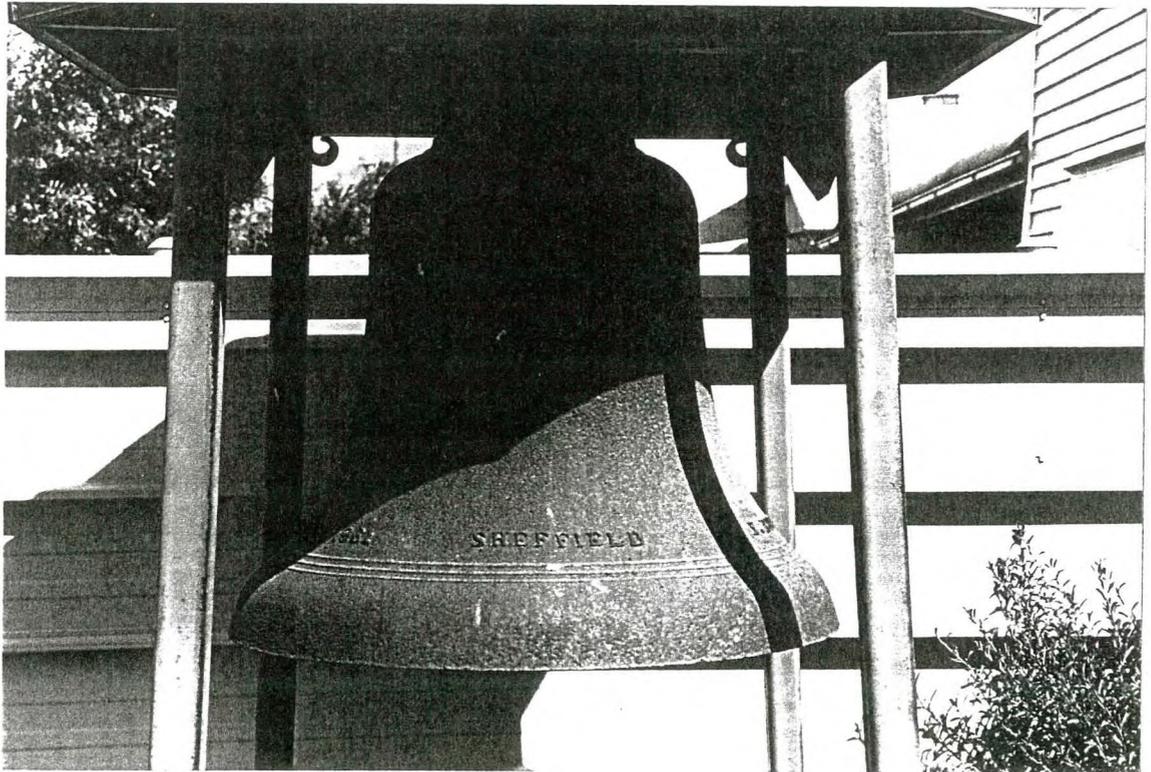
CAST:	1861 - ORIGINALLY AT TIMBER FIRE STATION BELFRY IN NEILL STREET
MOVED:	1880 MOVED TO FIRE TOWER? 1970S/1980S? MOVED HERE
THEMES ILLUSTRATED BY THIS PLACE:	GROWTH OF THE TOWN PUBLIC FACILITIES
DEGREE OF SIGNIFICANCE:	LOCAL SIGNIFICANCE
EXTENT OF SIGNIFICANCE:	ENTIRE BUILDING AND SITE
RECOMMENDATIONS:	LOCAL PLANNING PROTECTION

Stop rust and repaint in original or appropriate colour/colours.
Relocate the bell to the fire tower in Neill Street if this is
where it was after the construction of the tower.
Preferably install a plaque stating what the bell and its
history is.

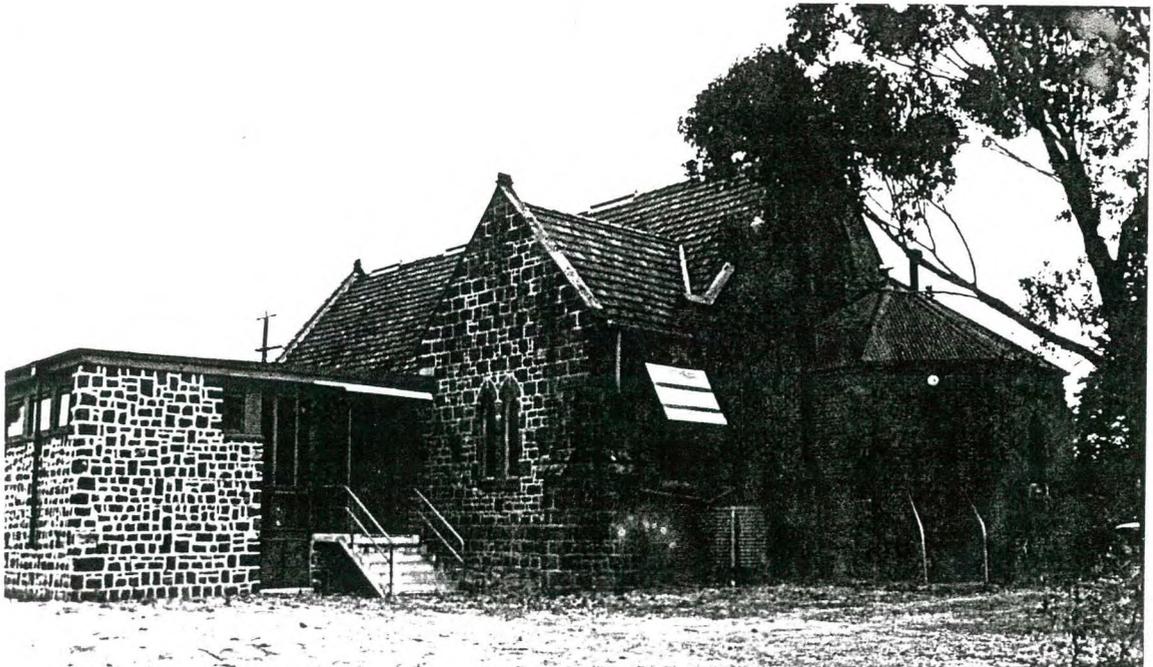
Recent entry building detracts from the church building; plant evergreen creepers to grown on columns and walls to soften the impact of this structure.

Keep church intact inside and out and conserve furnishings.

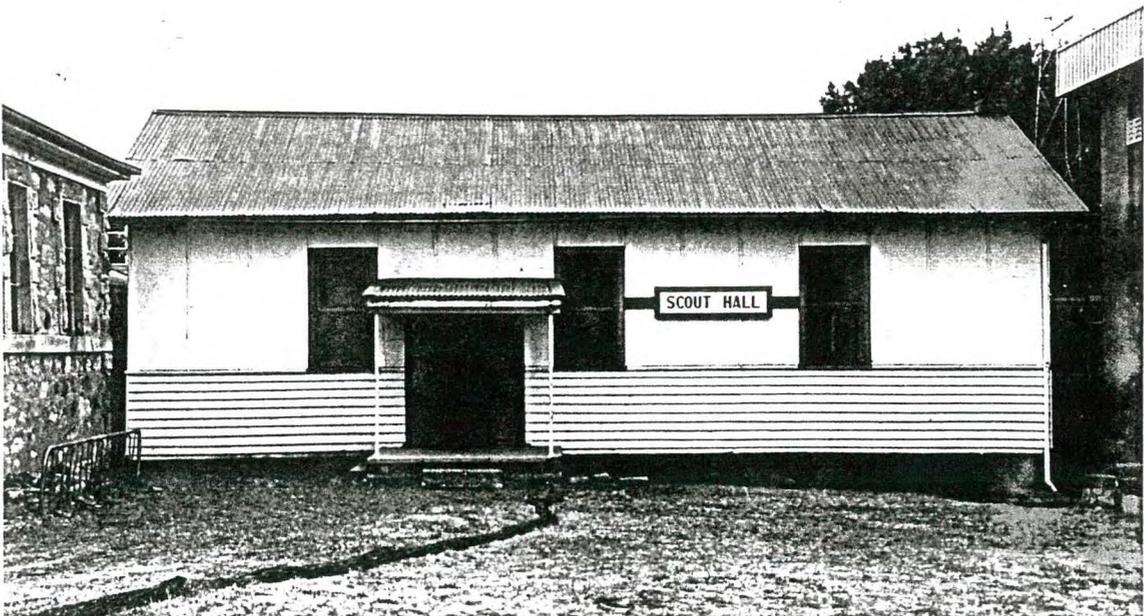
PRIOR TO RECLADDING IN 1992, WHICH REMOVED ANY CULTURAL SIGNIFICANCE

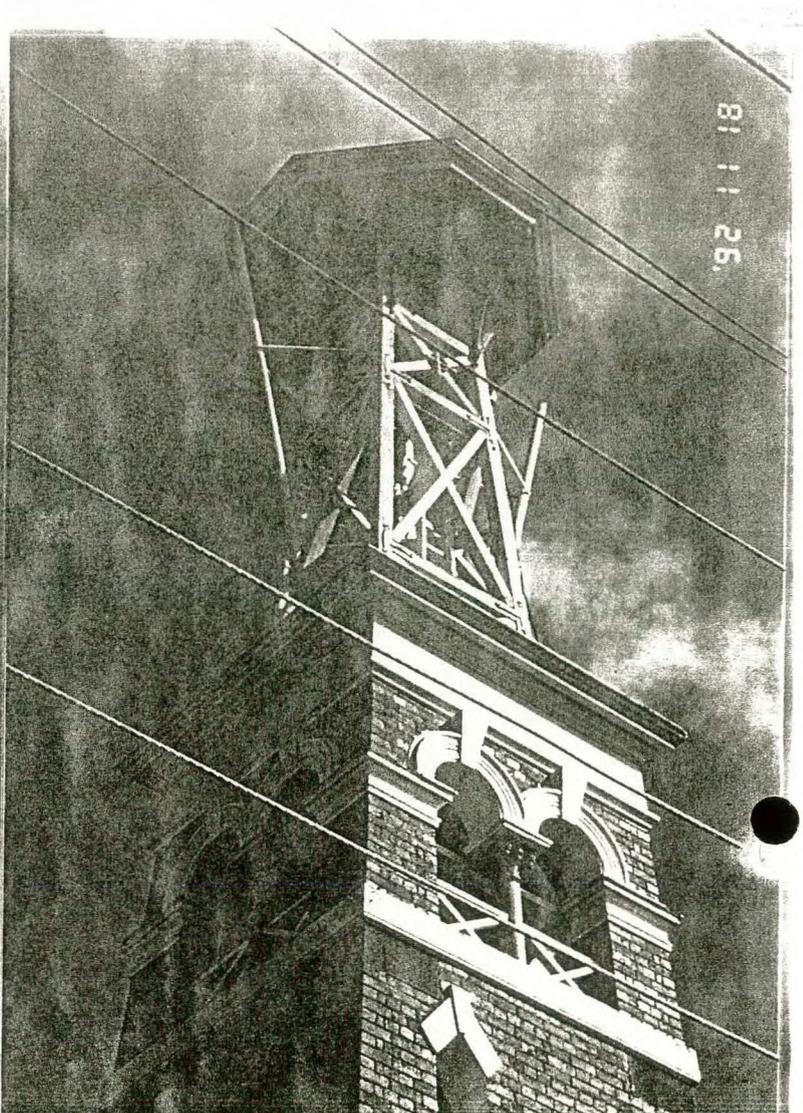
- In-use Disused Abandoned Threatened by Adjacent Use
 Unsympathetic Use Sympathetic Use Basic Maintenance Threatened by Subdivision
 Cosmetic Maintenance Required Threatened by Redevelopment Required

Metal connecting plates on the belfry are rusting and this should be stopped as a matter of urgency. Corroding through of these metal connections will see the structure disintegrate and collapse into the street.

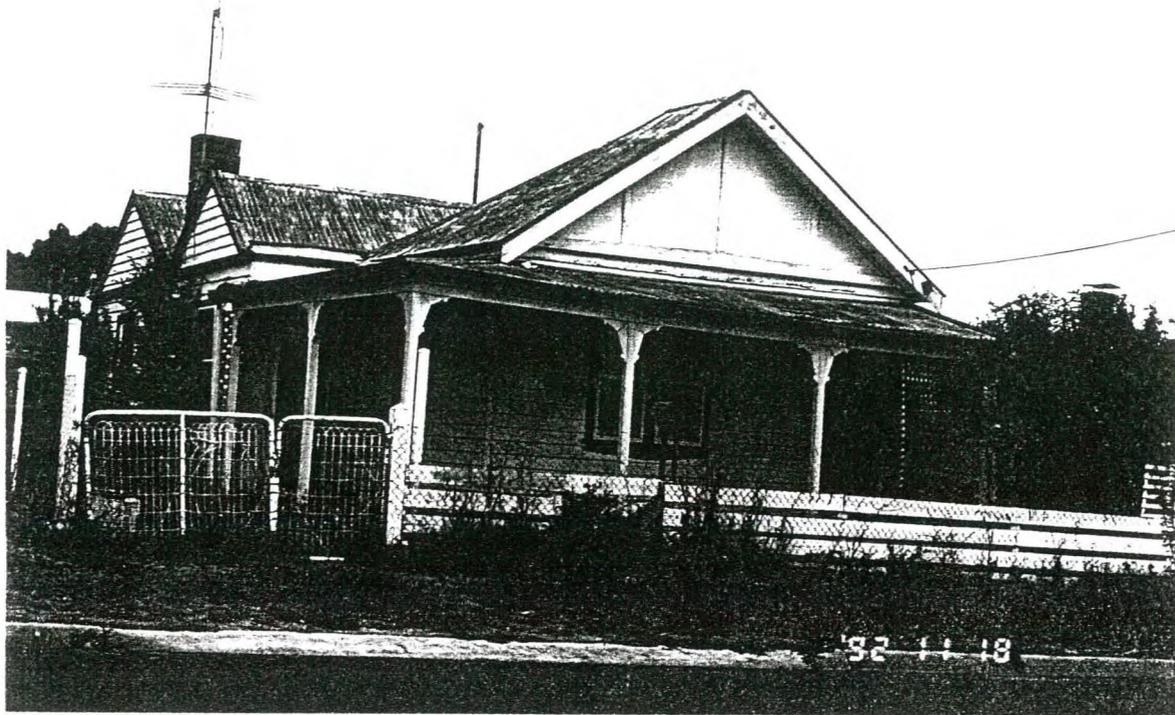
THE ADDED EDWARDIAN STYLE FRONT SECTION FACES THE ORIGINAL HOUSE, ILLUSTRATING THE ECONOMIC GROWTH OF MANY OF MARYBOROUGH'S RESIDENTS DURING THE 1900S AND 1910S

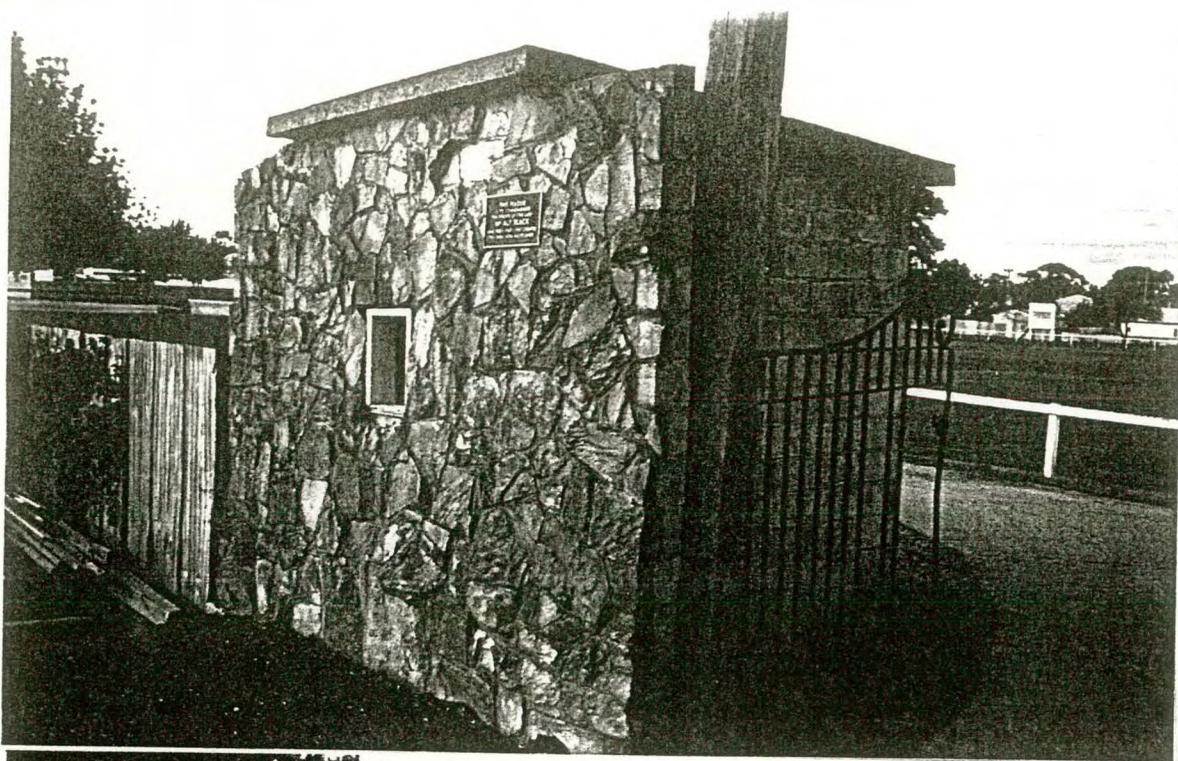
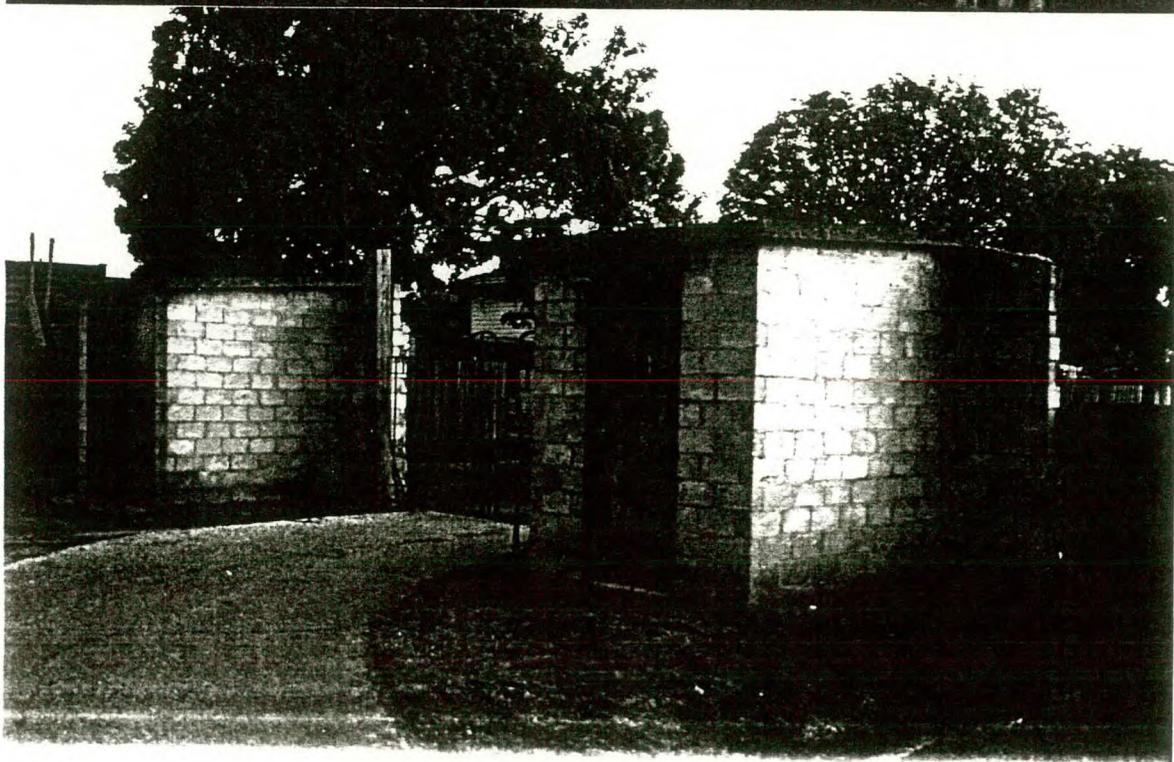
BUILT:	1950S/1960S
THEMES ILLUSTRATED BY THIS PLACE:	PRIVATE BUILDING - POST SECOND WORLD WAR
DEGREE OF SIGNIFICANCE:	LOCAL SIGNIFICANCE
EXTENT OF SIGNIFICANCE:	TWO TICKET BOXES, TWO GATES AND SITES TO A RADIUS OF 20 METRES.
RECOMMENDATIONS:	LOCAL PLANNING PROTECTION

Repair loose sandstone and wrought iron gates.

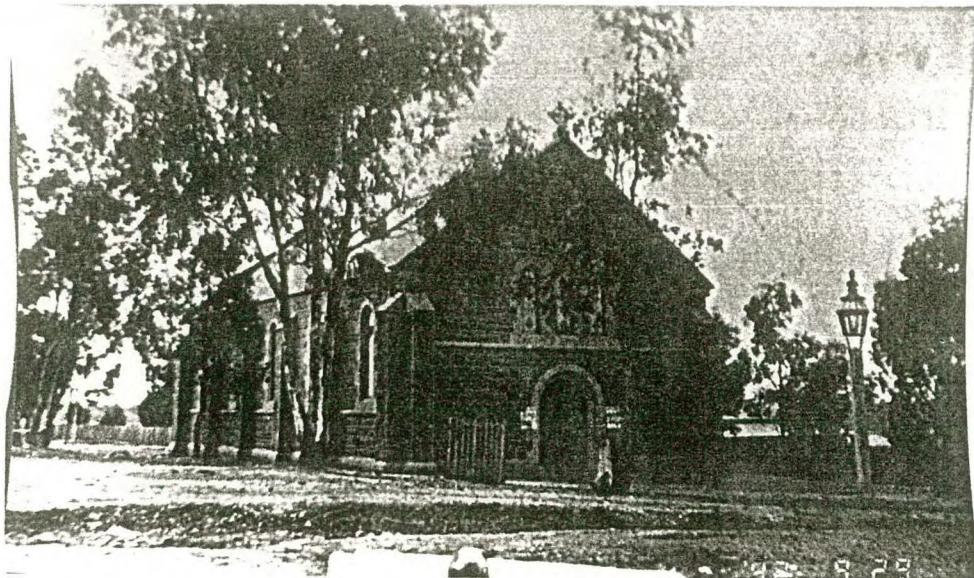
AS FIRST BUILT (PARISH RECORDS)

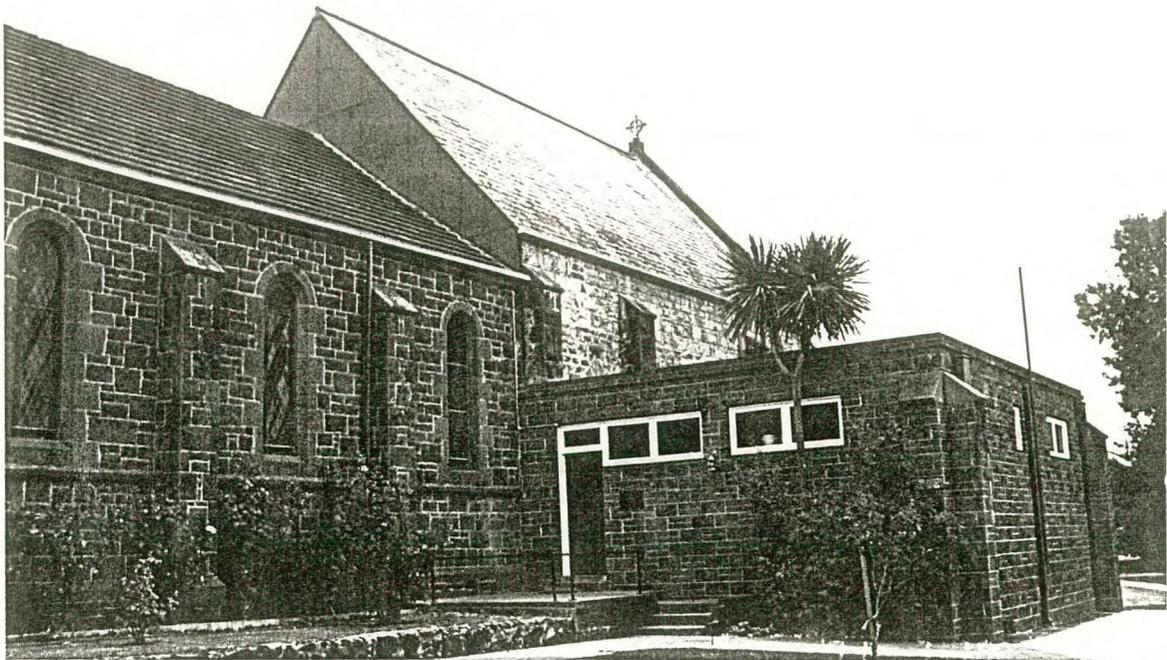
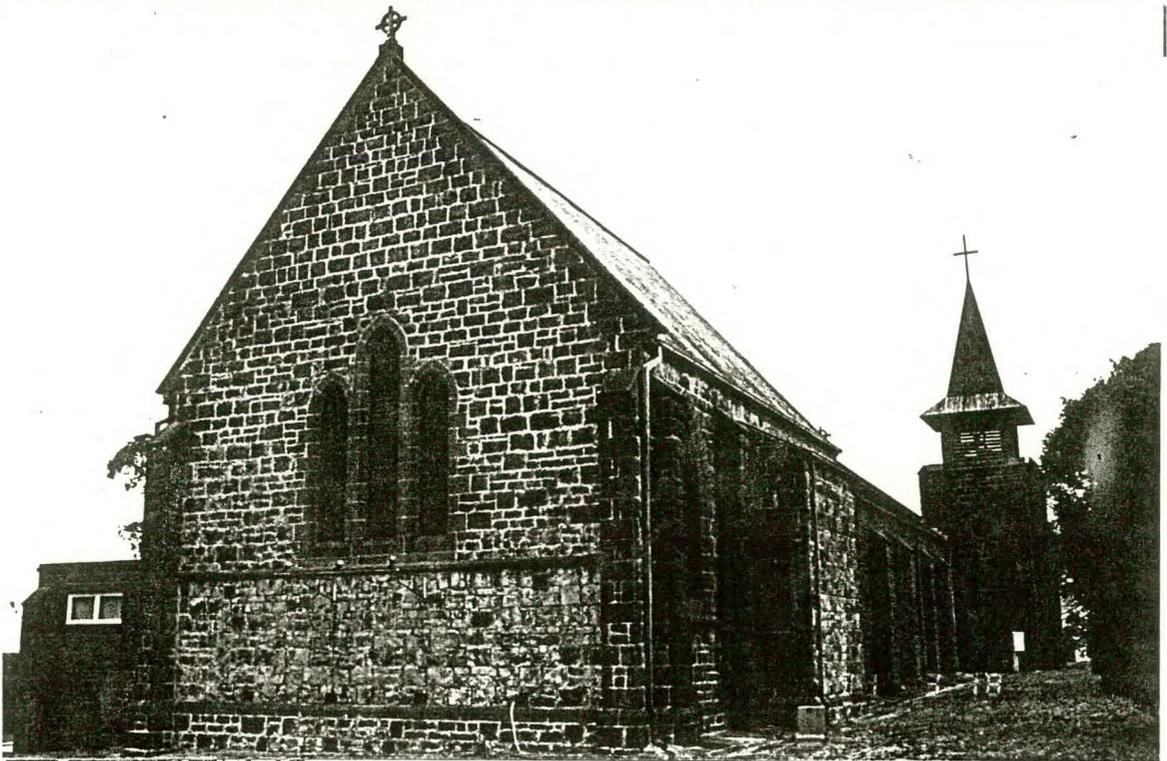
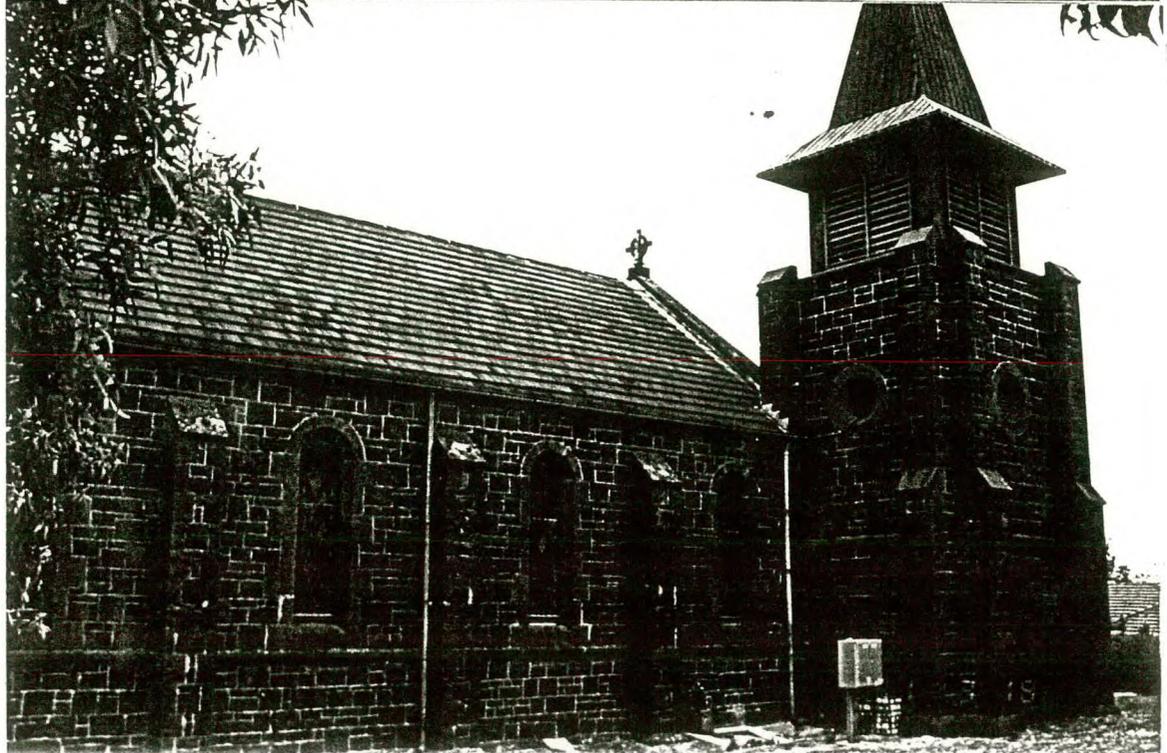
Christ Church Anglican Church Cont.

Roof gabled with no eaves, corrugated iron clad.

Features are the size of the building, face brick walls, gable, buttresses and windows.

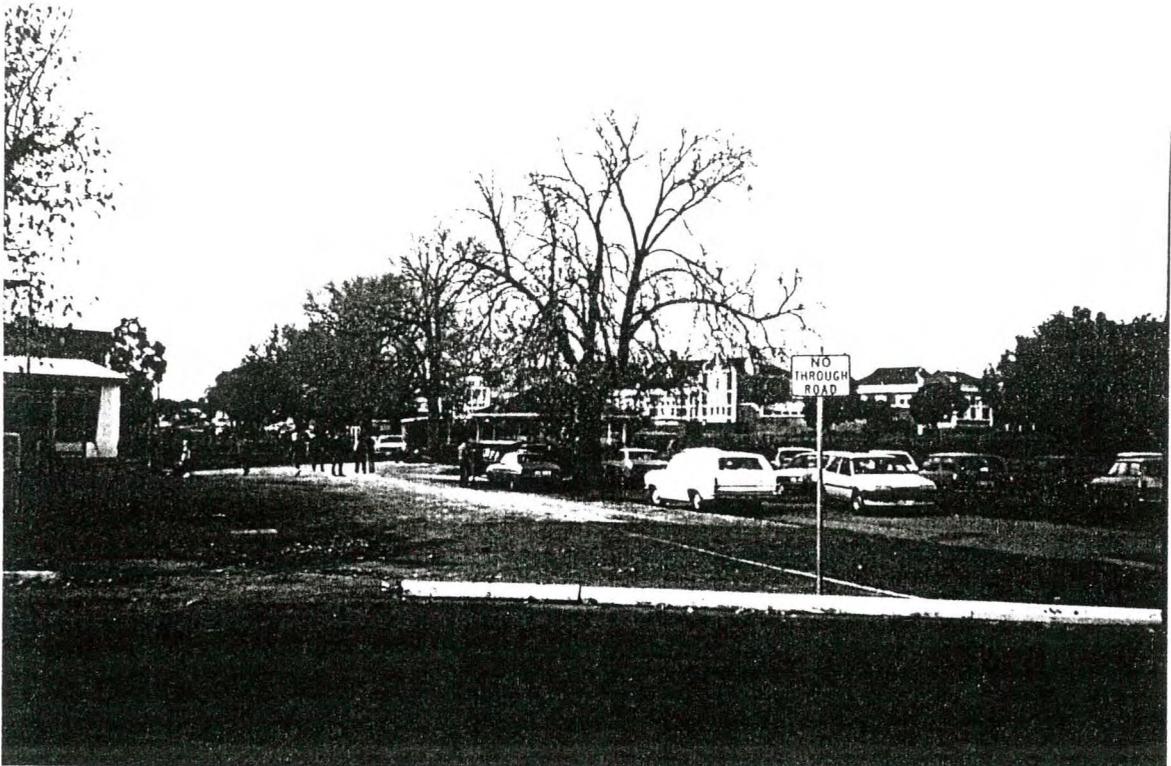
This row of trees performs a significant task as part of the approach to the Maryborough Station. Their role has been masked by their incorporation in the school playground.

Appear to be in sound condition. There may be a perception that the upper canopy should be lopped but this should be avoided.

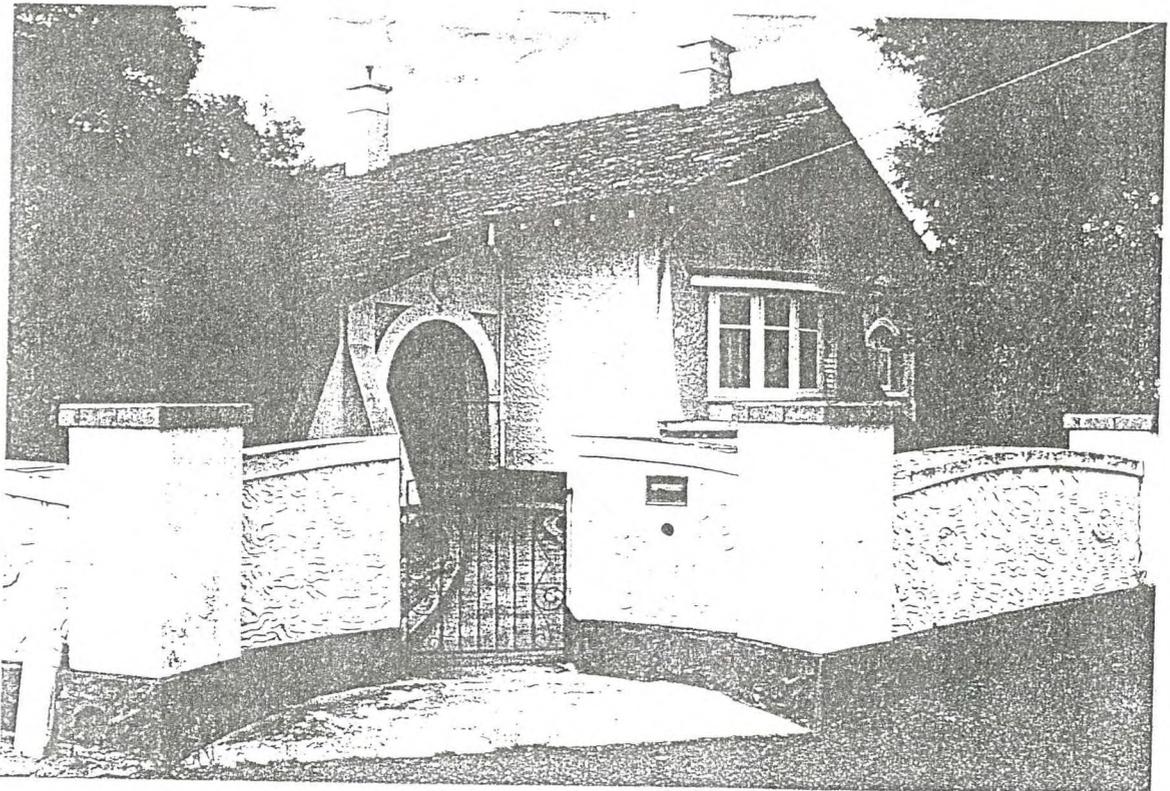
BUILT:	1930-1931 ¹
THEMES ILLUSTRATED BY THIS PLACE:	PRIVATE BUILDING - INTERWAR YEARS
DEGREE OF SIGNIFICANCE:	LOCAL SIGNIFICANCE
EXTENT OF SIGNIFICANCE:	ENTIRE BUILDING, GARAGE, FRONT FENCE AND SITE.
RECOMMENDATIONS:	LOCAL PLANNING PROTECTION CONSERVATION AREA: NOLAN STREET

Remove tiles from the facade.
Chemically remove the paint from walls to expose coloured render (visible in column) or repaint in original/period paint colours).
Ensure all roof and ground-water is collected and carried well away from the building.
Repairs as necessary.
Regular maintenance as necessary.
Investigate western shopfront and return to its original state or adapted form that has a viable present day use.

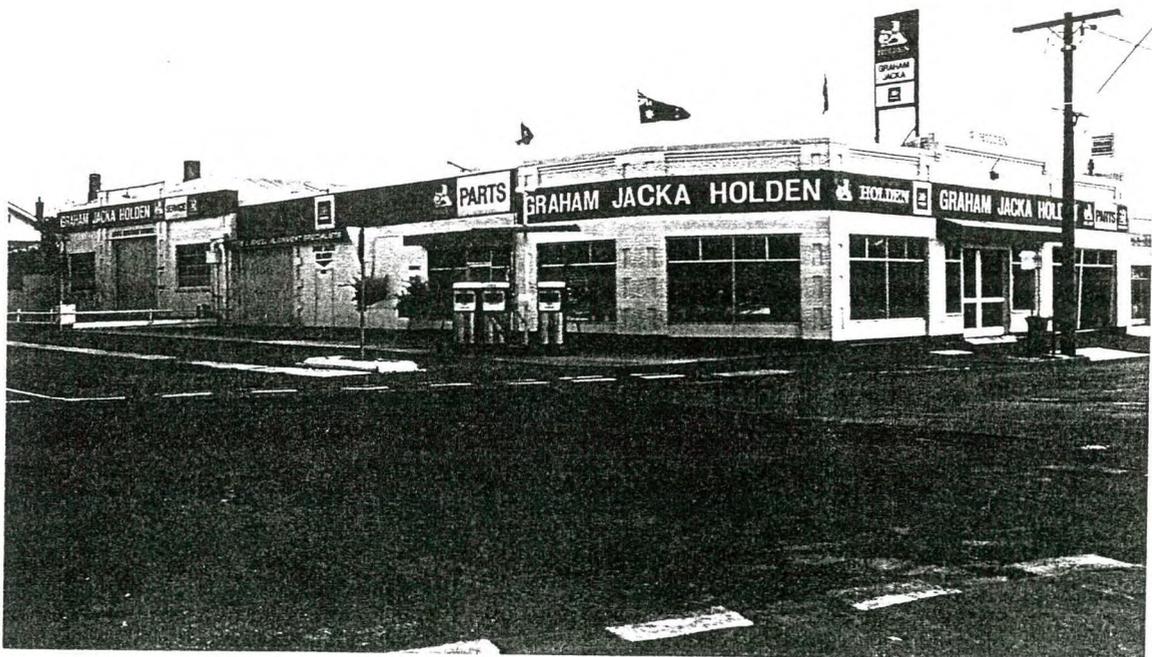
COMMERCIAL PREMISES,
S.W. CNR. BURKE STREET,
35 NOLAN STREET,
MARYBOROUGH.

BUILT:	1920S/1930S
	19TH/EARLY 20TH CENTURY CENTRAL SECTION?
THEMES ILLUSTRATED BY THIS PLACE:	PRIVATE BUILDING - INTER-WAR YEARS
DEGREE OF SIGNIFICANCE:	LOCAL SIGNIFICANCE
EXTENT OF SIGNIFICANCE:	ENTIRE BUILDING AND SITE
RECOMMENDATIONS:	LOCAL PLANNING PROTECTION
	CONSERVATION AREA: NOLAN STREET

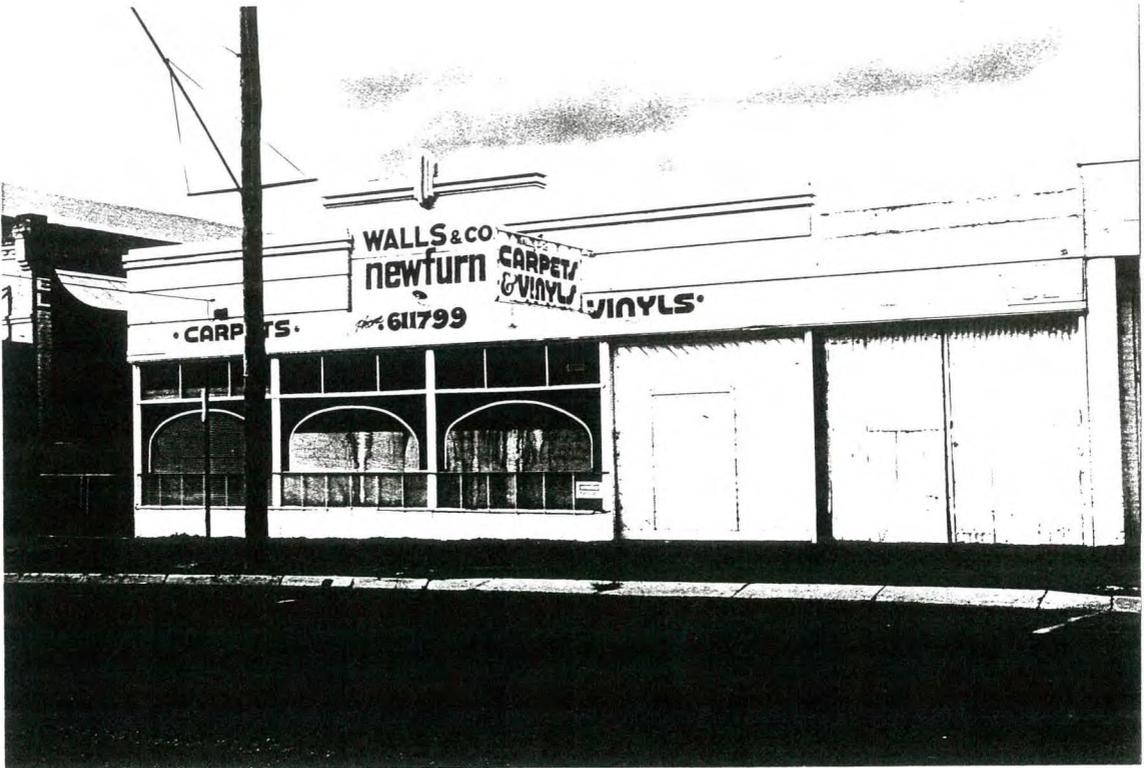
COMMERCIAL PREMISES,
50 NOLAN STREET,
MARYBOROUGH.

BUILT:	1930S?
THEMES ILLUSTRATED BY THIS PLACE:	PRIVATE BUILDING - INTER-WAR YEARS
DEGREE OF SIGNIFICANCE:	LOCAL SIGNIFICANCE
EXTENT OF SIGNIFICANCE:	ENTIRE MAIN BUILDING AND SITE
RECOMMENDATIONS:	LOCAL PLANNING PROTECTION CONSERVATION AREA: NOLAN STREET

Repair parapet and building as necessary and made waterproof.
When repainting use original/period/appropriate paint colours and placement.
Ensure all roof and ground-water is collected and taken well away from the building.
Regular maintenance as necessary.
Ensure all new signage is similarly lettered and placed.

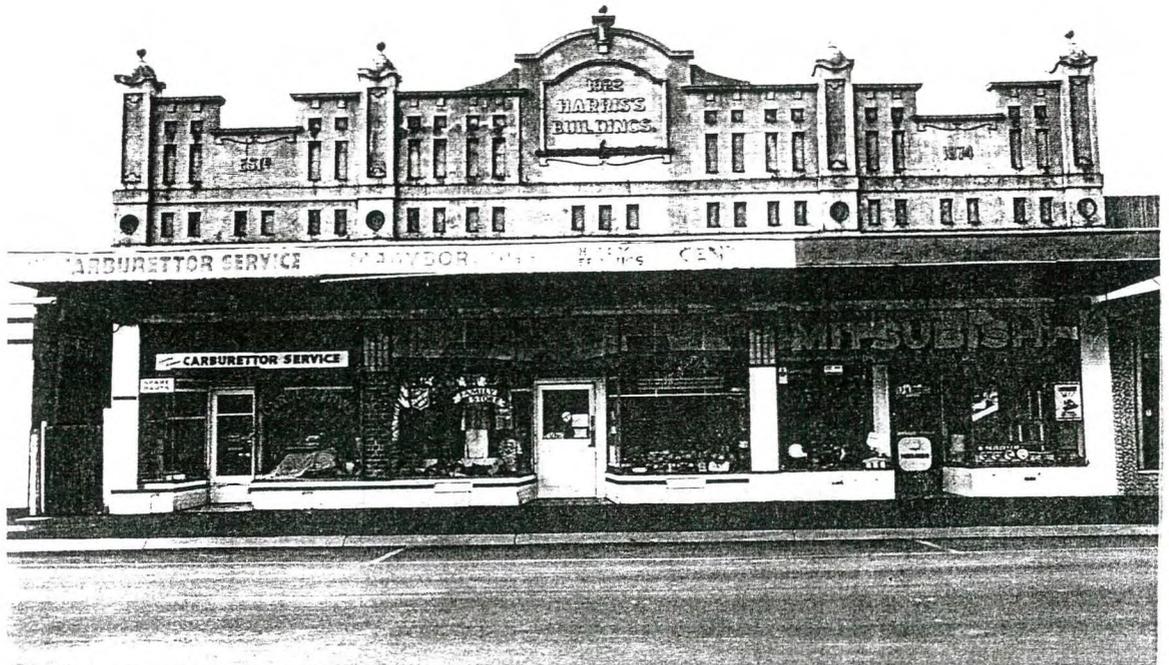
SHOP WITH ORIGINAL SHOPFRONT,
78 NOLAN STREET,
MARYBOROUGH.

BUILT:	1920S/1930S
THEMES ILLUSTRATED BY THIS PLACE:	PRIVATE BUILDING - INTER-WAR YEARS
DEGREE OF SIGNIFICANCE:	LOCAL SIGNIFICANCE
EXTENT OF SIGNIFICANCE:	ENTIRE BUILDING - THE INTACT FRONT FACADE, VERANDAH AND TO A LESSER DEGREE THE SHOP AREA COMPRISE THE SIGNIFICANCE.
RECOMMENDATIONS:	LOCAL PLANNING PROTECTION CONSERVATION AREA : HIGH STREET - NOLAN STREET

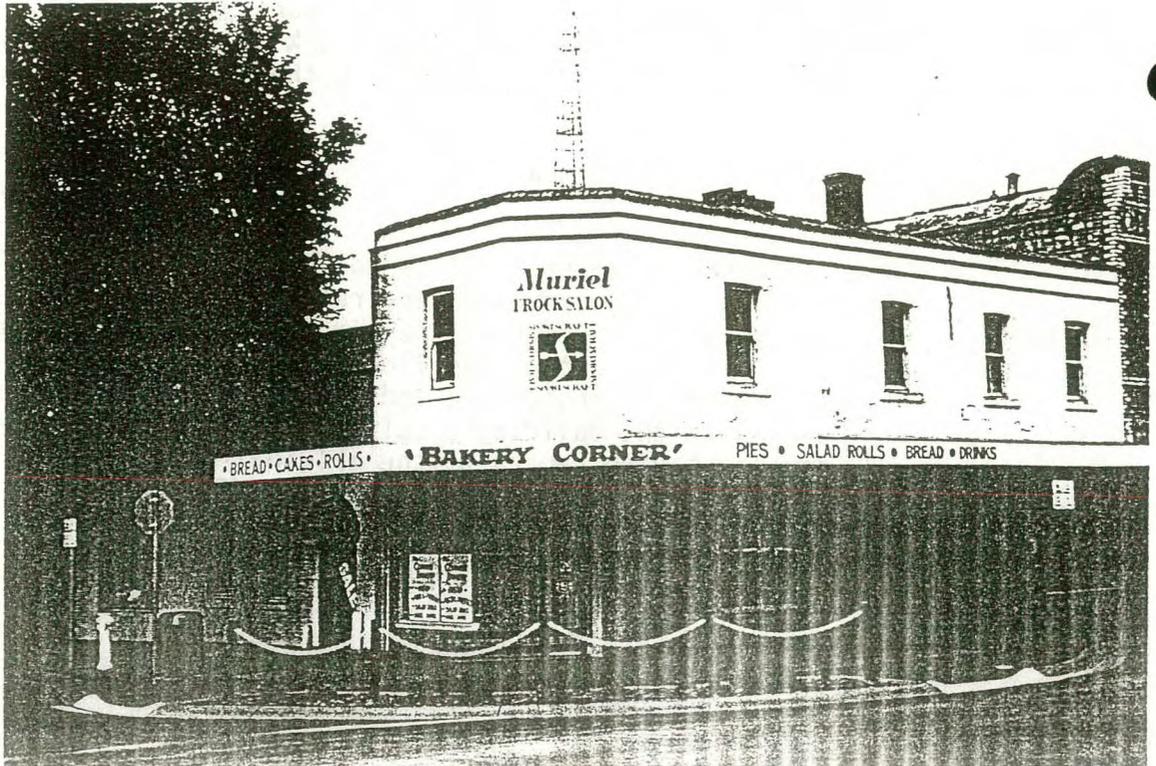
TWO SHOPS,
N.E. CNR. ALMA STREET,
96-100 NOLAN STREET,
MARYBOROUGH.

BUILT:	19TH CENTURY - 1850S/1860S/1870S? C.1930S FACADE REWORKED 1950S/1960S AND RECENT TIMES SHOPFRONTS
THEMES ILLUSTRATED BY THIS PLACE:	PRIVATE BUILDING - VICTORIAN
DEGREE OF SIGNIFICANCE:	LOCAL SIGNIFICANCE
EXTENT OF SIGNIFICANCE:	ENTIRE BUILDING AND SITE, INCLUDING PRE 1920 REAR OUTBUILDINGS.
RECOMMENDATIONS:	LOCAL PLANNING PROTECTION CONSERVATION AREA: NOLAN STREET

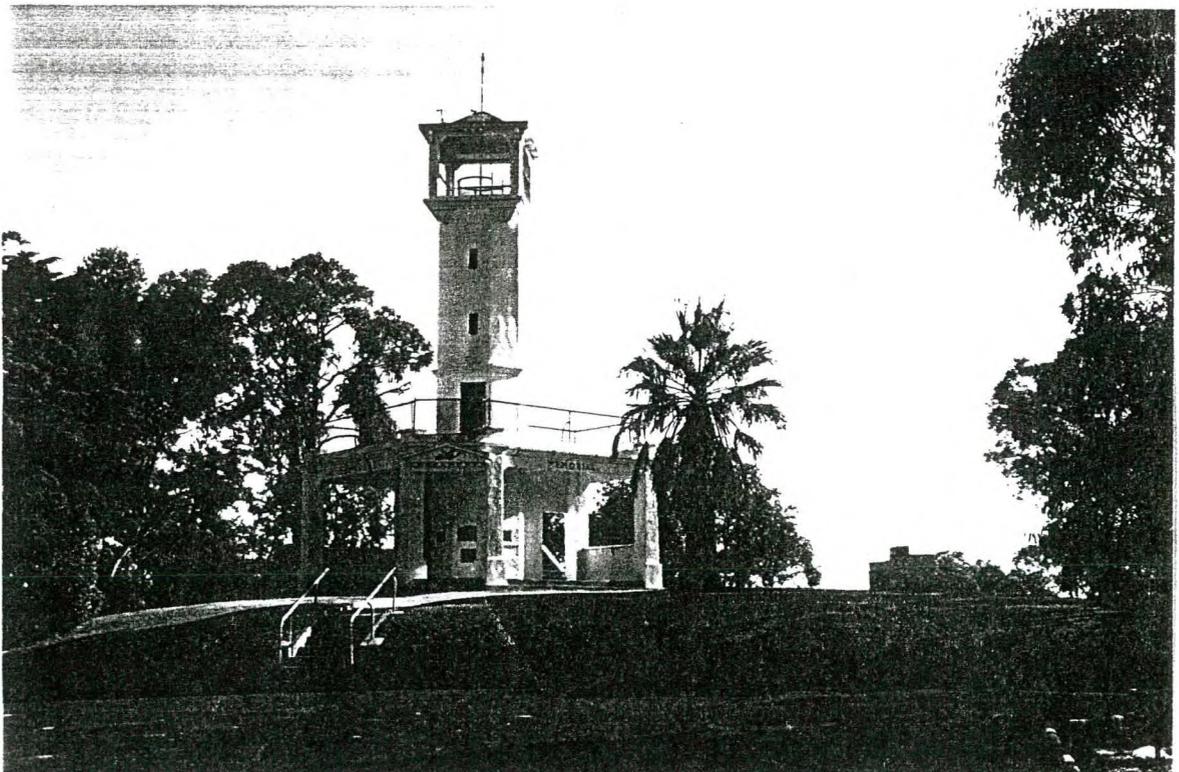
BUILT:	1932-33 ¹
THEMES ILLUSTRATED BY THIS PLACE:	SPORT AND RECREATION PUBLIC BUILDING - INTER-WAR
DEGREE OF SIGNIFICANCE:	OF LOCAL SIGNIFICANCE
EXTENT OF SIGNIFICANCE:	TOWER, STONE SEAT, MATURE PALM AND CONIFER TREES, SITE TO A RADIUS OF 1,000 METRES
RECOMMENDATIONS:	LOCAL PLANNING PROTECTION CONSERVATION AREA - BRISTOL HILL

- Regular maintenance as necessary.
Monitor the lack of drainage outlets to the top floor to establish if this causes rainwater to soak into the structure and cause decay, as well as making the steps slippery. Keep the tower intact.
- When repainting use original colour or another appropriate paint colour. The present white colour causes the tower to merge into the sky when seen from a distance, while a suitable colour would ensure that the tower could always be seen and thus appreciated.
- Keep the exotically planted character of the tower's immediate surroundings, which have always contrasted with their bushland surroundings and illustrate public landscaping of the period.
