central Goldfields Shire
(Former city of Maryborough)
Maryborough
Heritage Study 1992

BOOK 4 - Majorca - Palmerston

HERITAGE STUDY

BOOK 4

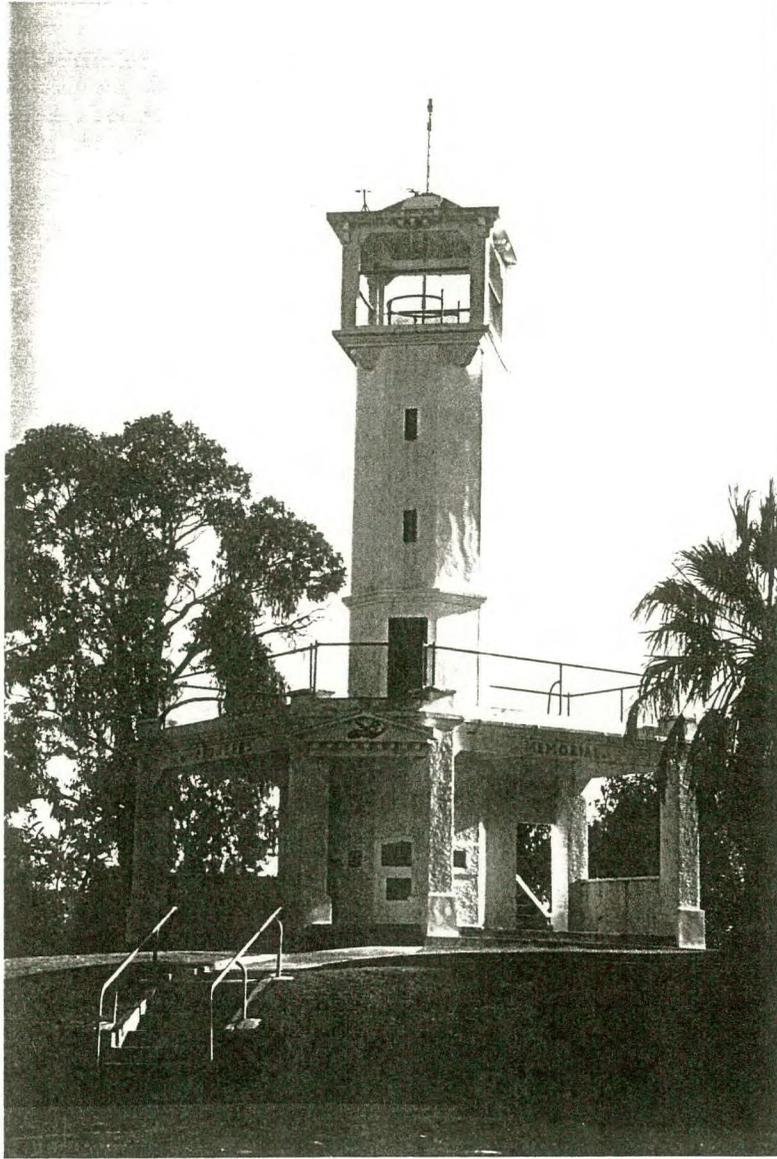
LOOK-OUT TOWER, TWO STONE SEATS,
TWO MATURE PALM AND CONIFER TREES,
OUTEN DRIVE,
BRISTOL HILL,
MARYBOROUGH.

BUILT:	1932-33 ¹
THEMES ILLUSTRATED BY THIS PLACE:	SPORT AND RECREATION PUBLIC BUILDING - INTER-WAR
DEGREE OF SIGNIFICANCE:	OF LOCAL SIGNIFICANCE
EXTENT OF SIGNIFICANCE:	TOWER, STONE SEAT, MATURE PALM AND CONIFER TREES, SITE TO A RADIUS OF 1,000 METRES
RECOMMENDATIONS:	LOCAL PLANNING PROTECTION CONSERVATION AREA - BRISTOL HILL

- Regular maintenance as necessary.
Monitor the lack of drainage outlets to the top floor to establish if this causes rainwater to soak into the structure and cause decay, as well as making the steps slippery. Keep the tower intact.
- When repainting use original colour or another appropriate paint colour. The present white colour causes the tower to merge into the sky when seen from a distance, while a suitable colour would ensure that the tower could always be seen and thus appreciated.
- Keep the exotically planted character of the tower's immediate surroundings, which have always contrasted with their bushland surroundings and illustrate public landscaping of the period.

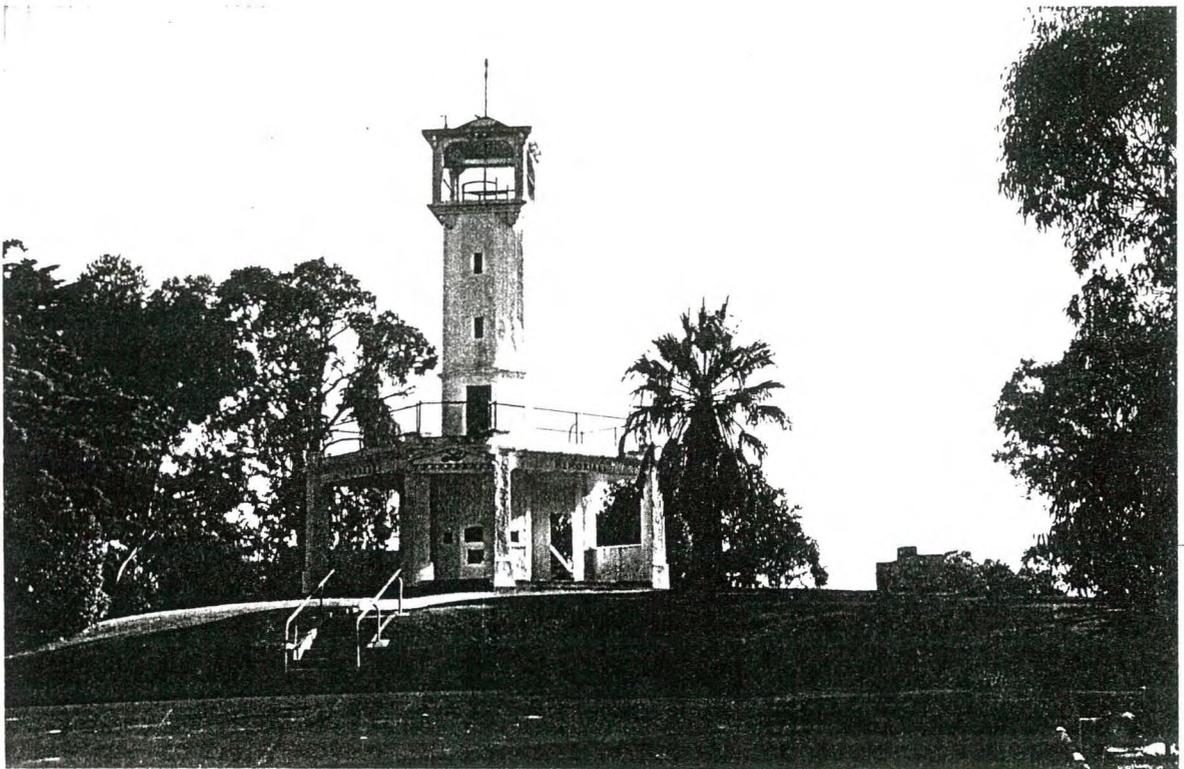
Washingtonia filifera AND
Trachycarpus futurei - CHINESE WINDMILL PALM,
PIONEERS MEMORIAL,
BRISTOL HILL,
MARYBOROUGH.

Poor forms of trees because of stress, mostly water stress, which has now been reduced because of irrigation. Trees form an excellent group in conjunction with memorial tower.

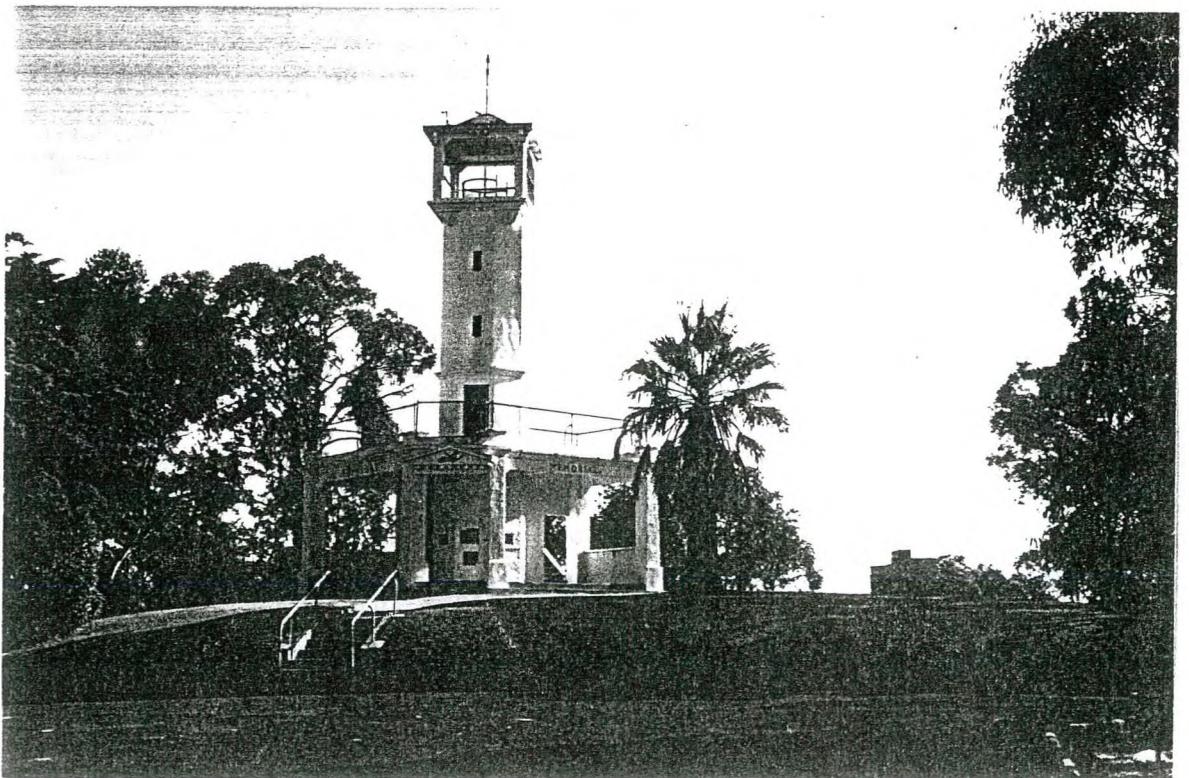
Look-out Tower Cont.

BUILT:	1932-33 ¹
THEMES ILLUSTRATED BY THIS PLACE:	SPORT AND RECREATION PUBLIC BUILDING - INTER-WAR
DEGREE OF SIGNIFICANCE:	OF LOCAL SIGNIFICANCE
EXTENT OF SIGNIFICANCE:	TOWER, STONE SEAT, MATURE PALM AND CONIFER TREES, SITE TO A RADIUS OF 1,000 METRES
RECOMMENDATIONS:	LOCAL PLANNING PROTECTION CONSERVATION AREA - BRISTOL HILL

Monitor the lack of drainage outlets to the top floor to establish if this causes rainwater to soak into the structure and cause decay, as well as making the steps slippery. Keep the tower intact.

When repainting use original colour or another appropriate paint colour. The present white colour causes the tower to merge into the sky when seen from a distance, while a suitable colour would ensure that the tower could always be seen and thus appreciated.

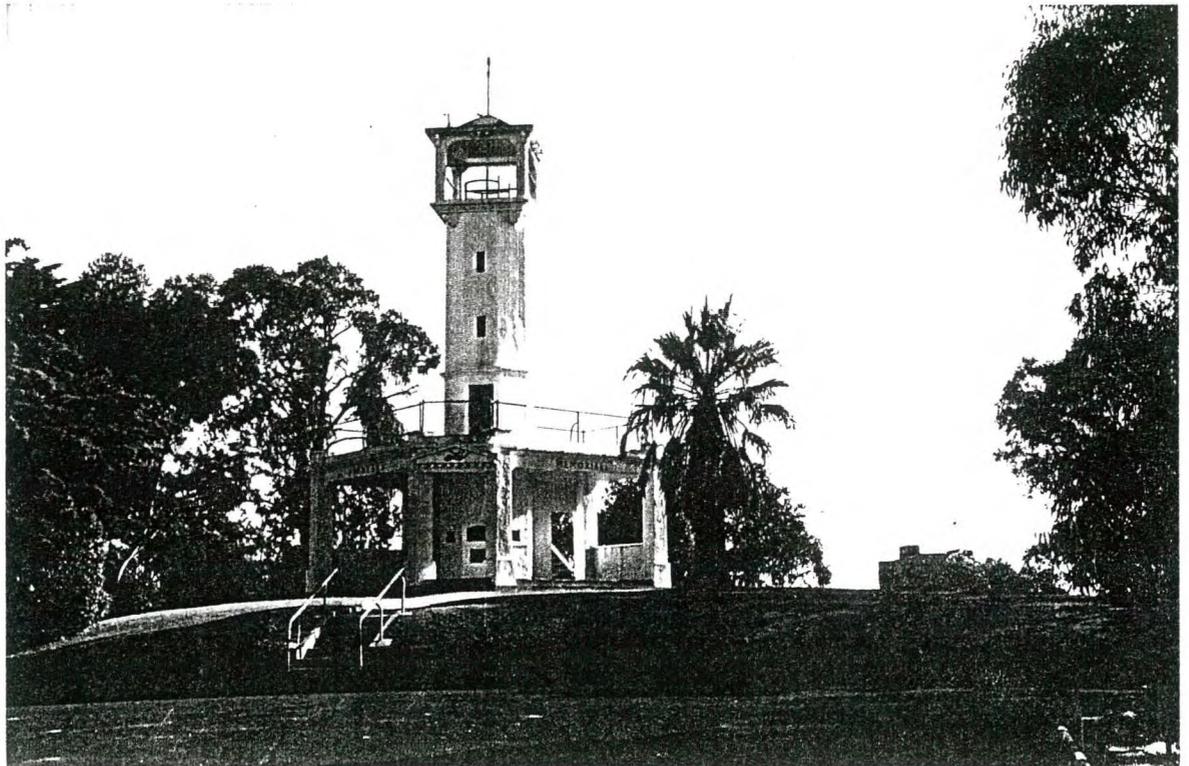
Washingtonia filifera AND
Trachycarpus fortunei - CHINESE WINDMILL PALM,
PIONEERS MEMORIAL,
BRISTOL HILL,
MARYBOROUGH.

Poor forms of trees because of stress, mostly water stress, which has now been reduced because of irrigation. Trees form an excellent group in conjunction with memorial tower.

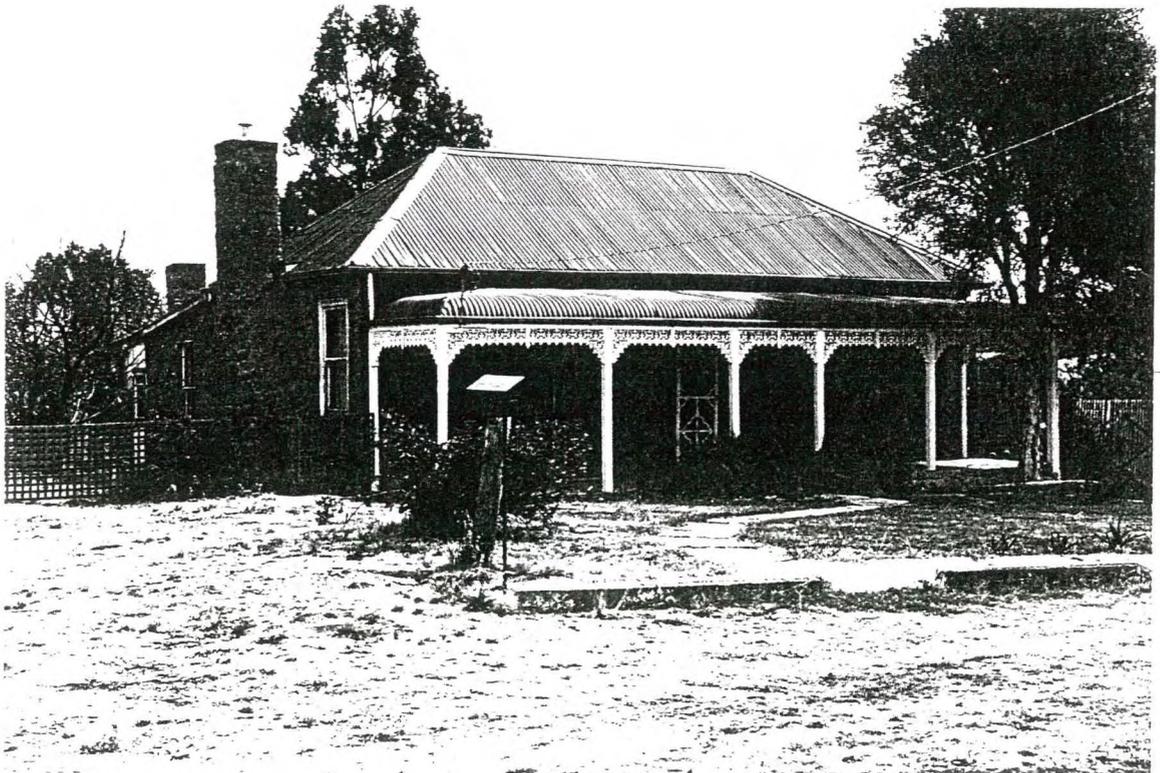
1) ADOBE HOUSE AND 2) CONCRETE BLOCK GARAGE,
27 OUTTRIM STREET,
MARYBOROUGH.

BUILT:	1) 1880S/1890S/1900S 2) 1930S OR LATER
THEMES ILLUSTRATED BY THIS PLACE:	PRIVATE BUILDING - 1) VICTORIAN/EDWARDIAN 2) INTERWAR YEARS
DEGREE OF SIGNIFICANCE:	LOCAL SIGNIFICANCE
EXTENT OF SIGNIFICANCE:	ENTIRE BUILDING, GARAGE AND SITE
RECOMMENDATIONS:	LOCAL PLANNING PROTECTION

The concrete verandah floor slab will be causing rising damp.

This could be obviated by installing in-ground drains around the perimeter of the building, as well as lowering the ground levels near the building on the south side.

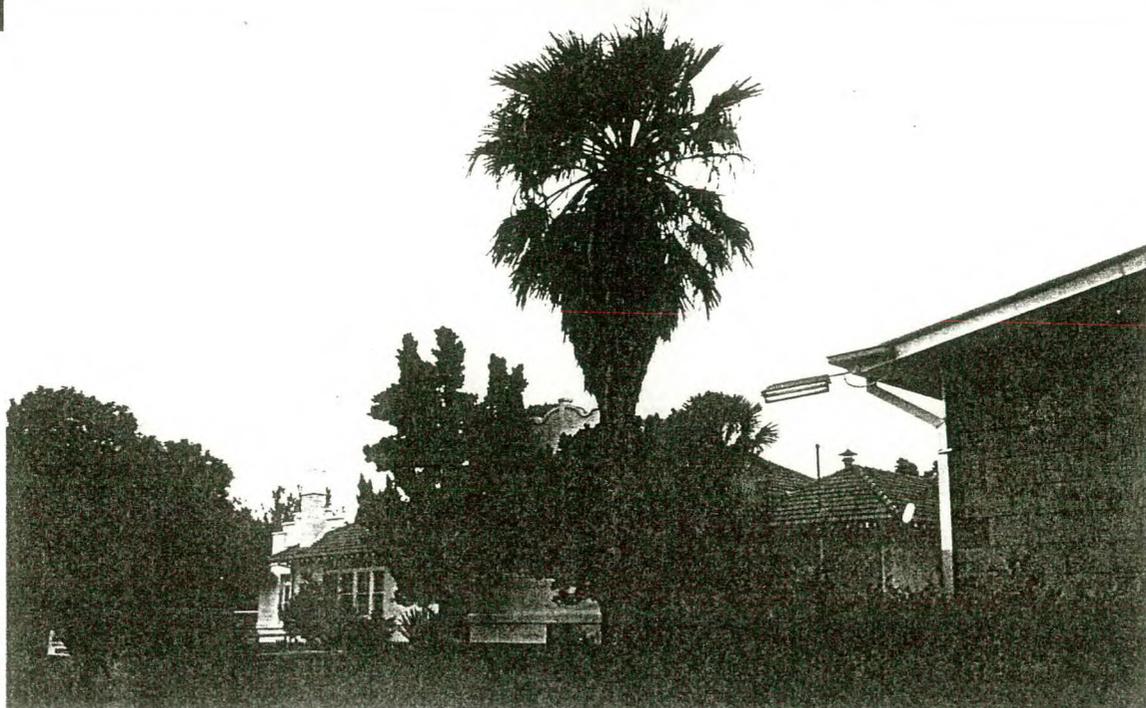
MARYBOROUGH HIGH SCHOOL MAIN
BUILDING, MATURE EXOTIC SITE
PLANTING AND SITE TO A RADIUS
OF 50 METRES FROM EACH
SIGNIFICANT ELEMENT,
PALMERSTON STREET,
MARYBOROUGH.

BUILT:	1915 ¹ (- 1916?)
THEMES ILLUSTRATED BY THIS PLACE:	EDUCATION PUBLIC BUILDING - EDWARDIAN
DEGREE OF SIGNIFICANCE:	LOCAL SIGNIFICANCE
EXTENT OF SIGNIFICANCE:	ENTIRE BUILDING, EXOTIC SITE PLANTING AND SITE TO A RADIUS OF 50 METRES
RECOMMENDATIONS:	LOCAL PLANNING PROTECTION CONSERVATION AREA: MARYBOROUGH WEST

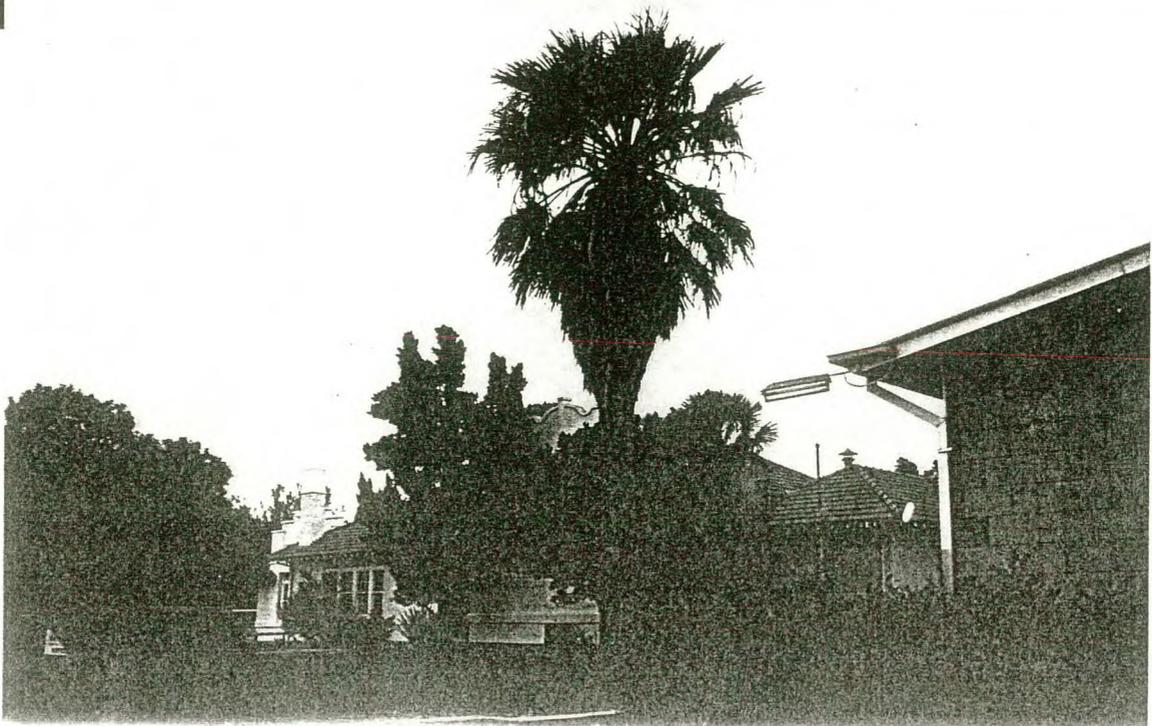
Arbutus unedo - IRISH STRAWBERRY TREE,
Washingtonia filifera AND
Lophostemon aufotus - QUEENSLAND BRUSH BOX,
SCHOOL GROUNDS OF MARYBOROUGH HIGH SCHOOL,
MARYBOROUGH.

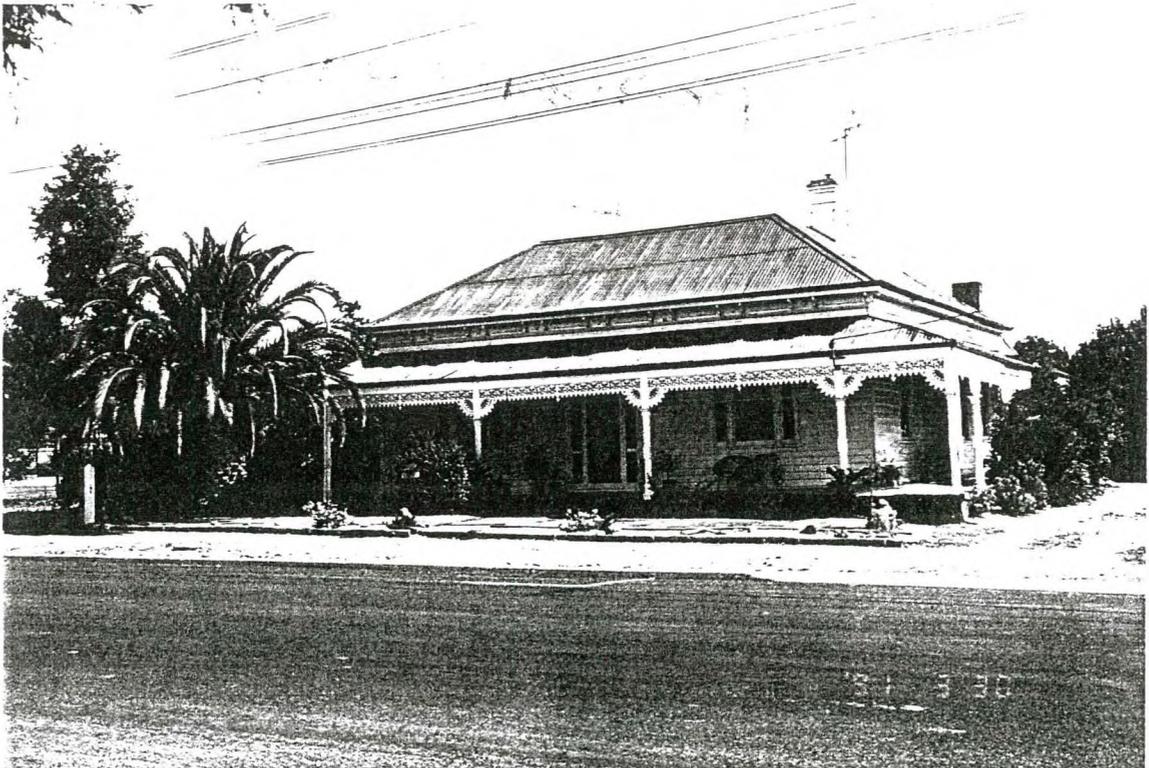
WEATHERBOARD RESIDENCE AND MATURE
CANARY ISLAND PALM TREE,
37 PALMERSTON STREET,
MARYBOROUGH.

BUILT:	CIRCA 1890/1900
THEMES ILLUSTRATED BY THIS PLACE:	PRIVATE BUILDING - VICTORIAN/EDWARDIAN
DEGREE OF SIGNIFICANCE:	LOCAL SIGNIFICANCE
EXTENT OF SIGNIFICANCE:	ENTIRE BUILDING, INCLUDING CANARY ISLAND PALM TREE AND SITE.
RECOMMENDATIONS:	LOCAL PLANNING PROTECTION CONSERVATION AREA: MARYBOROUGH WEST GROUP WITH NO.39

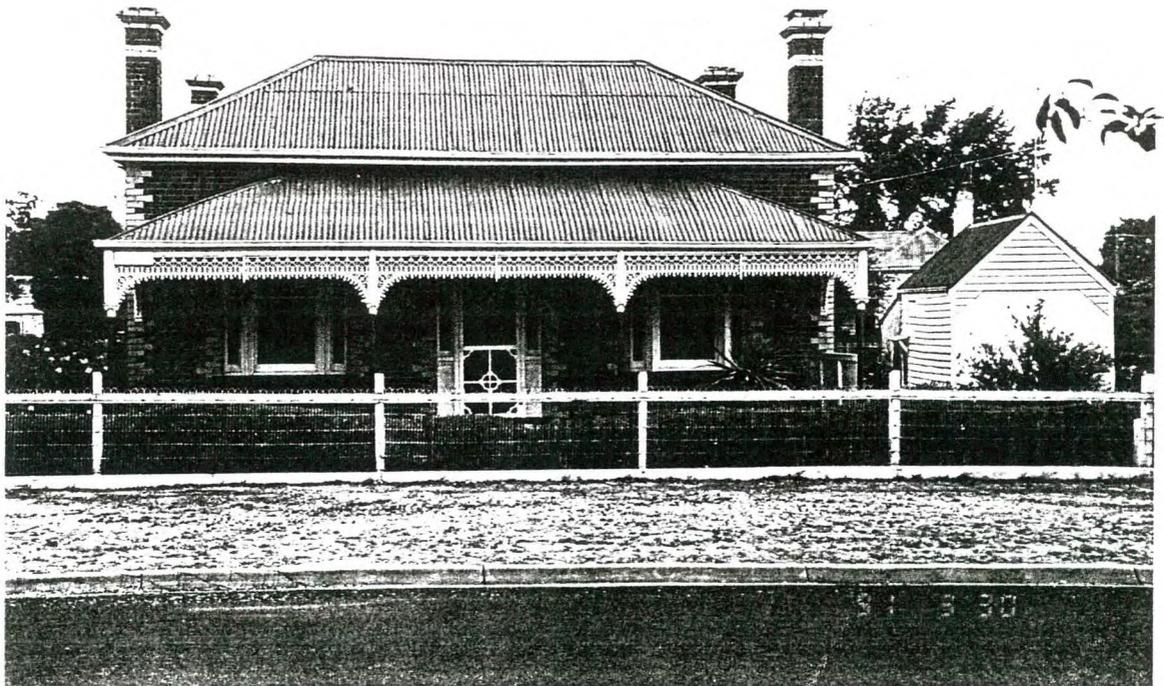
DUOCHROMATIC FACE BRICK RESIDENCE,
FRONT FENCE AND WEATHERBOARD
GARAGE BUILDING,
N.E. CNR. NEWTON STREET,
41 PALMERSTON STREET,
MARYBOROUGH.

BUILT:	1890 ¹
THEMES ILLUSTRATED BY THIS PLACE:	PRIVATE BUILDING - VICTORIAN/EDWARDIAN
DEGREE OF SIGNIFICANCE:	LOCAL SIGNIFICANCE
EXTENT OF SIGNIFICANCE:	ENTIRE BUILDING, FRONT FENCE, WEATHERBOARD GARAGE BUILDING AND SITE.
RECOMMENDATIONS:	LOCAL PLANNING PROTECTION CONSERVATION AREA: MARYBOROUGH WEST GROUP WITH NOS.37-39 AND 1 AND 6 NEWTON STREET

A key streetscape element at this intersection, part of a group of houses from that circa 1900 period, this residence is also one of the small number of pre 1910 brick dwellings in the Municipality, the vast majority being of timber construction. The woven wire fence replaced the original timber picket fence and has an uncommon pattern with a central wire in each arched panel. This residence has been in the ownership of the one family since it was built.¹

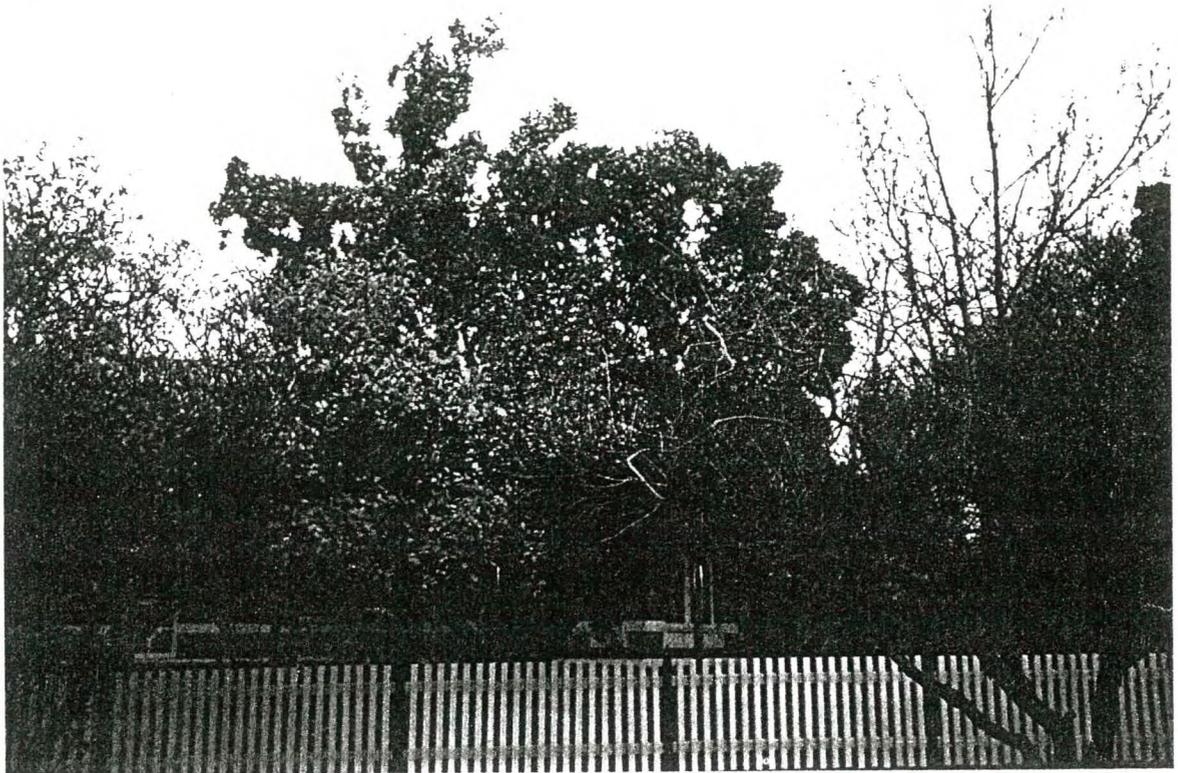
Crataegus stipulacea - MEXICAN HAWTHORN,
42 PALMERSTON STREET,
MARYBOROUGH.

Very characteristic of plantings of the mid years of the twentieth century. An especially fine form in good vigour and health.

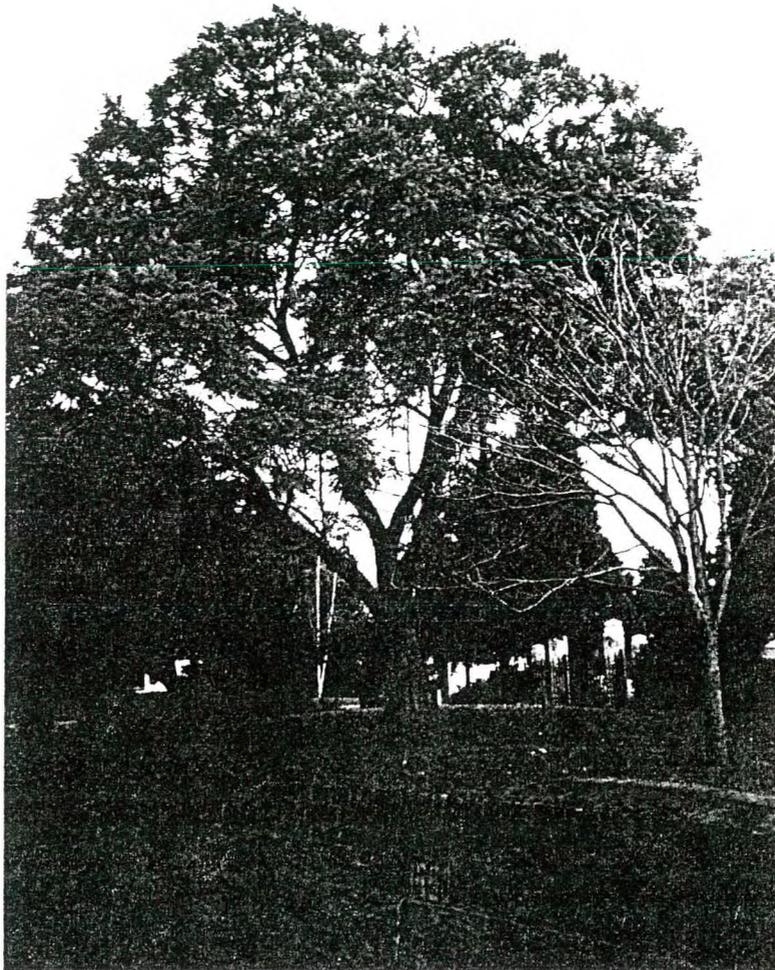
Jacaranda mimosaeifolia - JACARANDA,
PRINCE'S PARK,
NEAR MAIN ENTRANCE,
MARYBOROUGH.

Fine mature specimen with superb symmetrical canopy. Offers a significant visual element at entry to site.

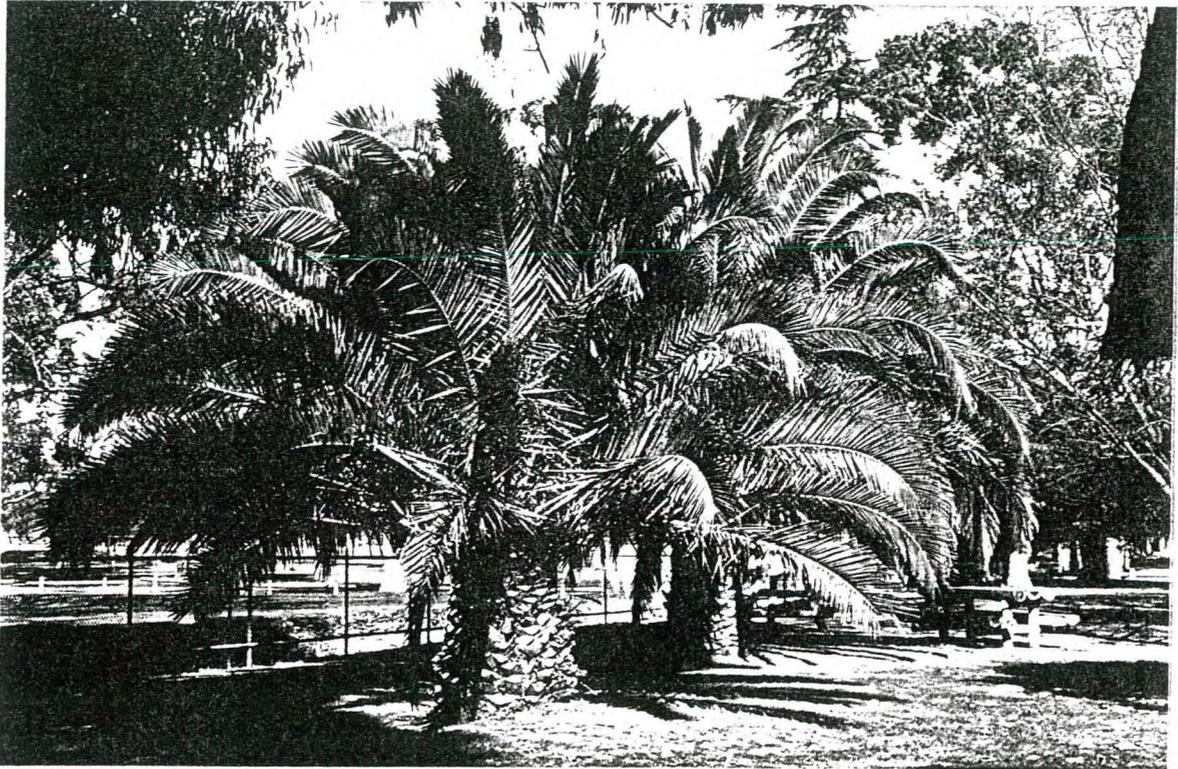
Phoenix canariensis (x2) - CANARY ISLAND PALM,
CORONATION PLANTATION,
PARK ROAD,
MARYBOROUGH.

Two trees in fine condition offering textural details and richness to an otherwise blandly textured landscape.

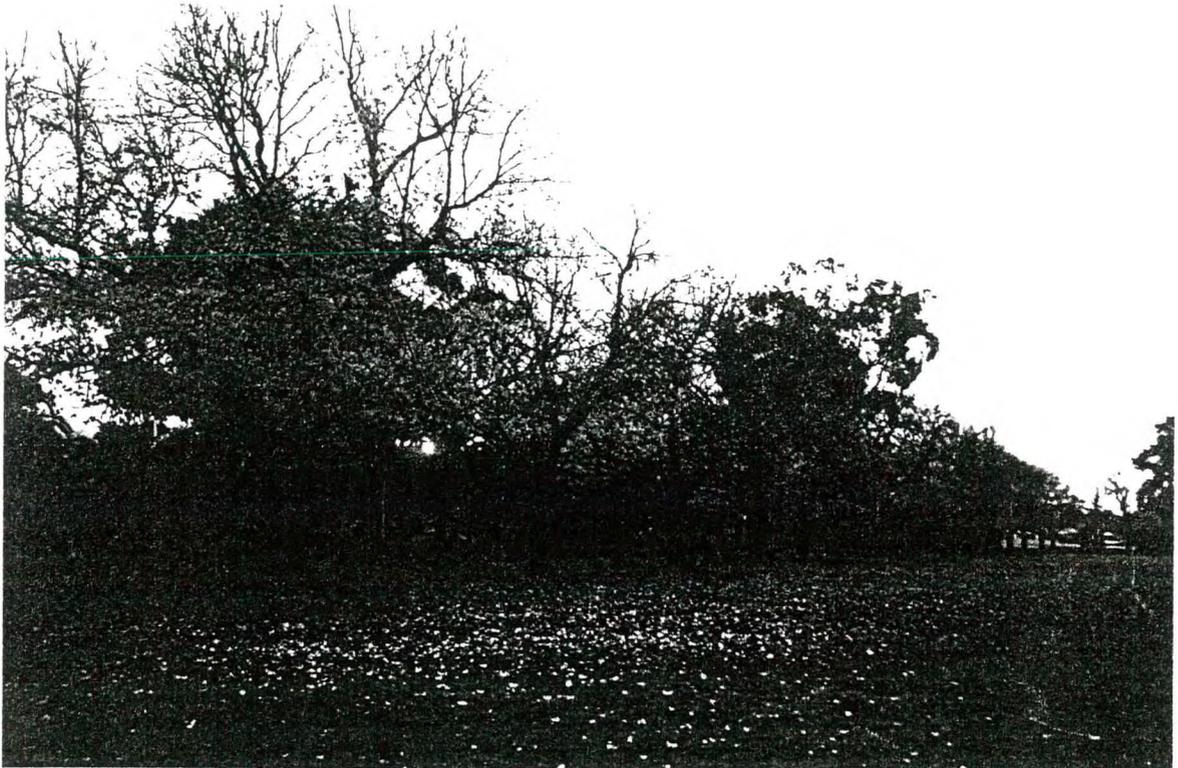
Ulmus procera (x20) - ENGLISH ELM,
INTERFACE BETWEEN NORTH-WEST CORNER OF
PRINCES PARK AND PARK AND HOLYROOD
ROADS,
MARYBOROUGH.

Critical planting element to achieve definition to boundary of park. Formal planting intact and without any evidence of upper canopy work which so often mars these trees.

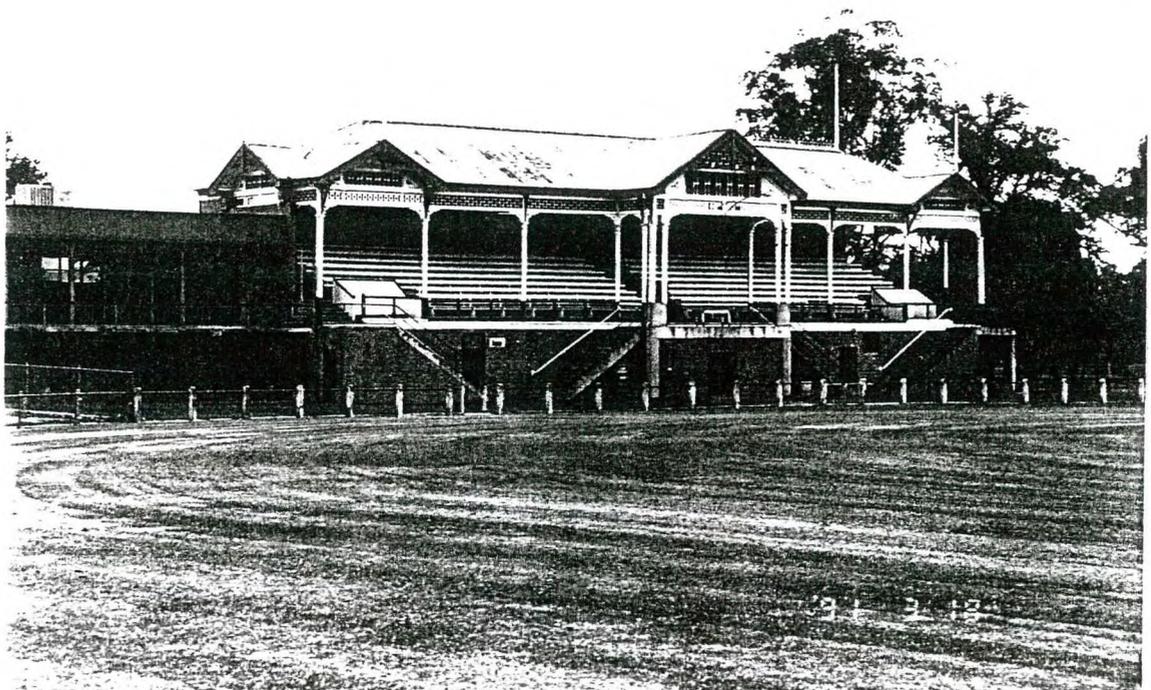
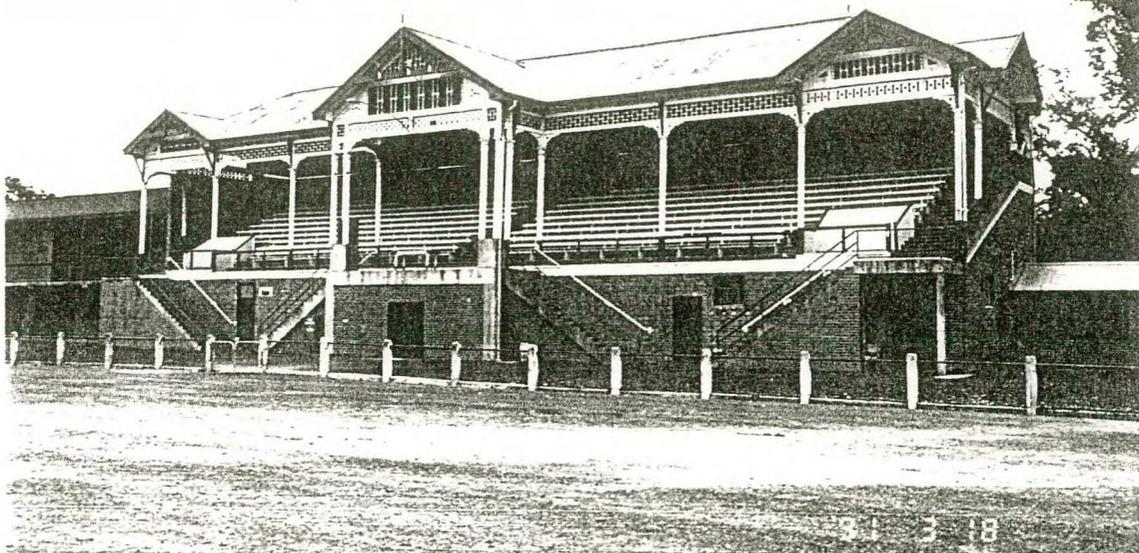
EXTENT OF SIGNIFICANCE: ENTIRE GRANDSTAND AND SITE
TO A RADIUS OF 300 METRES

The grandstand is in need of maintenance and repair.
Inspect regularly and maintain as necessary.
Ensure all roof and ground-water is collected and carried well away from the building.
Keep intact.
Replicate missing flagpole.
When repainting use original/period paint colours and placement.

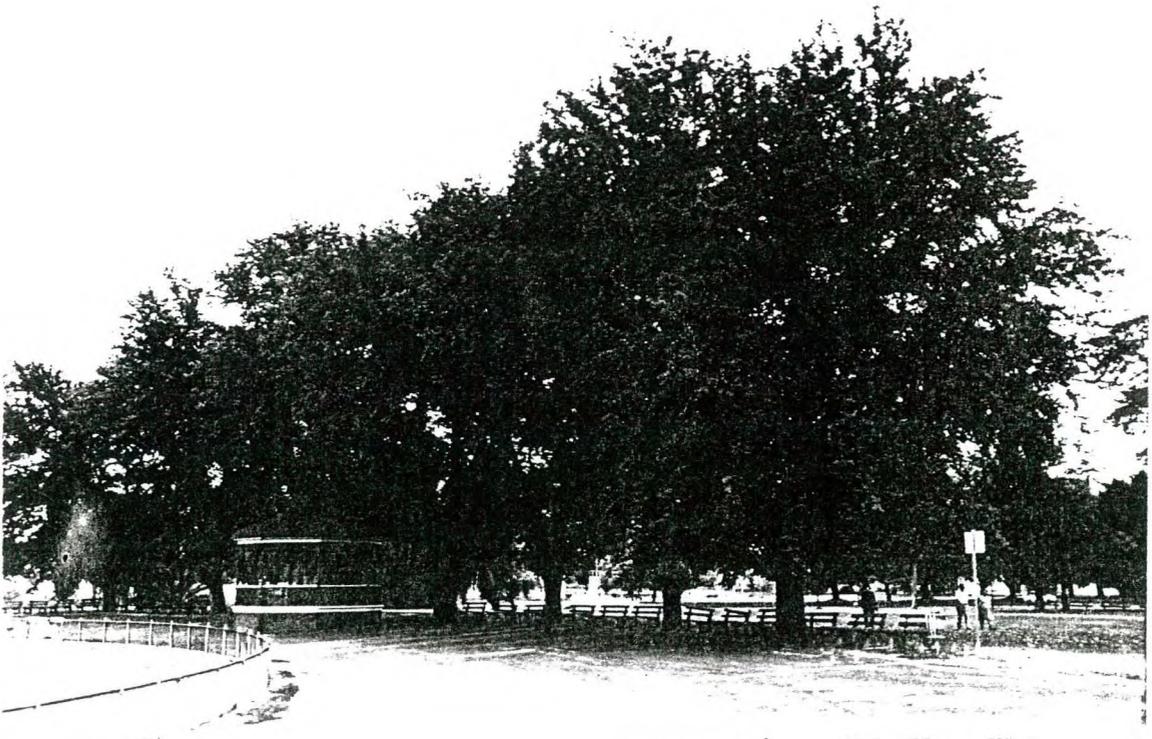
Designed in 1904 by H.N. Phillips, Maryborough's Town Clerk from 1888-1935 and completed in 1905,¹ the Rotunda in Prince's Park has significance for its associations with Maryborough's golden jubilee, with the historic recreational reserve, with an important local government officer, and as a fine example of the splendid cast iron work of a local firm, Robinson's Soho Foundry.¹ The bandstand was an important part of social life during the late 19th and early 20th centuries and the combination of bandstand, grandstand, lake, entry gates and mature exotic planting results in an intact circa 1900 pleasure park.

Original Use:	Band Rotunda
Original Owner:	Borough of Maryborough
Architect/Designer:	H.N. Phillips, Town Clerk. ¹
Builder/Artisan:	Robinson's Soho Foundry (cast iron work). ¹
Cost:	£130 (included gas lighting). ¹

Regular maintenance as necessary.
Ensure all roof and ground-water is collected and carried well away.
When repainting use original/period paint colours and placement.

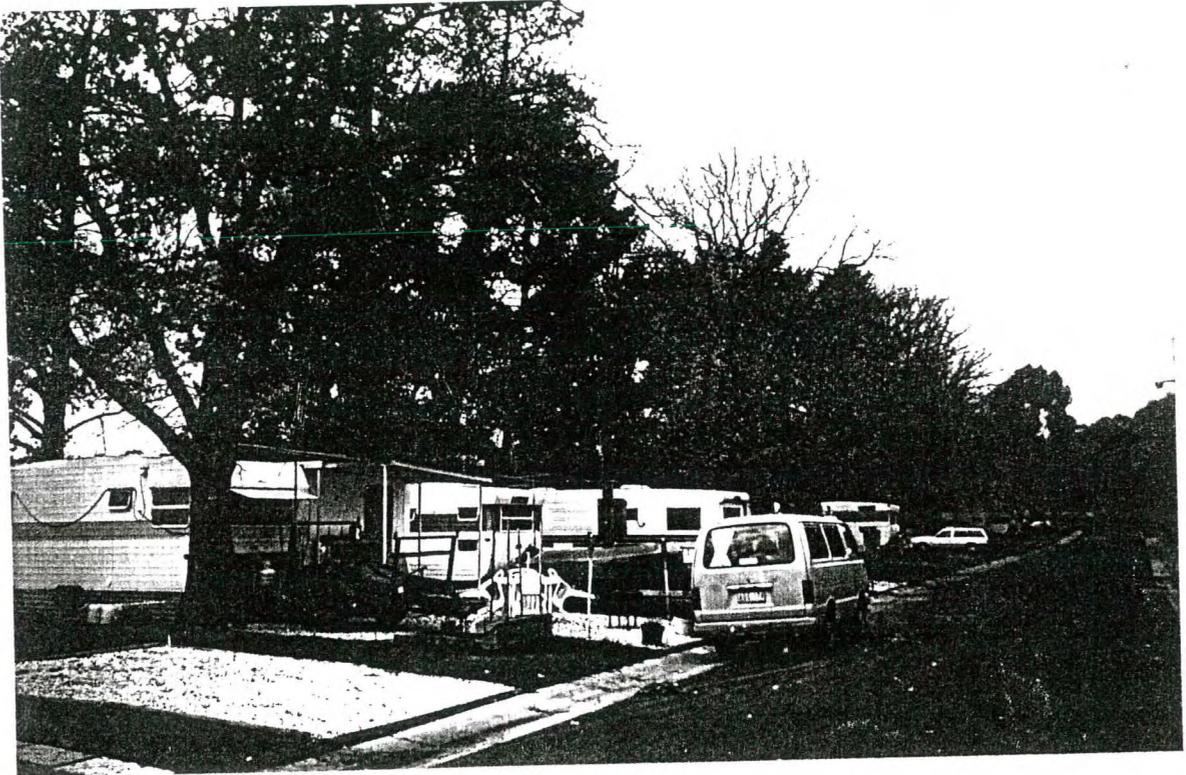
Row of trees providing an enclosing boundary to Princes Park, defining space and establishing visual screen to caravans.

Condition appears sound but must eventually suffer from compaction caused by caravans and vehicles. This should be restricted if possible.

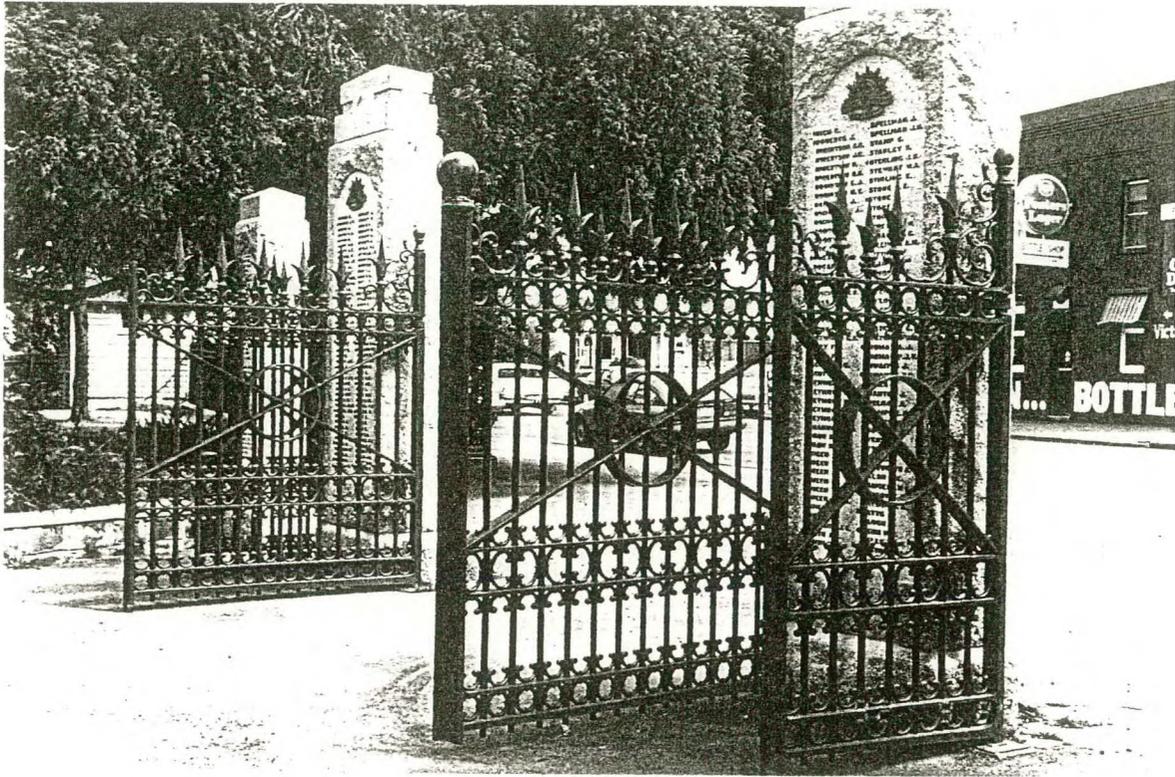
Regular maintenance as required - in good condition presently.
1991 black paint? is coming off the letters already.

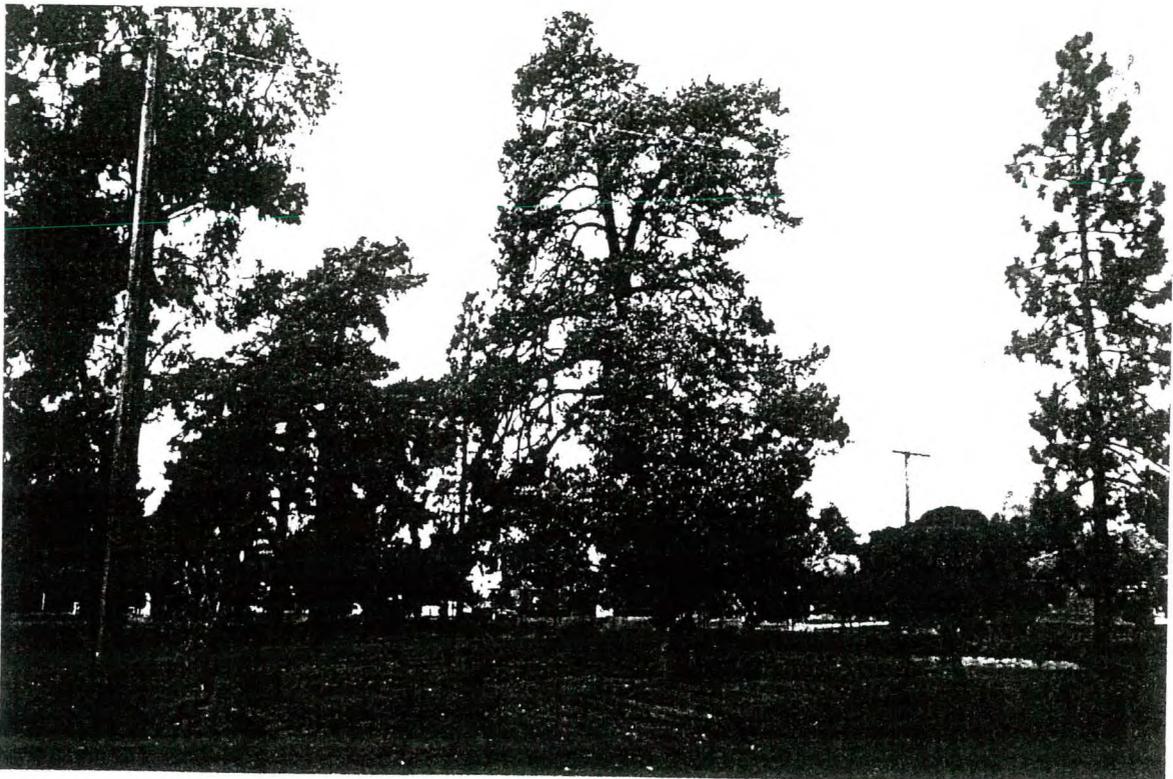
Planting to enclose and delineate the boudnary to Prince's Park, now rather tattered because of loss of several over-mature trees. General character of side of park has changed with loss of trees.

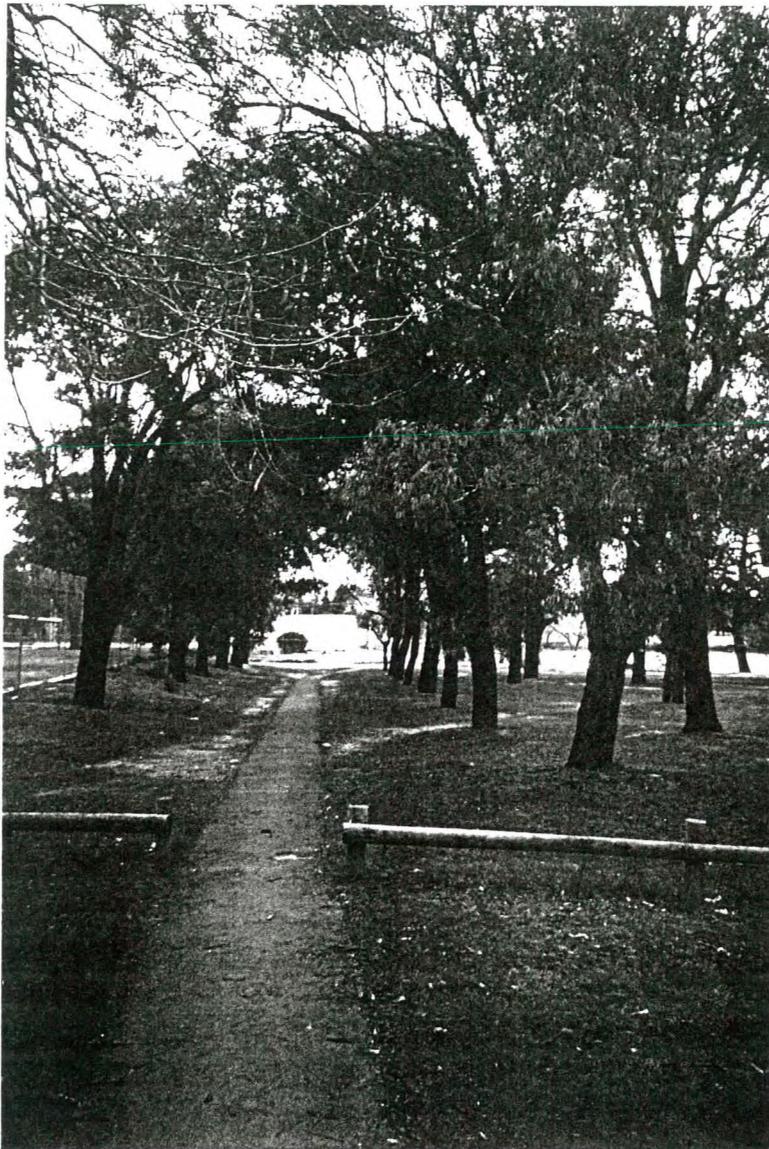
Eucalyptus tricarpa (x22)
- SUMMER FLOWERING IRONBARK TREES,
PRINCES PARK ADJACENT TO LAWN TENNIS COURT,
MARYBOROUGH.

The formal planting of Australian native trees is rare yet this outstanding group shows the dramatic effects which could be achieved. This is a planting showing extraordinary vision and is most advanced in the use of Australian native trees.
