# Rural Mapping – Tullaroop Creek

Amendment c31cgol

September 2019

North  
Central  
CMA

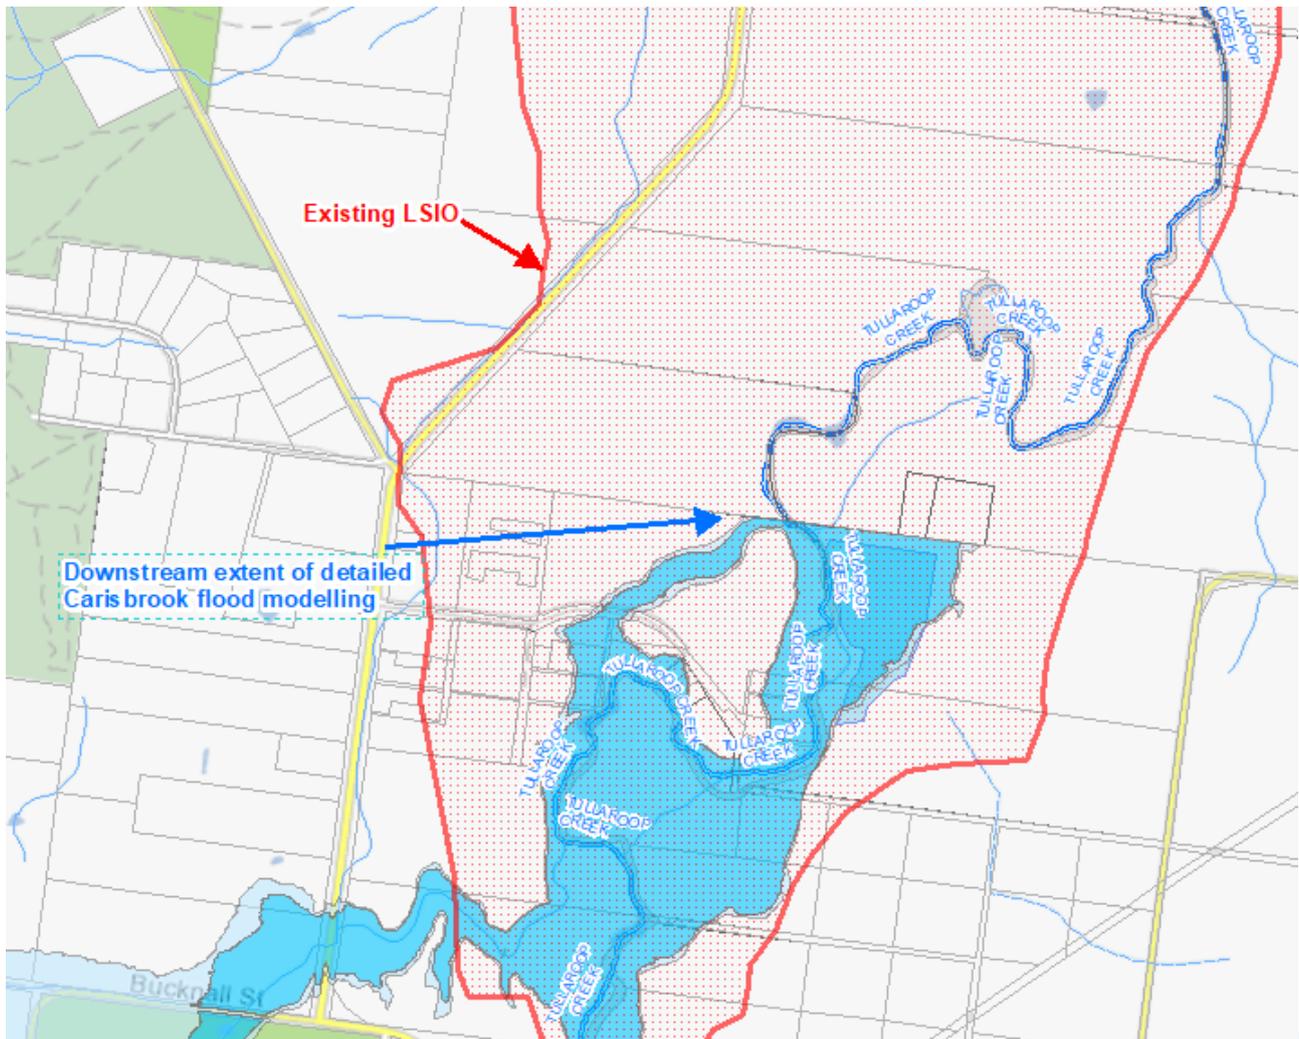
Figure 1 – Interface between existing LSIO and downstream boundary of detailed Carisbrook flood modelling

North Central CMA has taken this opportunity to undertake rapid flood modelling to refine and update the LSIO overlay upstream of Carisbrook through to Tullaroop Reservoir and downstream of Carisbrook through to the council boundary. This report provides a summary of the methodology undertaken to prepare updated LSIO maps for the rural sections of Tullaroop Creek within the Central Goldfields municipality.

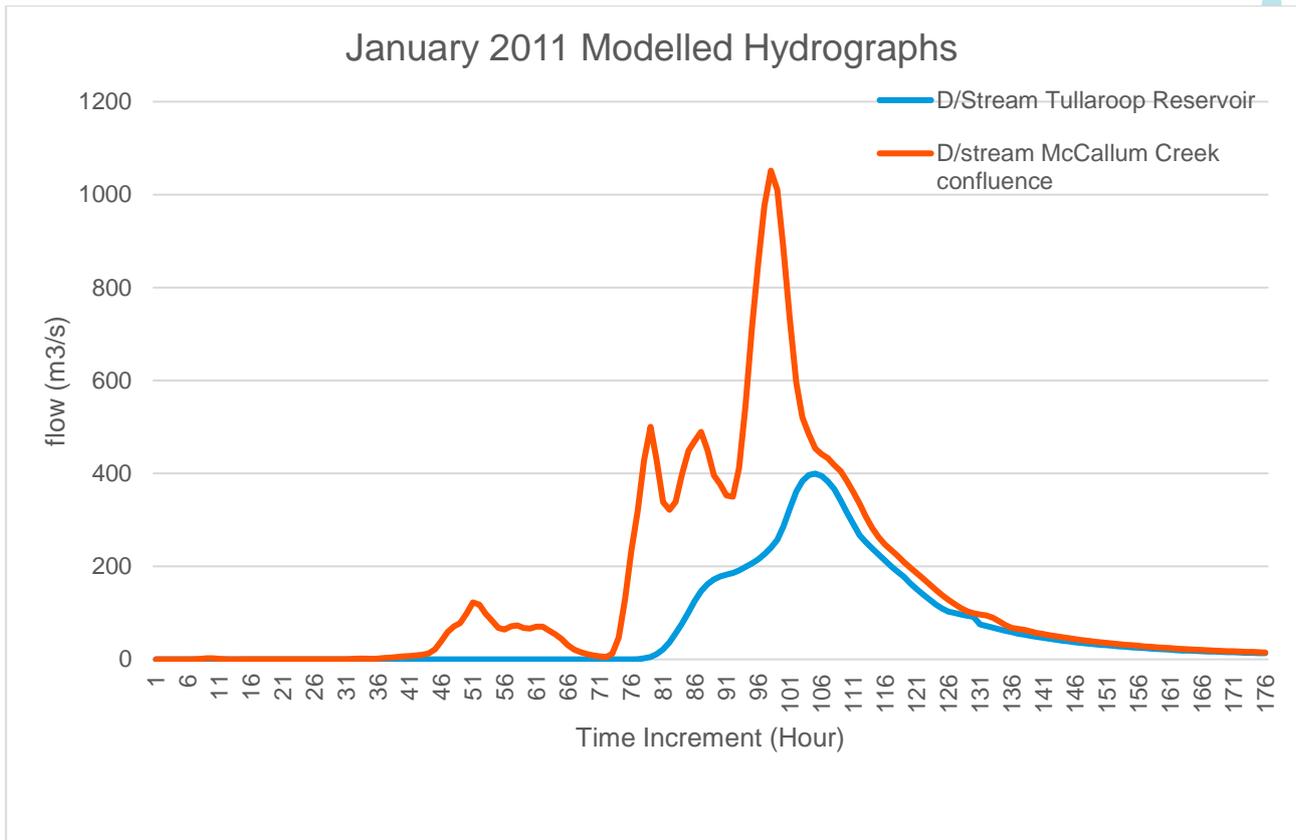
The two hydrographs extracted from the hydrologic model that were used in the hydraulic modelling are shown in Figure 2 below:

Figure 2 – January 2011 modelled hydrographs

A detailed hydrologic model was prepared as part of the Carisbrook Flood and Drainage Management Plan. Modelled hydrographs for the January 2011 flood event were extracted from this hydrologic model. There are two key locations where hydrographs are required:

- Tullaroop Creek downstream of Tullaroop Reservoir; and
- Tullaroop Creek downstream of the confluence with McCallums Creek

The inflow boundary condition for Model 1 was the calculated hydrograph for the January 2011 flood event directly downstream of Tullaroop Reservoir.

The inflow boundary condition for Model 2 was the calculated hydrograph for the January 2011 flood event directly downstream of the confluence of McCallums Creek. There are no significant tributaries or flow paths downstream of McCallums Creek to warrant adding inflow boundaries to the model.

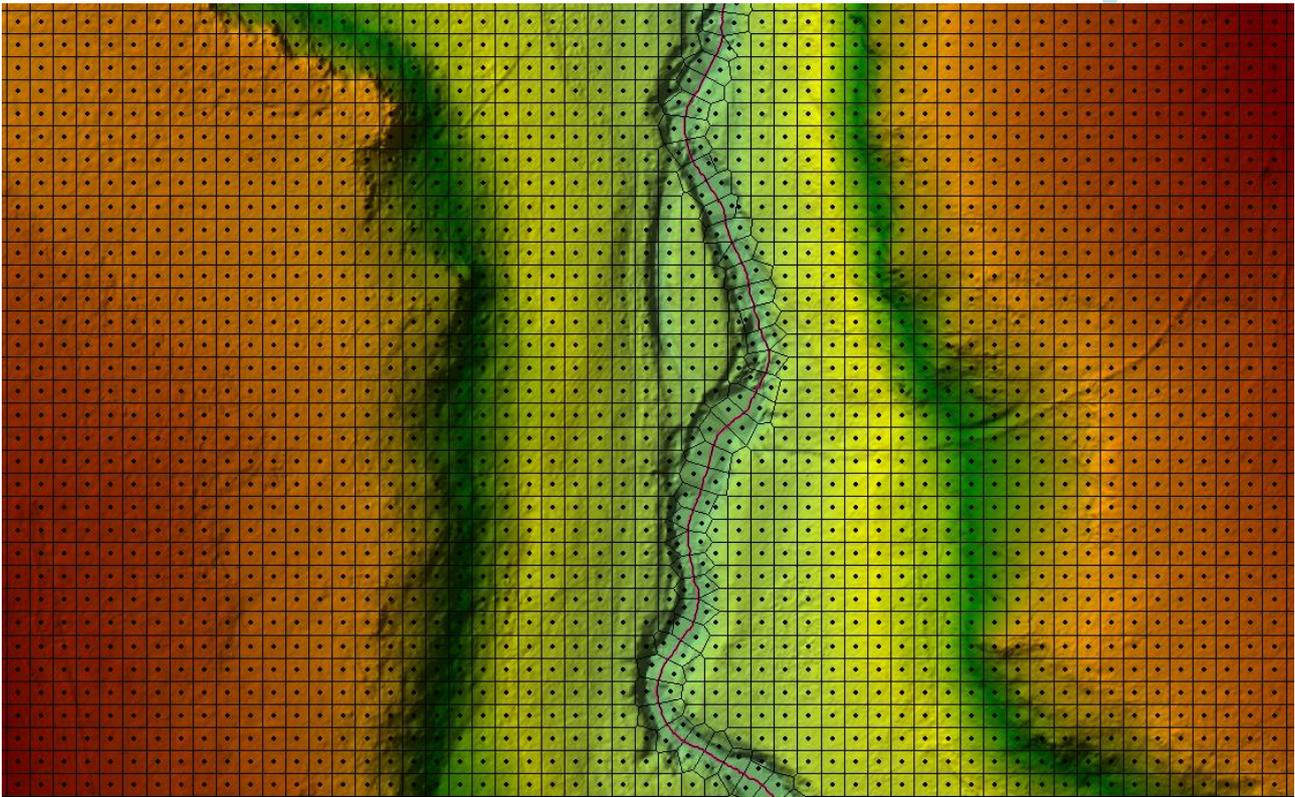
waterway. Figure 3 below shows an extract of the hydraulic model showing the delineation of the cells within the model.

Figure 3 – Example of cell delineation within the hydraulic model

A model cell grid size of 10 metres was used for each of the models. Breaklines for the centreline of Tullaroop Creek were used to ensure that there were sufficient cells to pick up the general topography of the

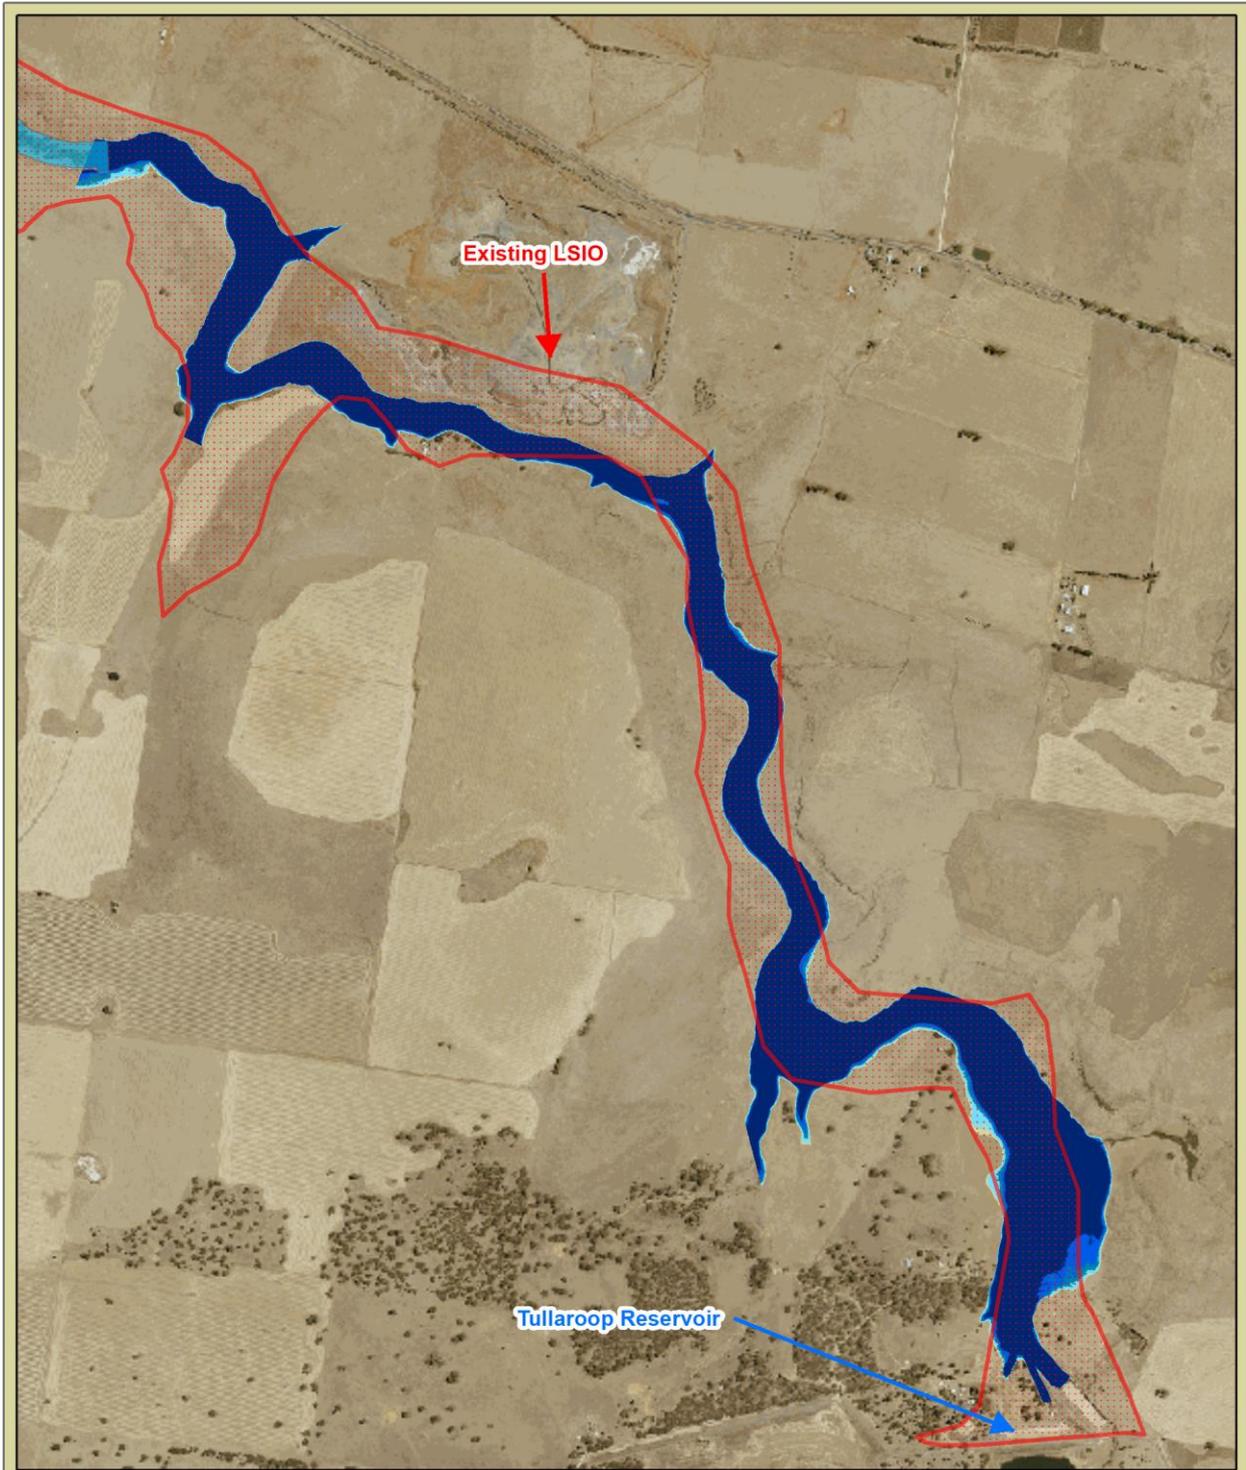
<p><b>Tullaroop Creek- downstream Tullaroop Reservoir</b>  <b>Extent of Flood Inundation</b>  <b>January 2011 Flood Event</b></p> <p>Flooding</p>

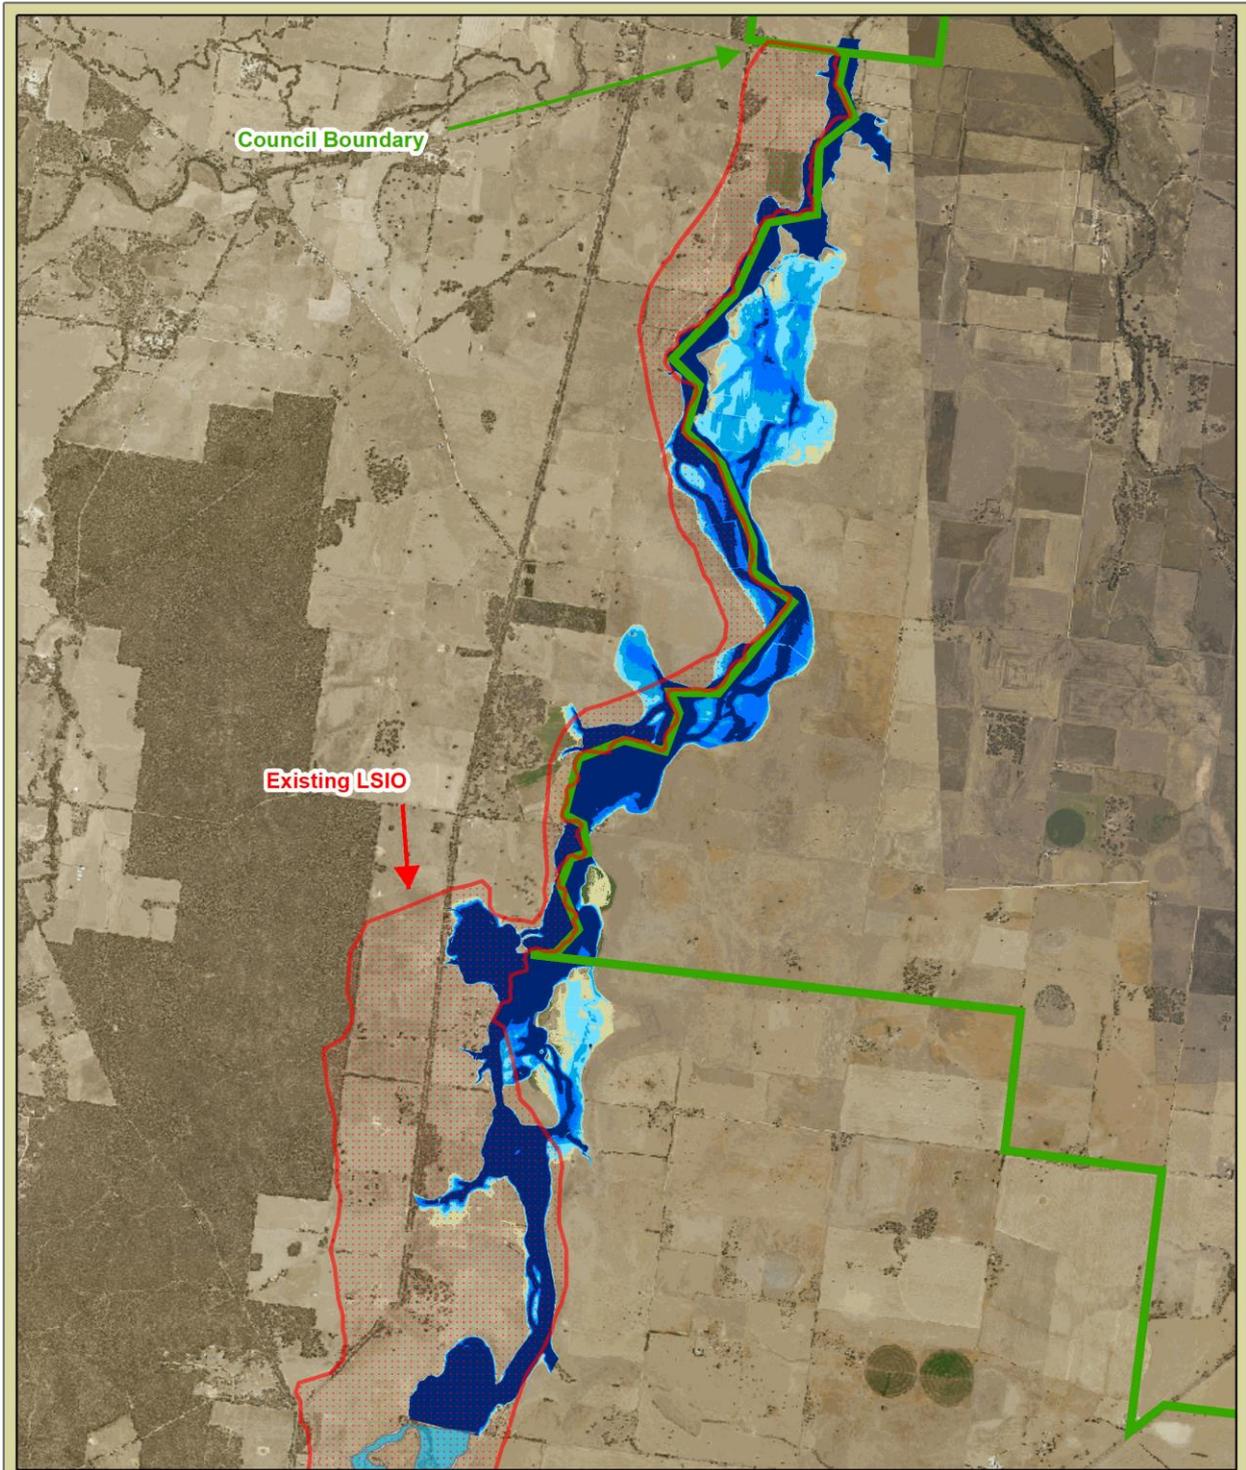
**Tullaroop Creek- downstream Carisbrook  
Extent of Flood Inundation  
January 2011 Flood Event**

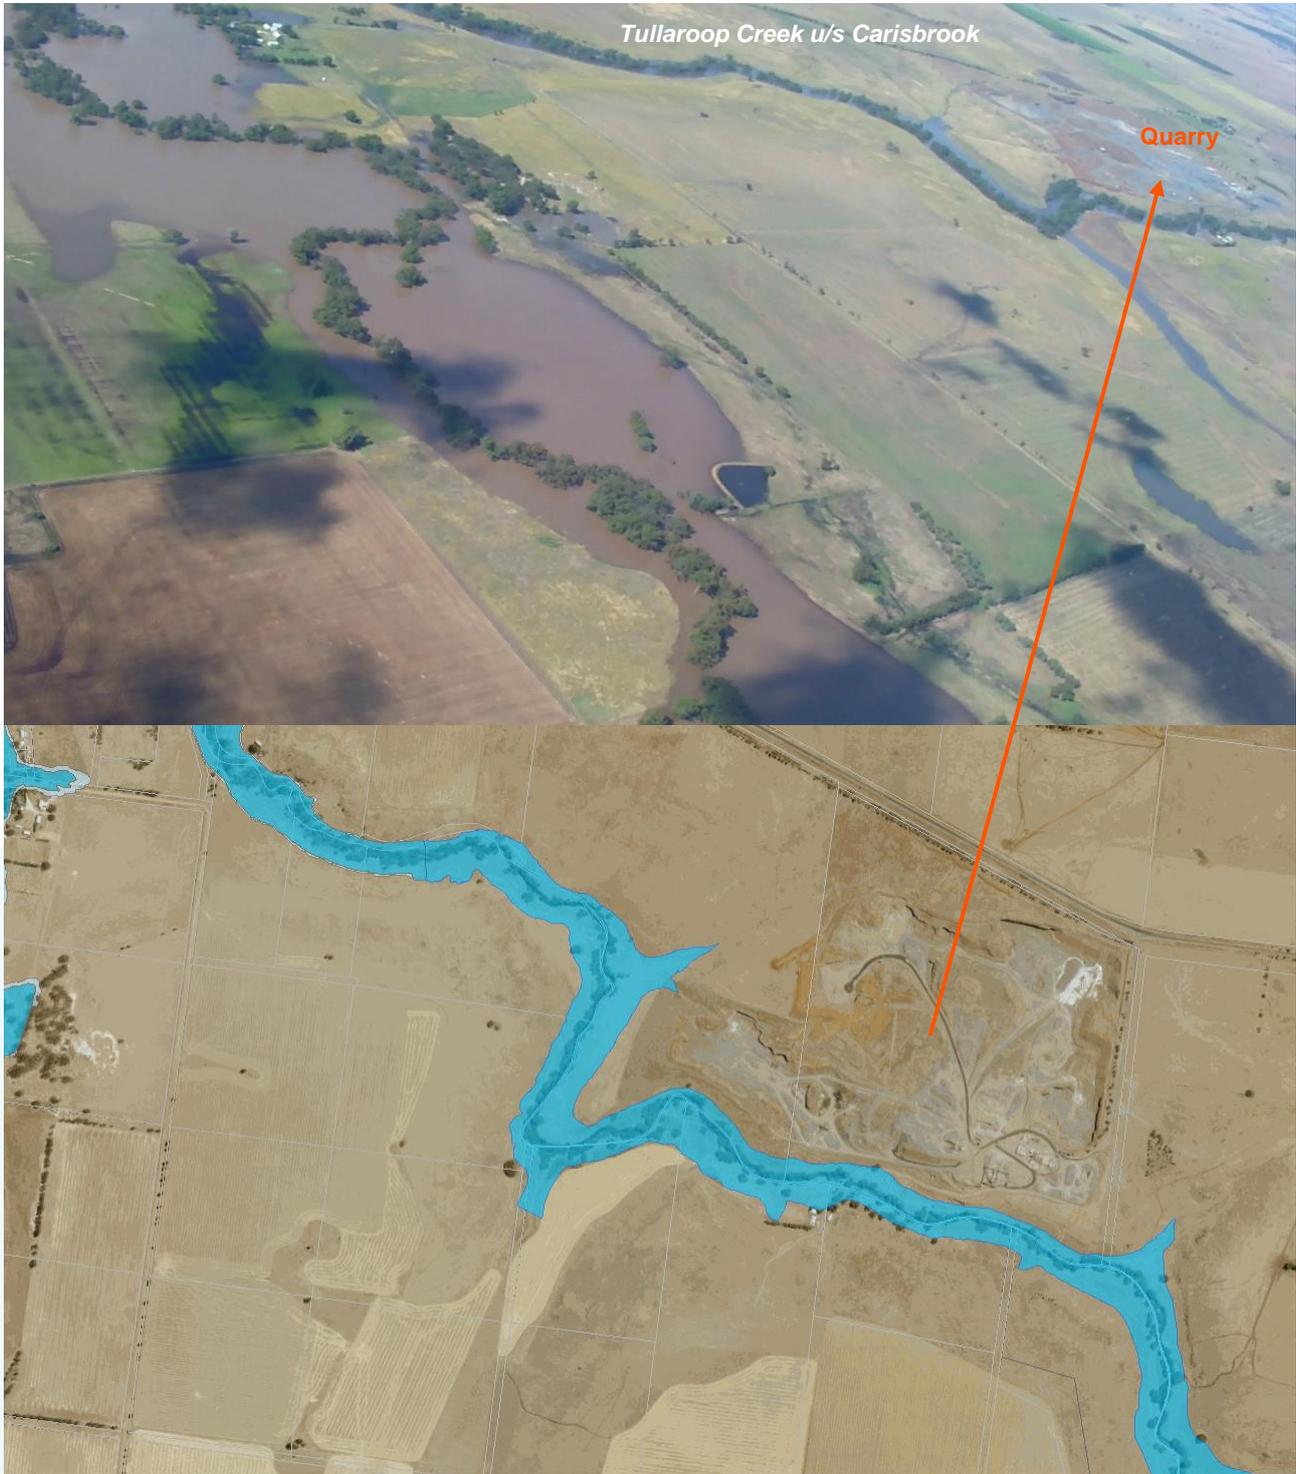
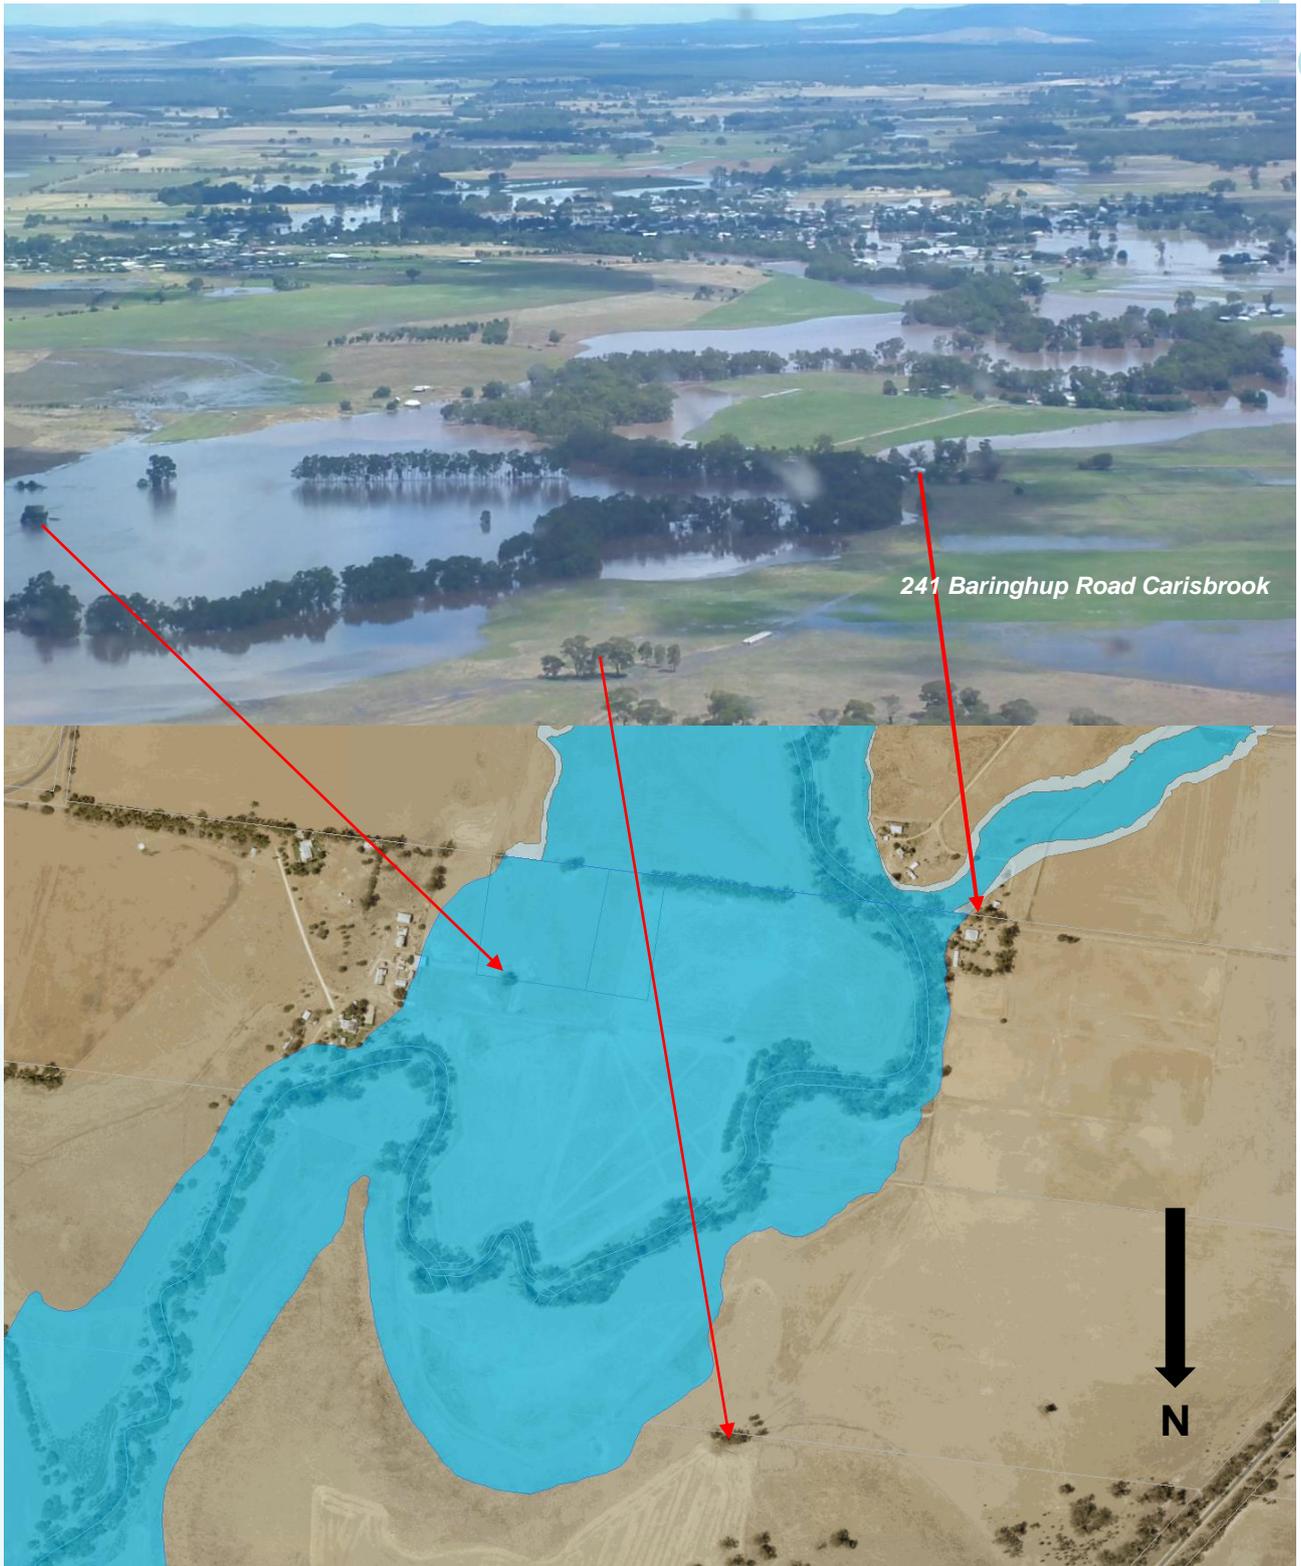
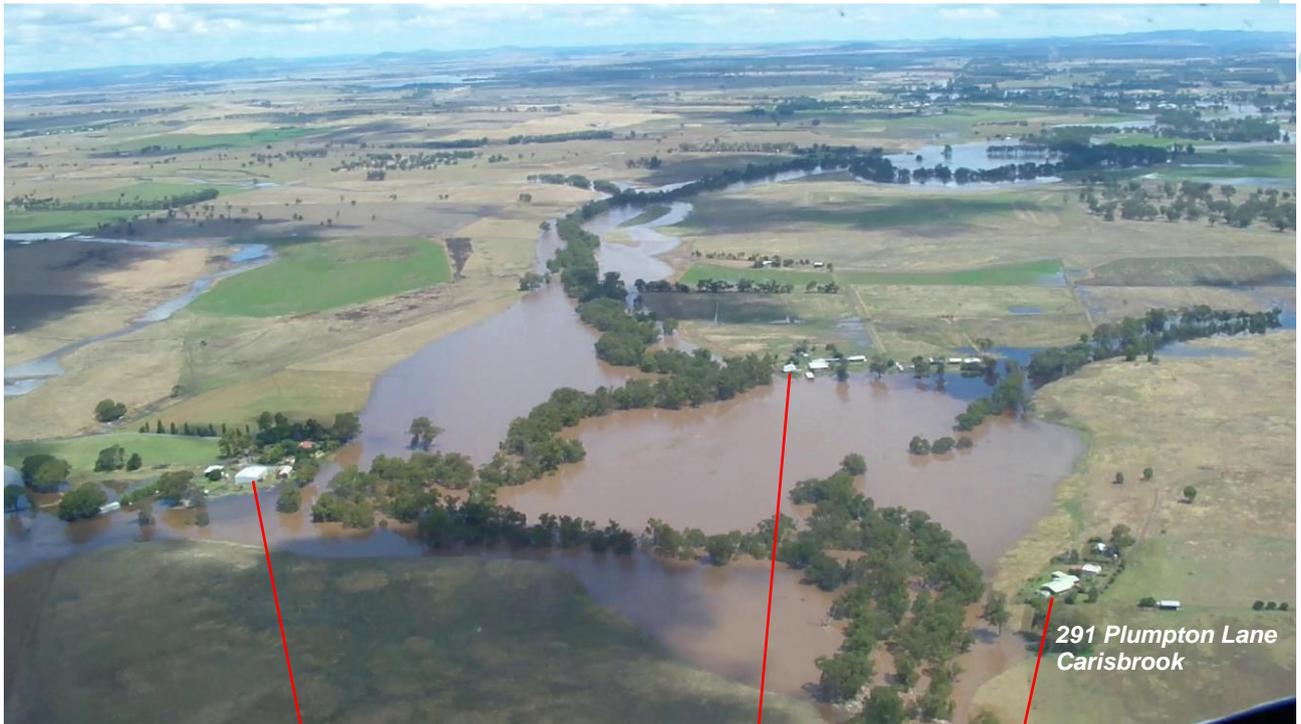
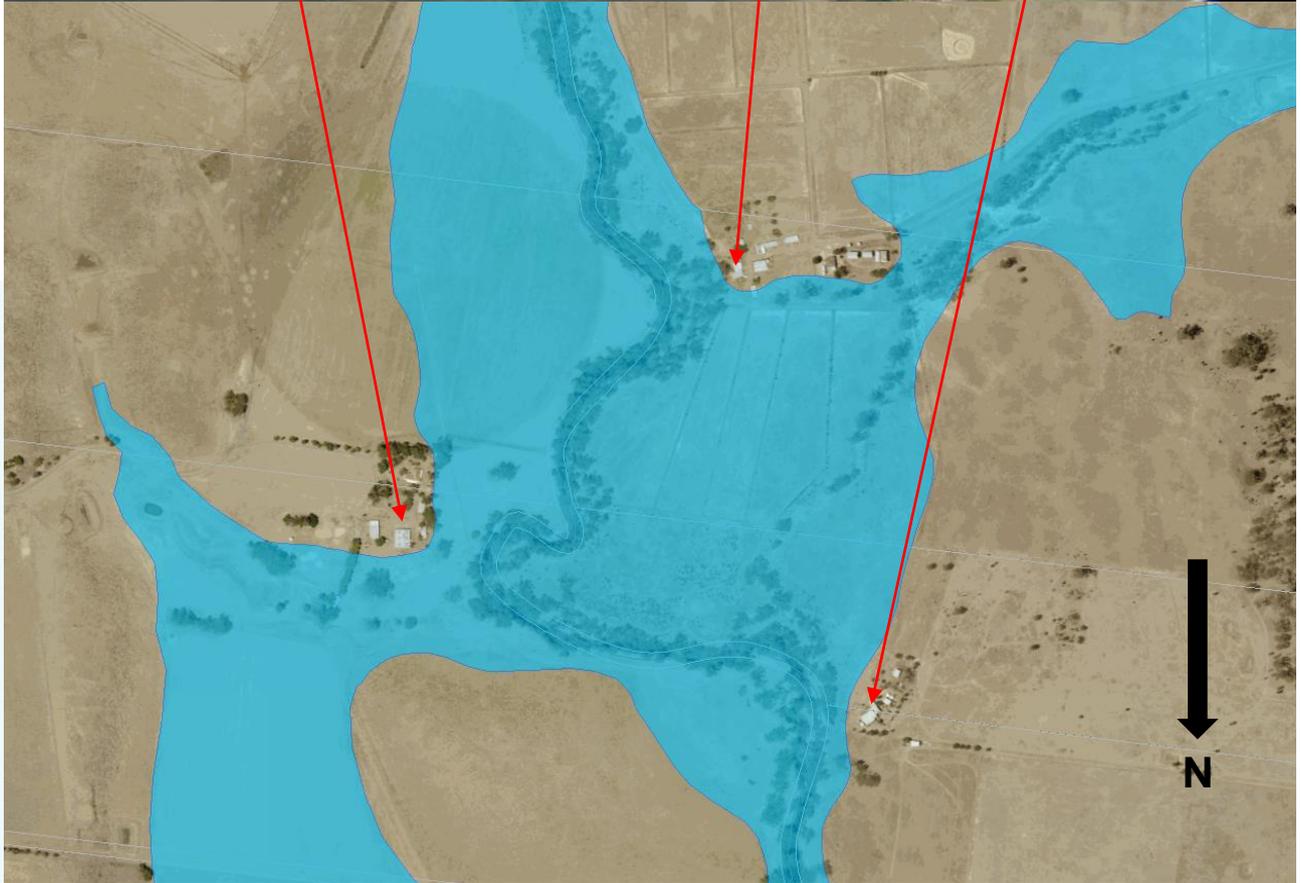
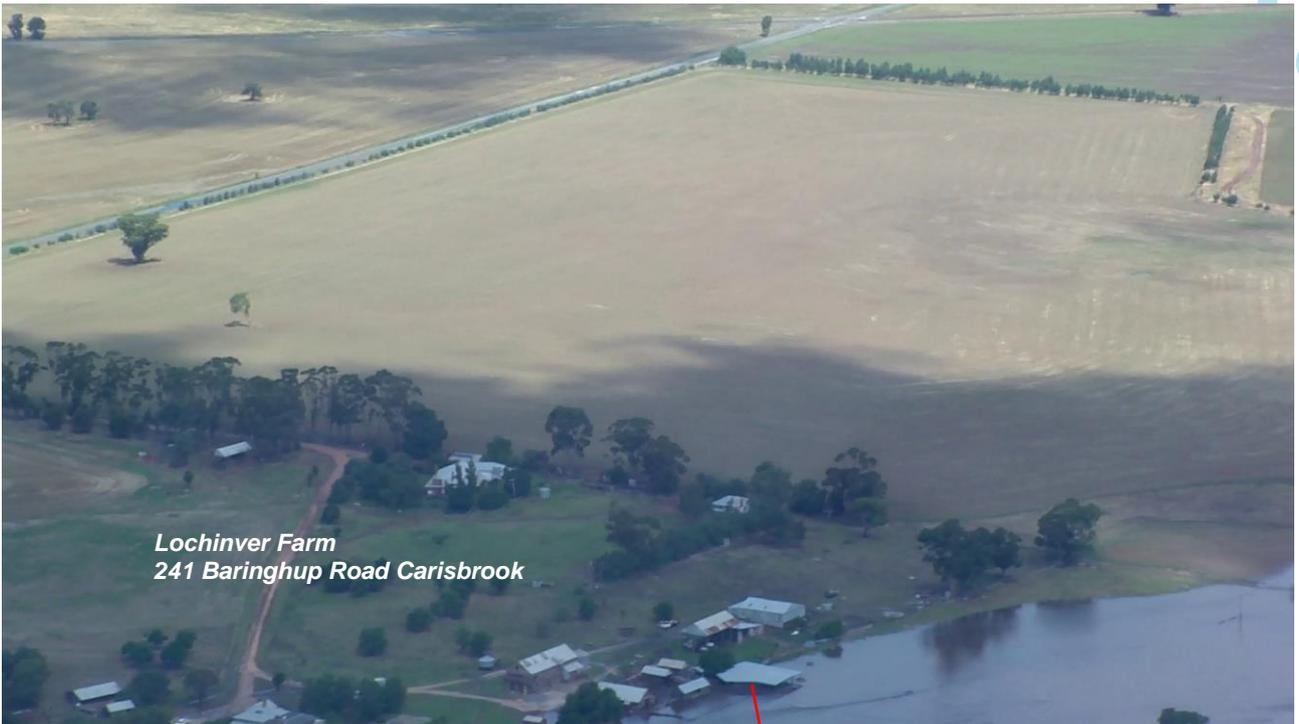
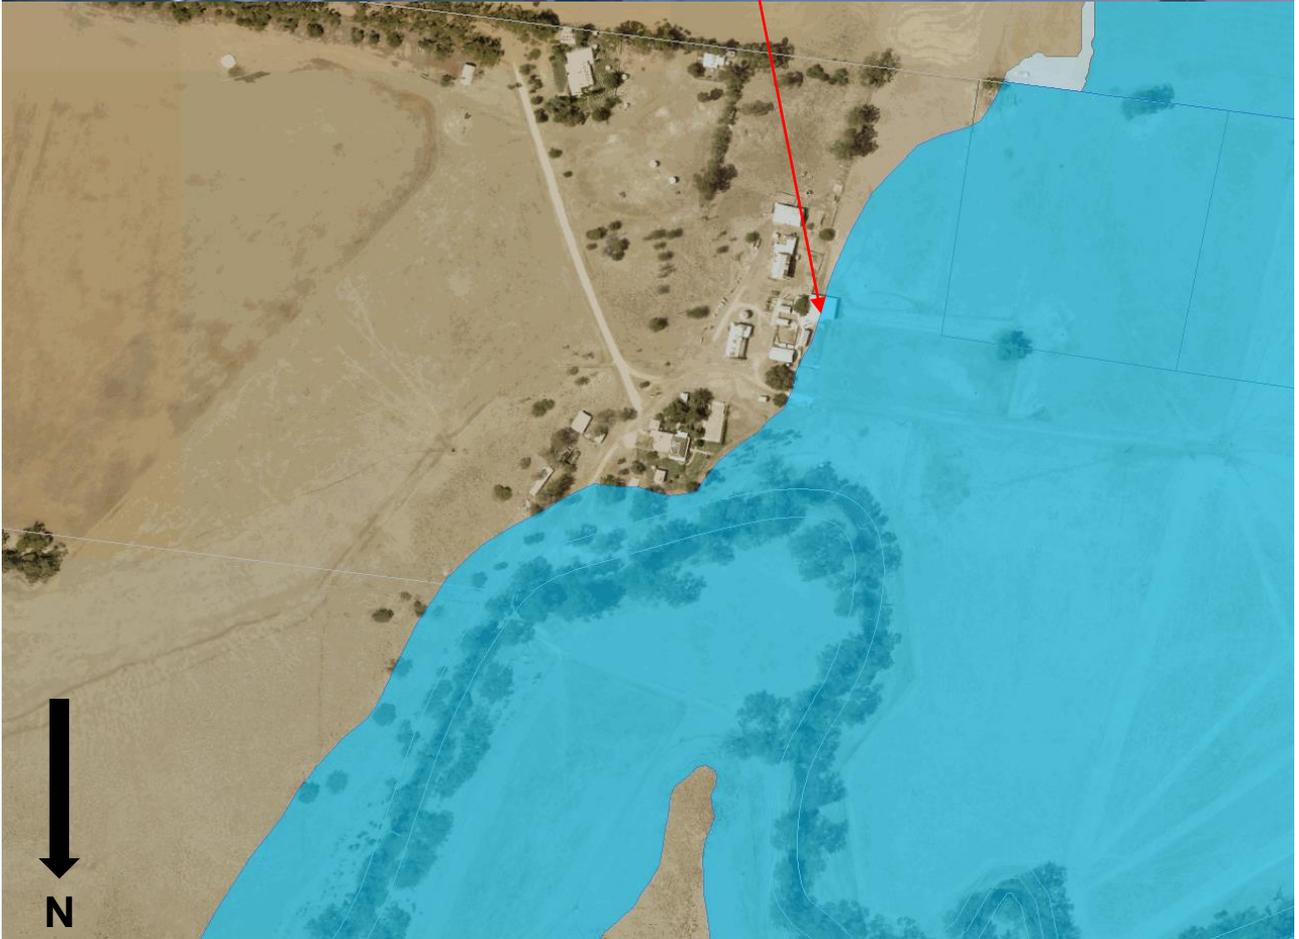
The following imagery is from video footage taken by VicSES emergency personnel on 14<sup>th</sup> January 2020 around 18:00, the subsequent map shows the proposed LSIO in vicinity to the photo.

The flood modelling generally accorded reasonably well with the aerial photography of the January 2011 event, however there were some location where the modelled extent was slightly higher. In preparing the LSIO, close attention was paid around existing buildings to ensure that the LSIO did not extend over buildings that were not flooded in the January 2011 flood event. In these situations, the proposed LSIO extent was manually manipulated to remove these locations from the proposed LSIO.
