central Goldfields Shire

Heritage Study 1992

BOOK 3 - Havelock - High

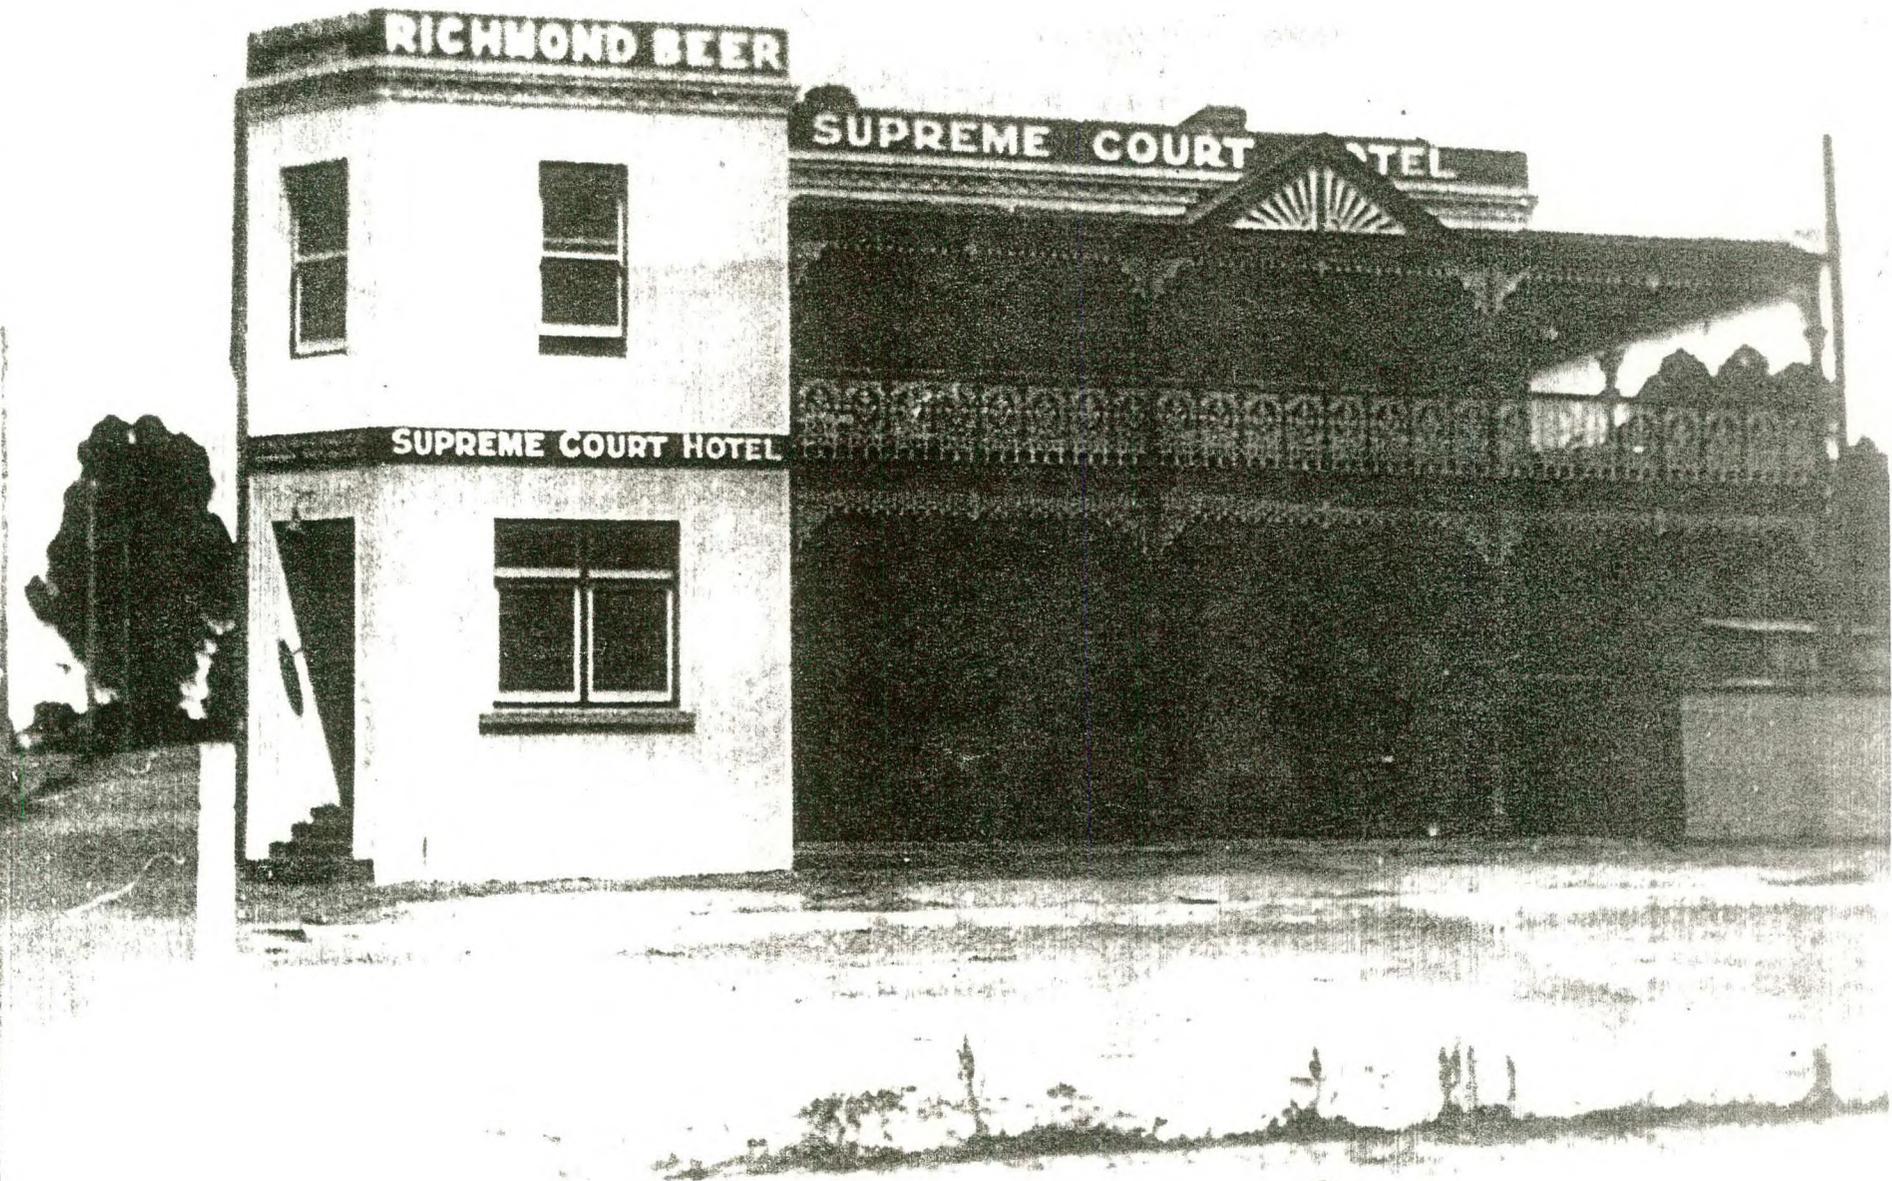
EARLY/MID 20TH CENTURY PHOTOGRAPH - NOTE GABLED VERANDAH ROOF HAS BEEN REMOVED AND WESTERN SIDE TOILETS HAVE NOT YET BEEN BUILT. COLLECTION OF WARREN TATTERSALL, DALE TATTERSALL STUDIOS, MARYBOROUGH

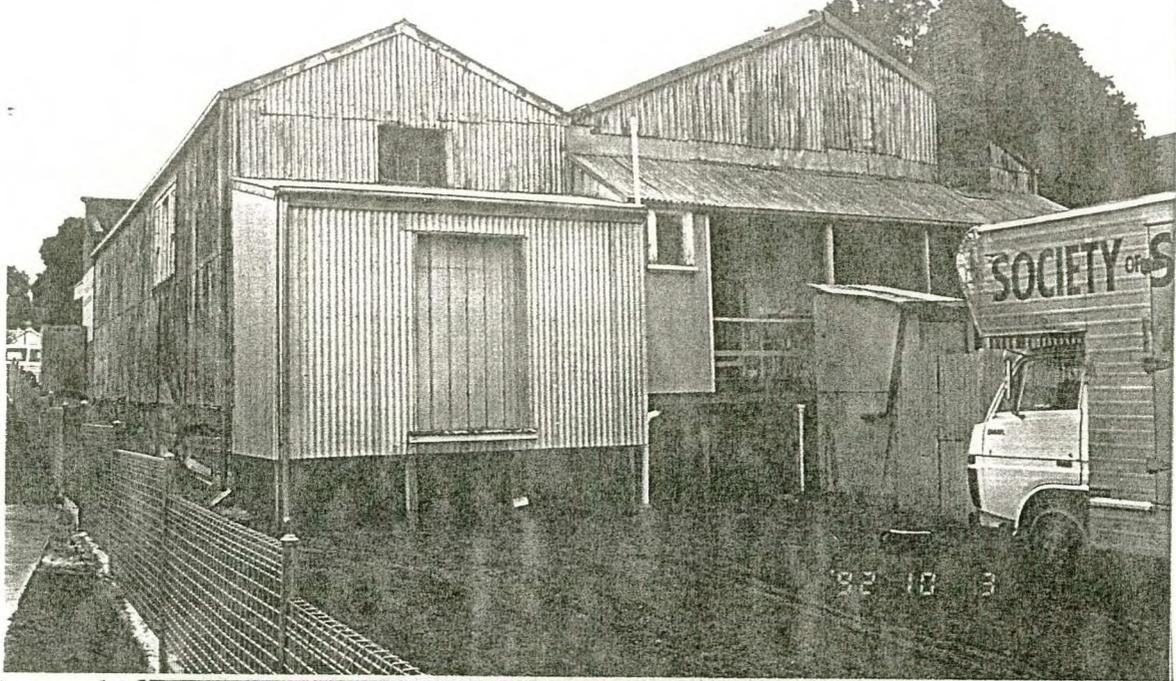
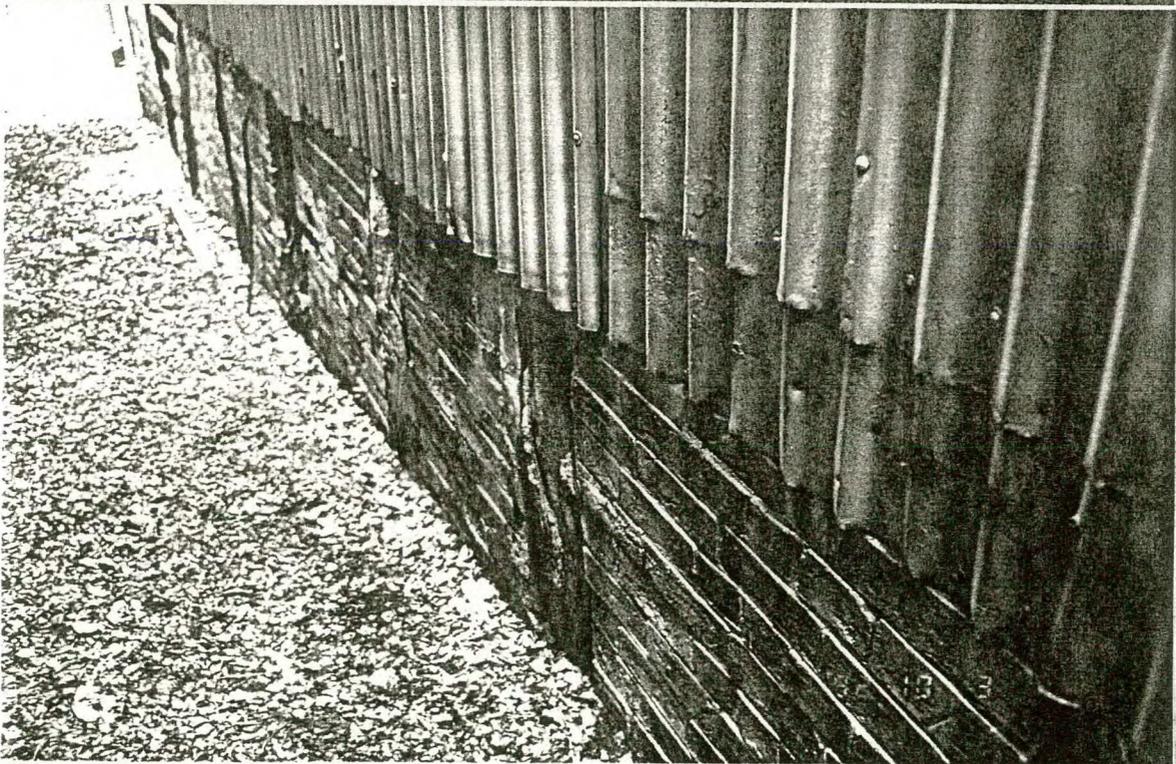
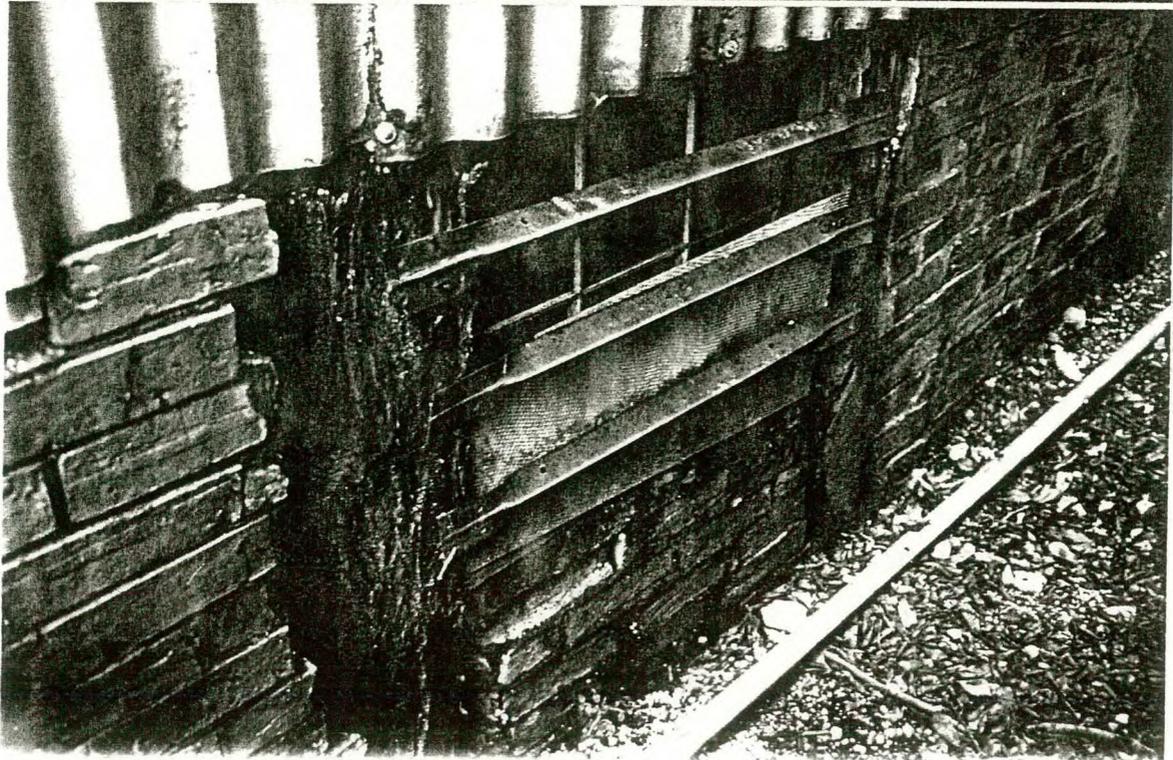
Former Guthrie Bros. Store and Stable Cont.

Features are the corrugated iron sheet walls, brick nogging, rear single board timber walls and the parapet and shopfront, with its leadlight toplights, tiles and fine metal sections. At the rear are very worn sandstone steps and a face brick chimney which sits on a high sandstone plinth.

The facade is in good condition, but the remainder is in need of repair. Given its age of approaching 120 years, this building is in quite good condition.

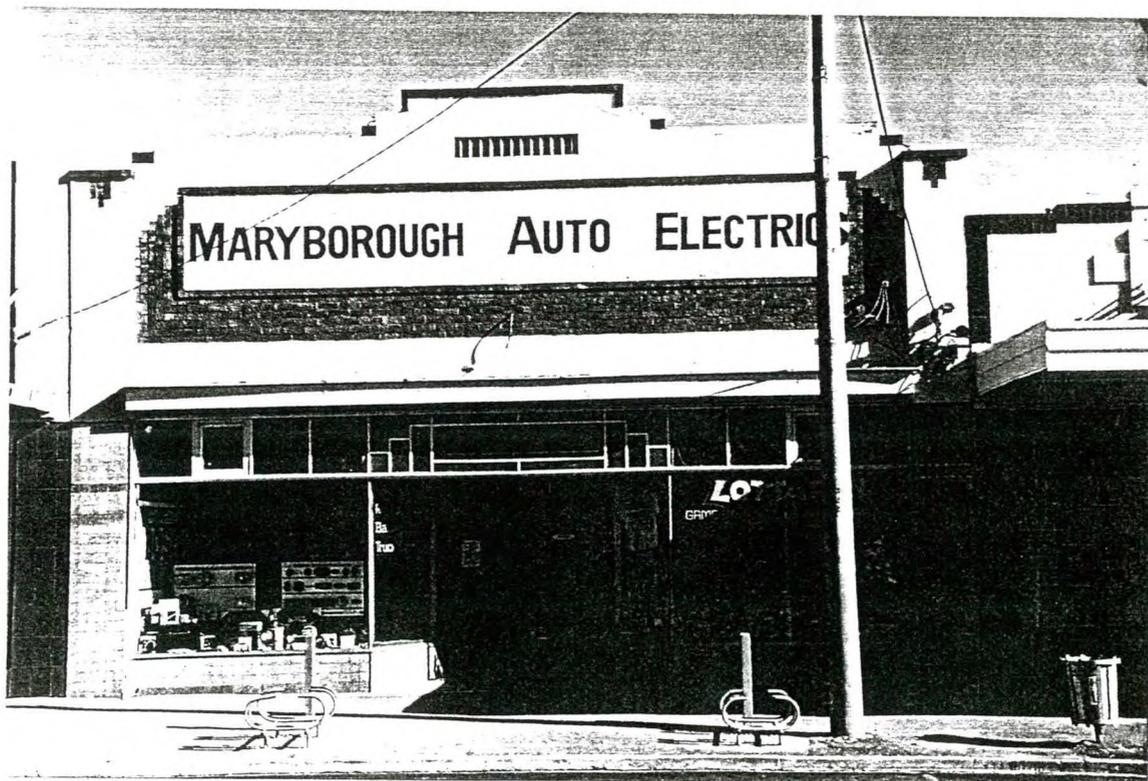
BRICK SHOP,
69 HIGH STREET,
MARYBOROUGH.

Maryborough's finest typically sized 1930s-1950s shop building is remarkably intact and complete with its original shopfront, tiles and parapet decorated with tapestry bricks. The former G.J. Coles store at number 180 is the City's best large store building from that period. There are barely 10 1930s-1950s shops in Maryborough and most are in the southern block of the High Street commercial area, which did not become solely commercial until the 1930s and later, when the last of the existing commercial buildings were built to replace the houses, stables and other miscellaneous land uses here prior to that time.¹

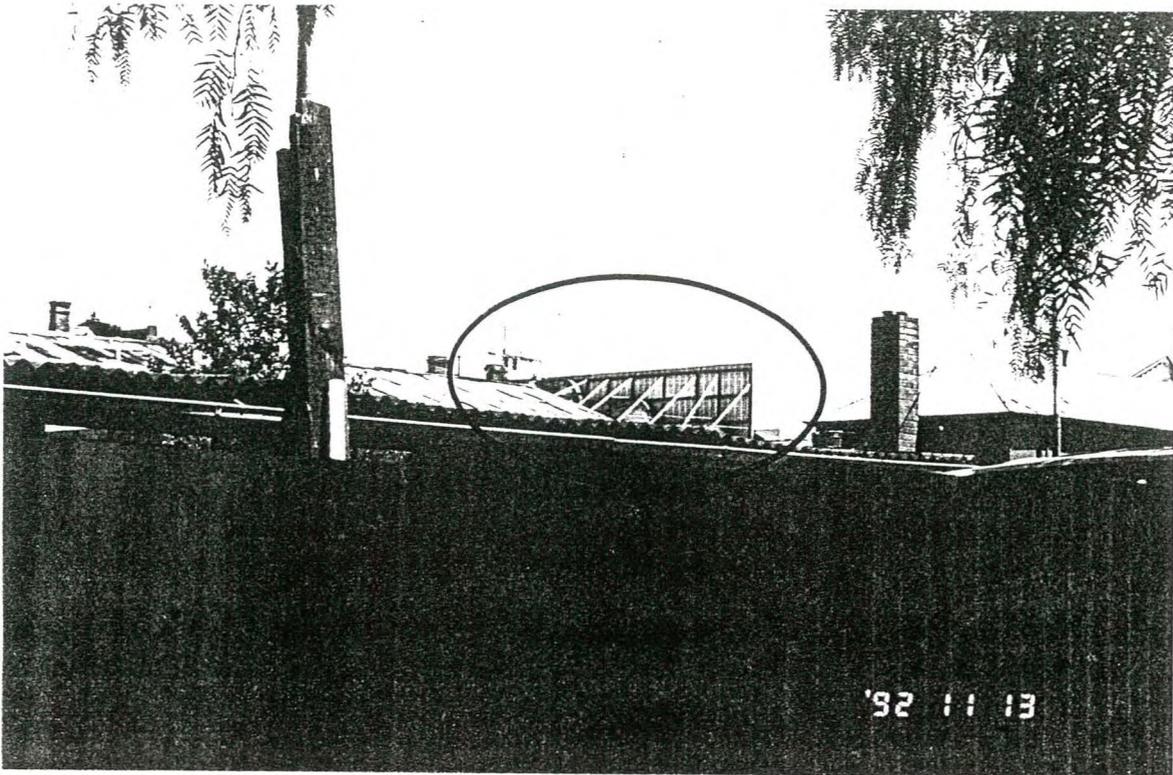
ORIGINAL SHAPED PARAPET IS CONCEALED BY THE METAL SHEET
CLADDING

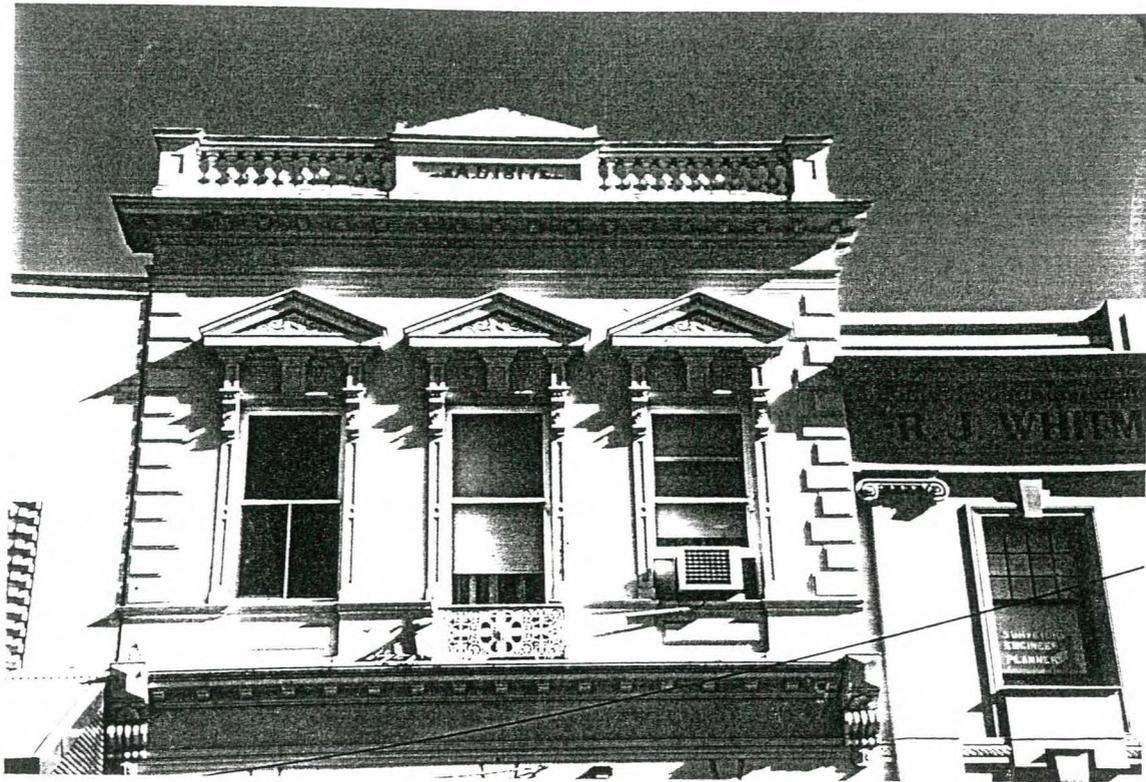
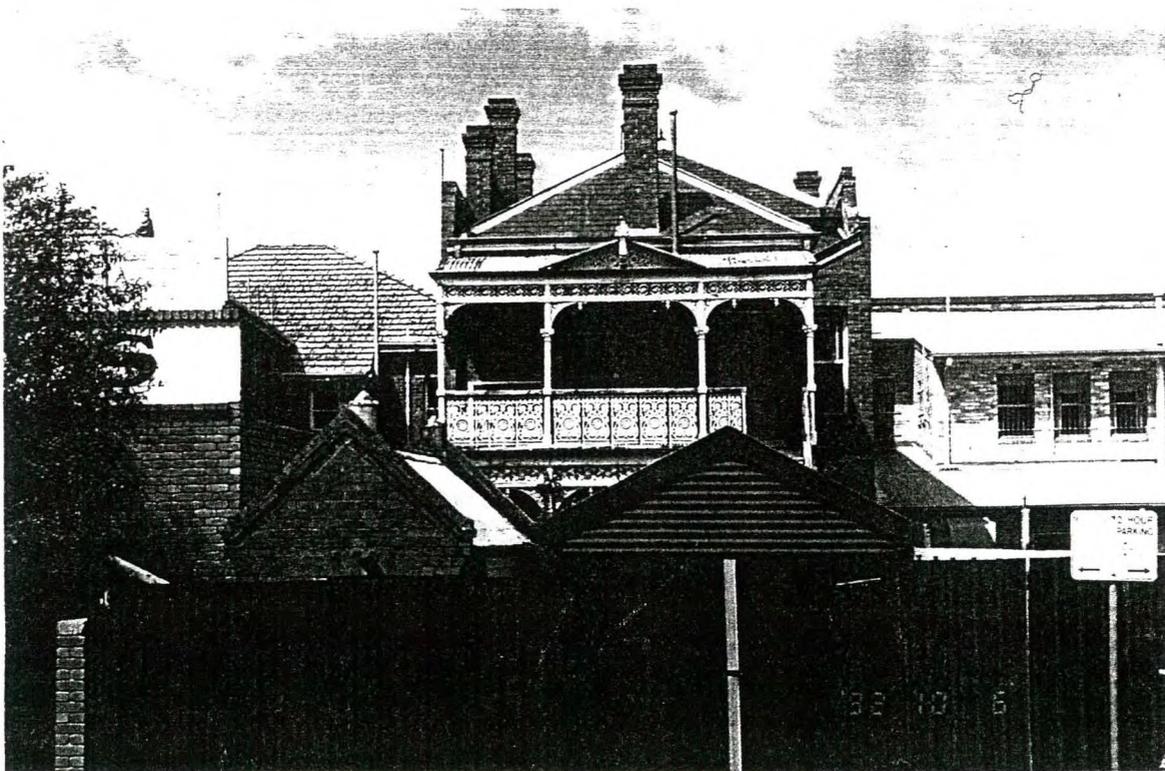
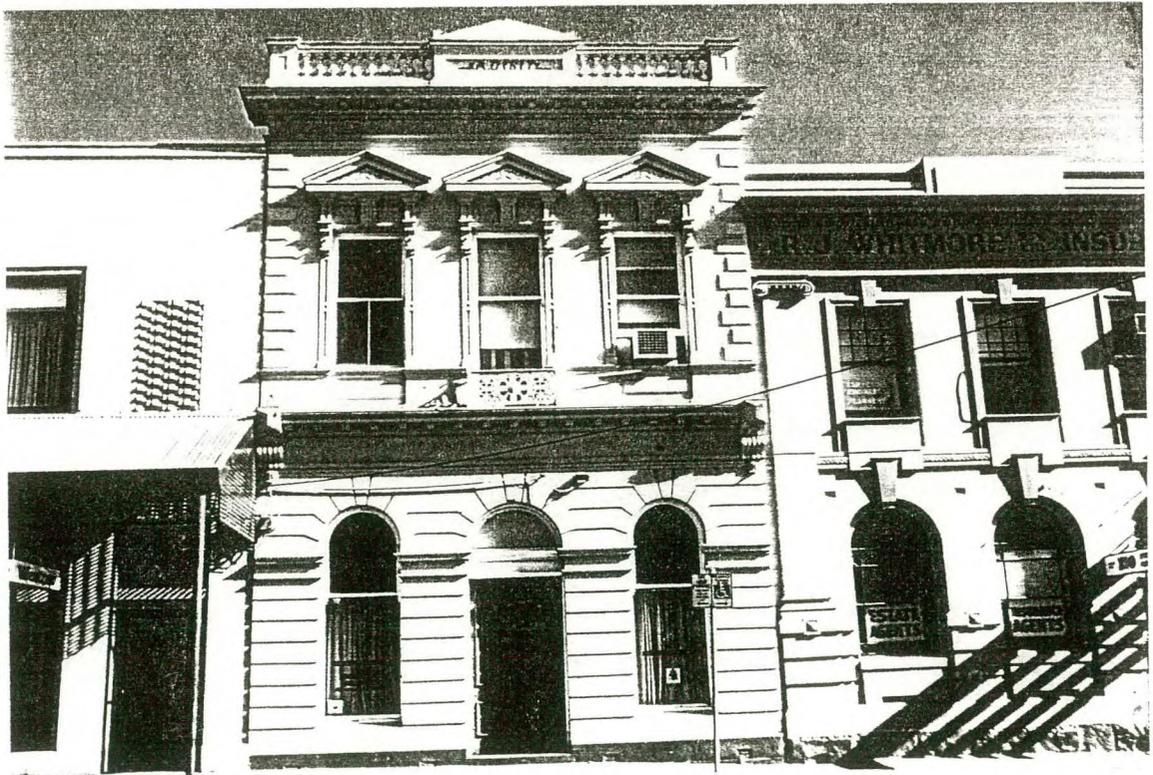
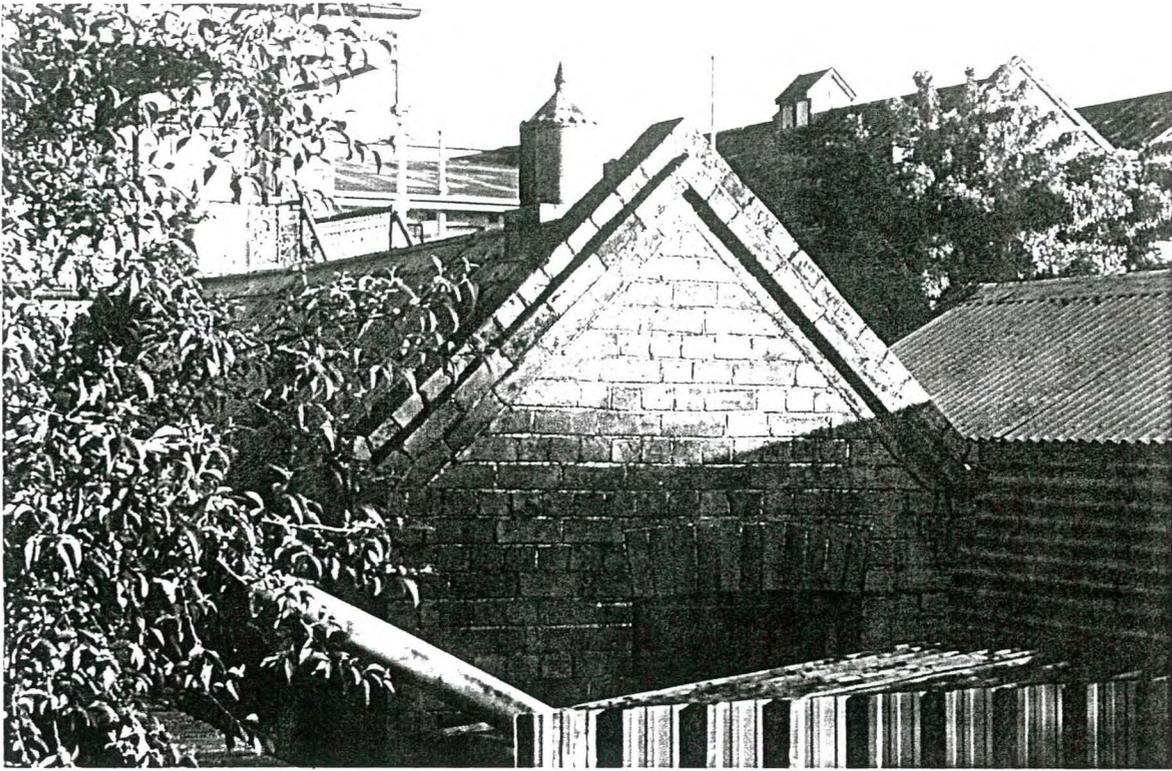
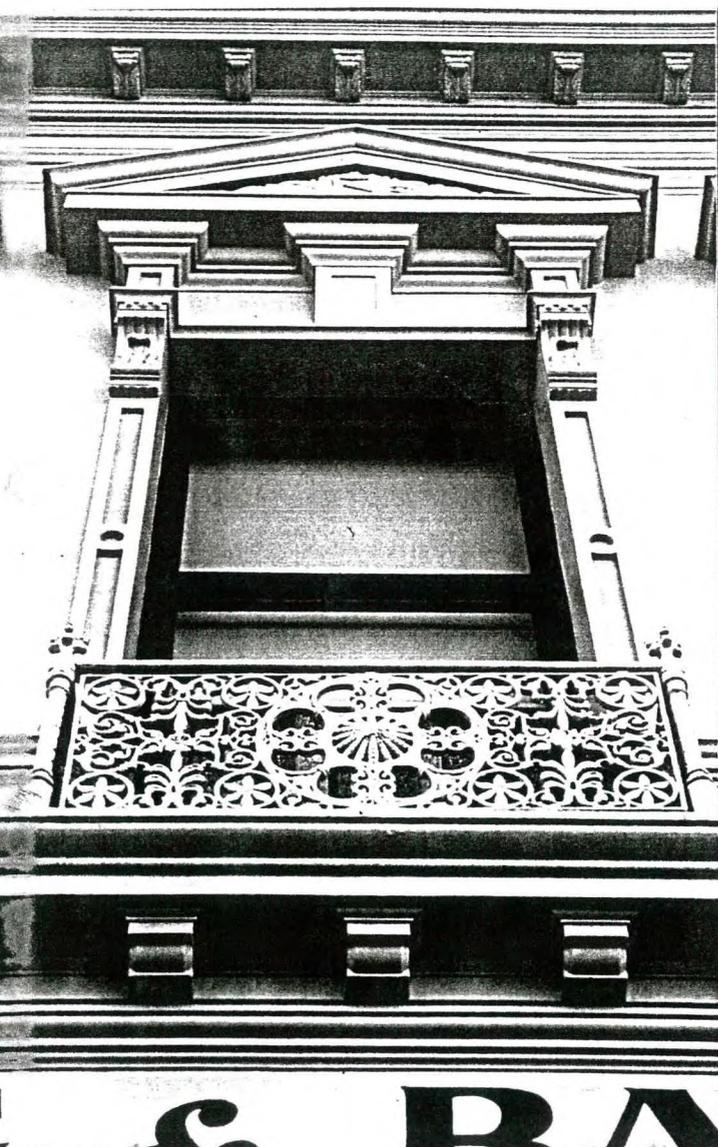
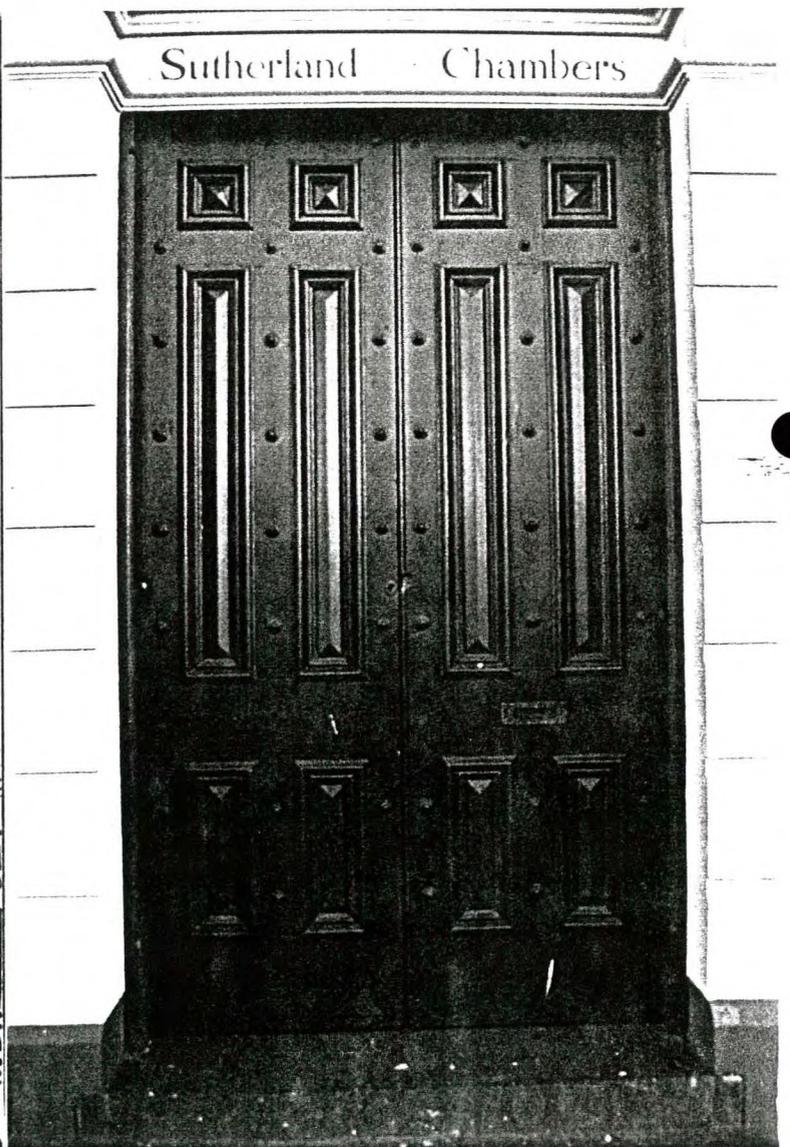
HERRING AND BATHURST OFFICES
(ORIGINALLY CITY OF MELBOURNE BANK),
113 HIGH STREET,
MARYBOROUGH.

Features are the facade with its smooth rusticated ground floor and arch-headed windows, pedimented first floor windows with central balcony, stringcourses, balustrated parapet, the rear double storeyed cast iron verandah and the former banking chamber.

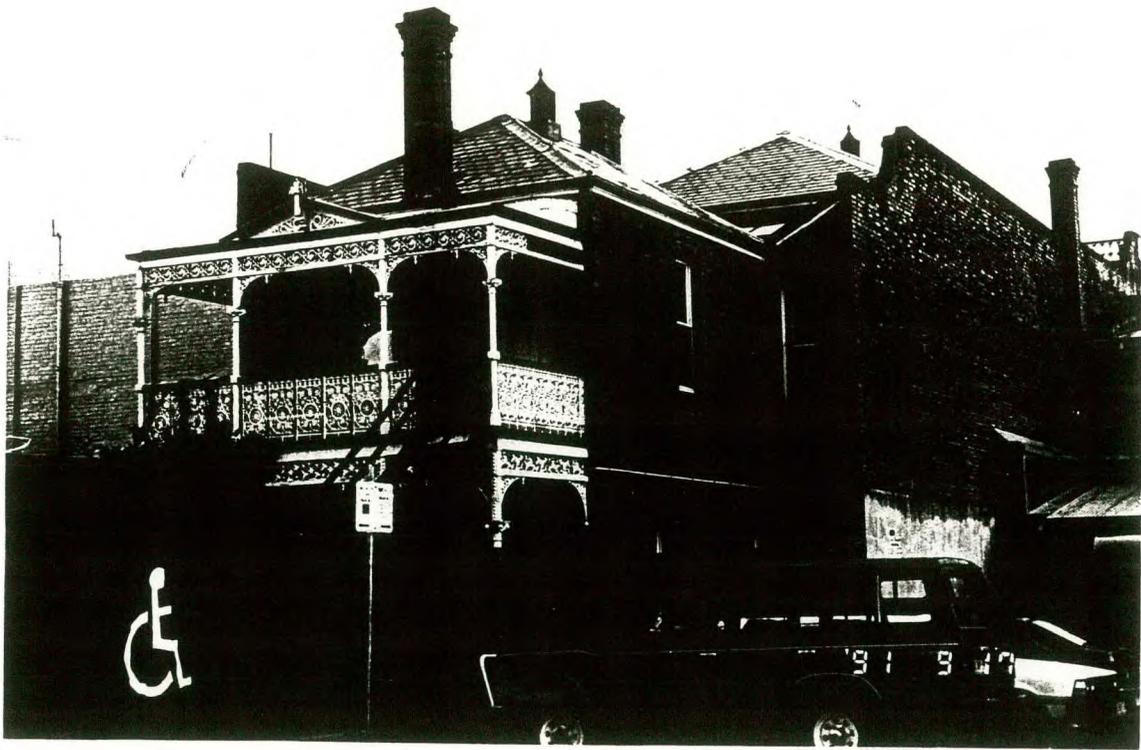
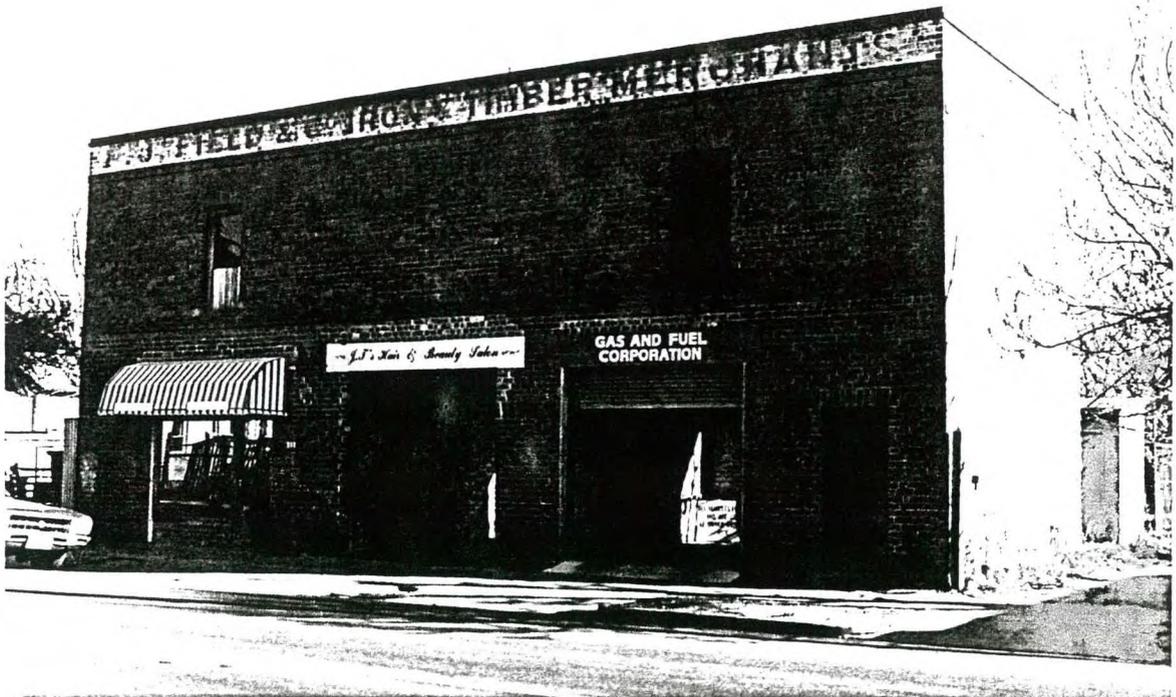
- 1) TWO STOREY REAR BRICK BUILDING AND
- 2) TWO STOREY BRICK BUILDING ON THE ALMA STREET FRONTAGE,
REAR 112-118 HIGH STREET,
MARYBOROUGH.

Style Victorian.
Design one-off.
Plans rectangular.
Two storeyed.
Walls solid face brickwork, rusticated bluestone lintel to central building.
Roofs hipped with no eaves.
Features are the size of the Alma Street building and the multi-pane window and simple detailing of the central building.

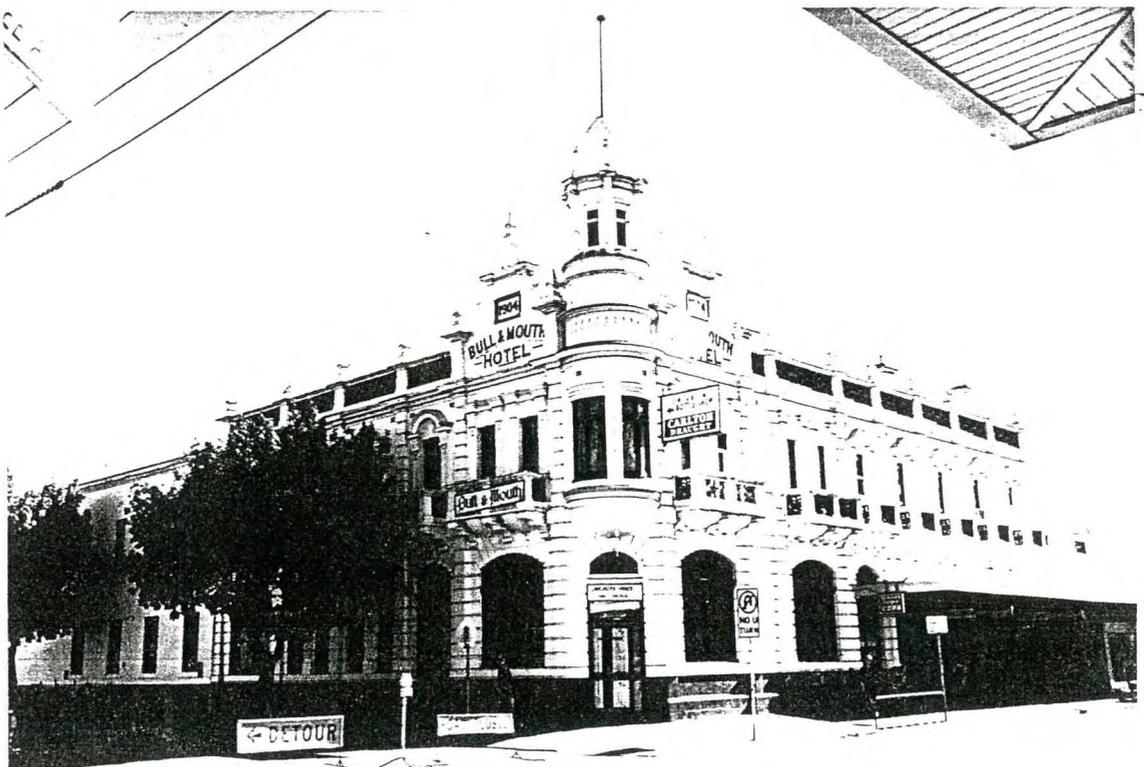
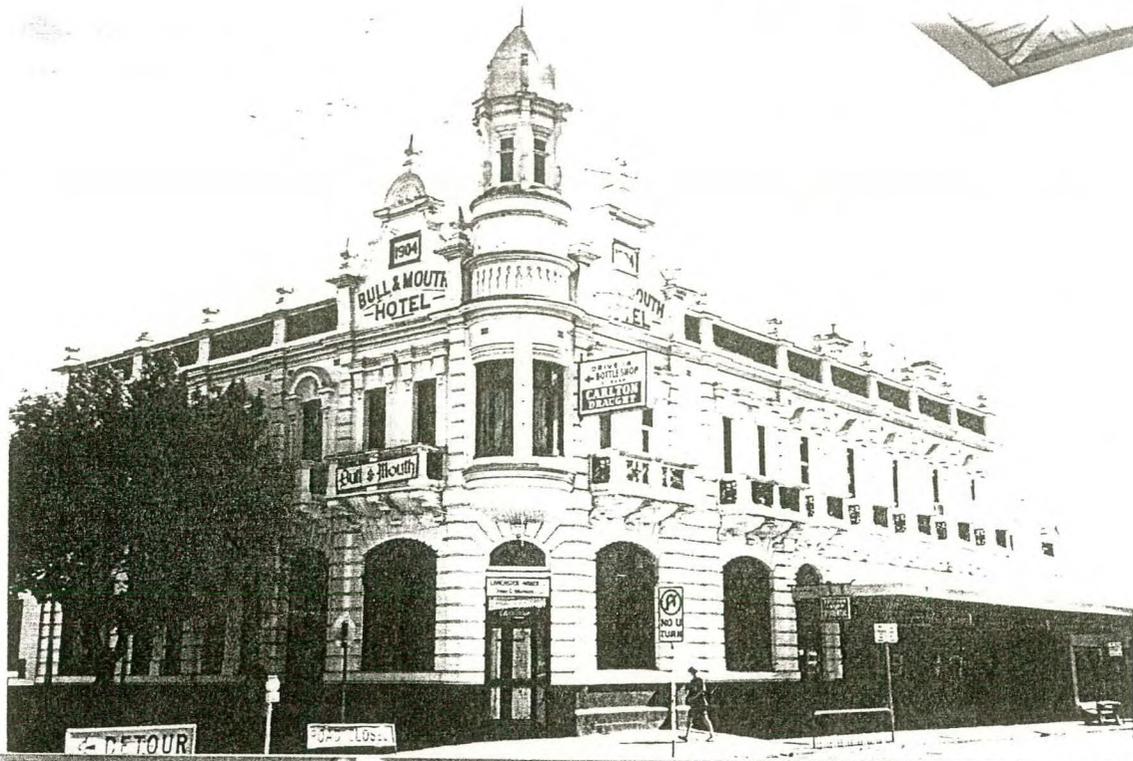
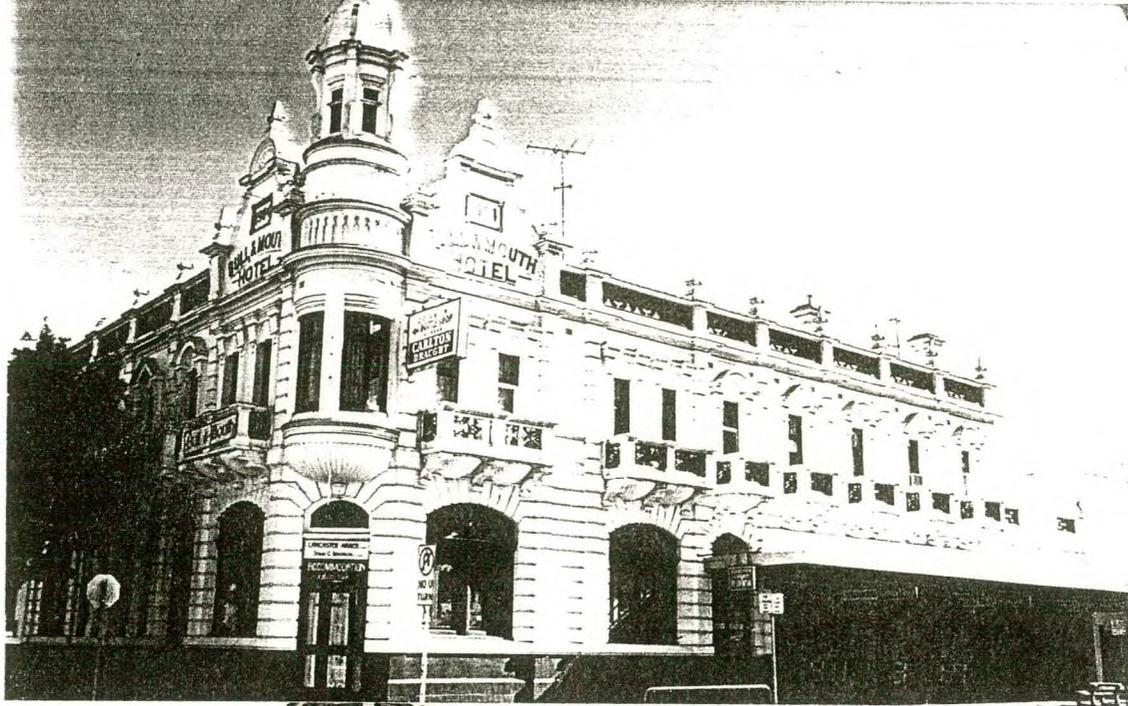
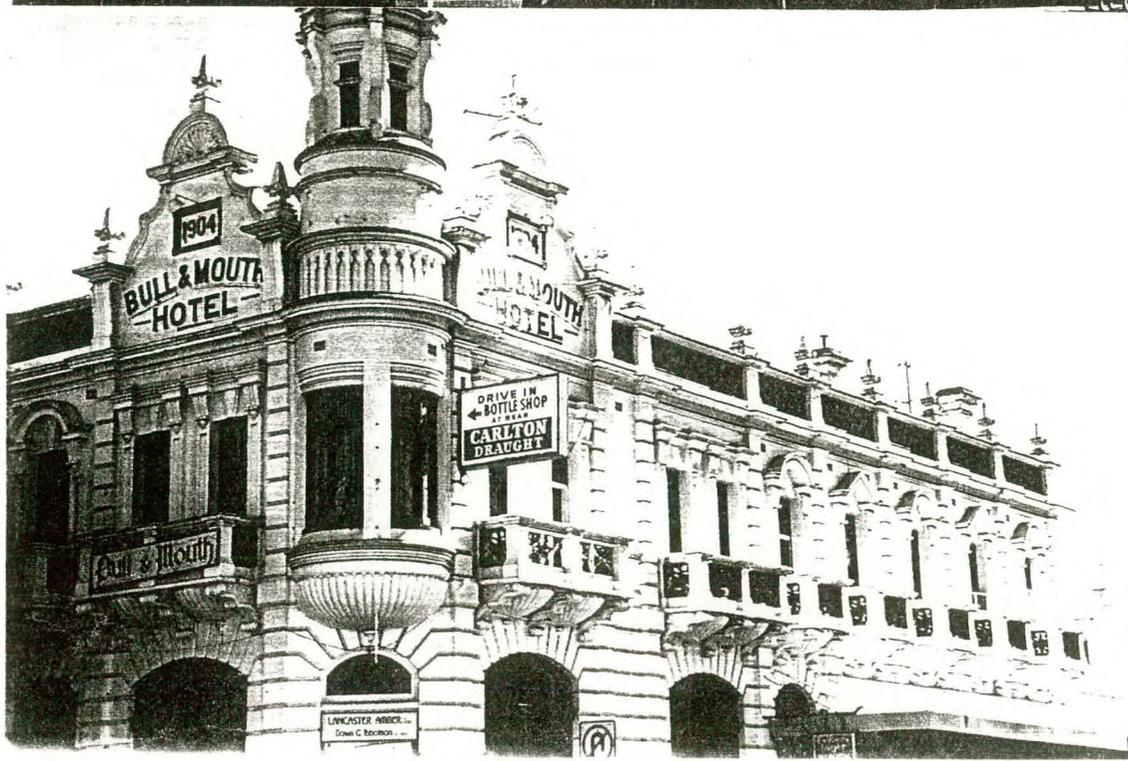
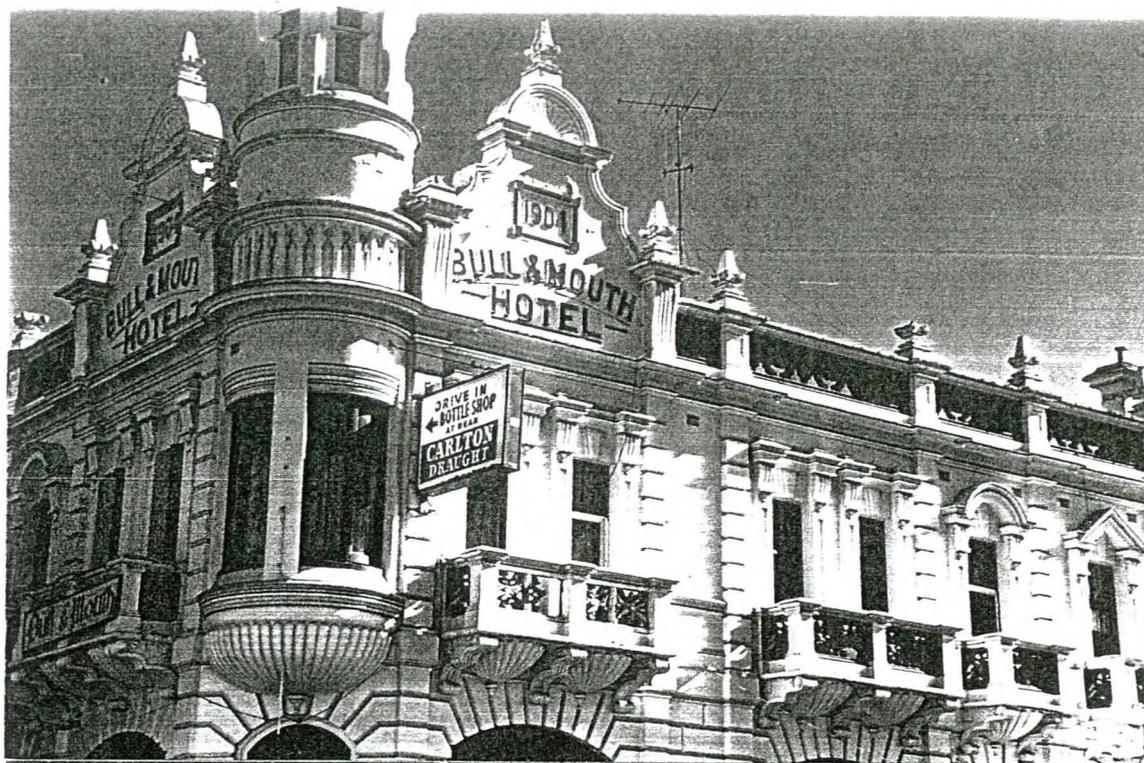
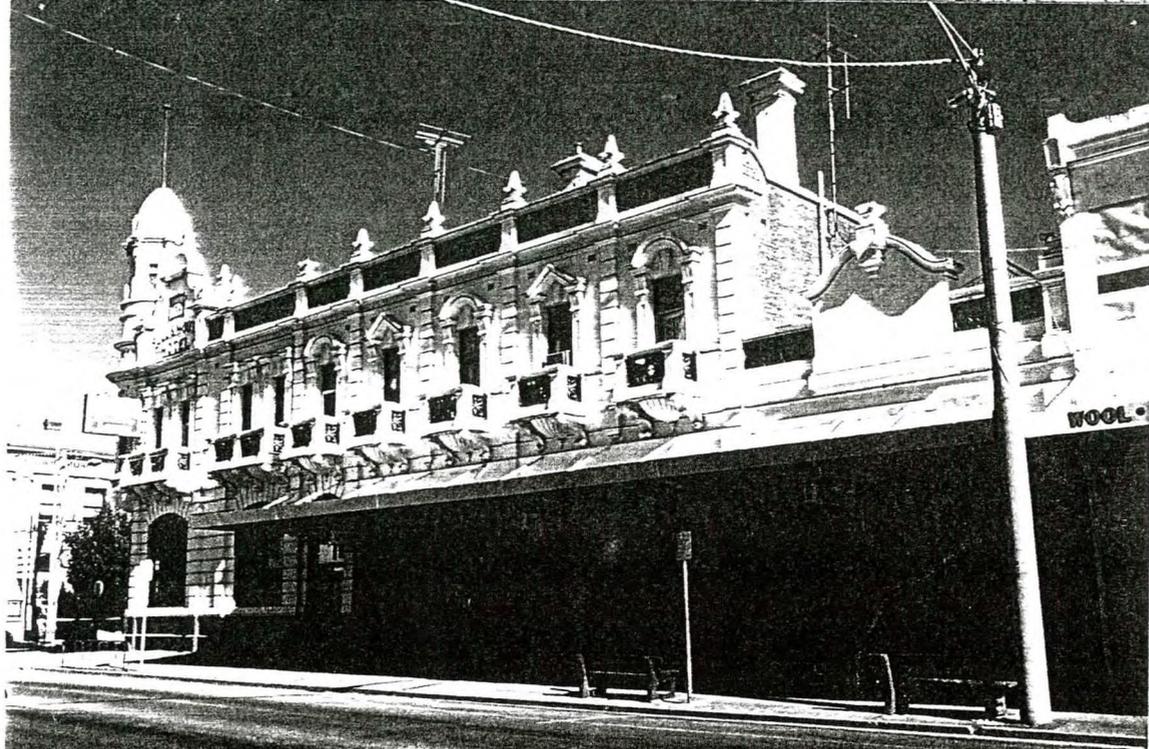
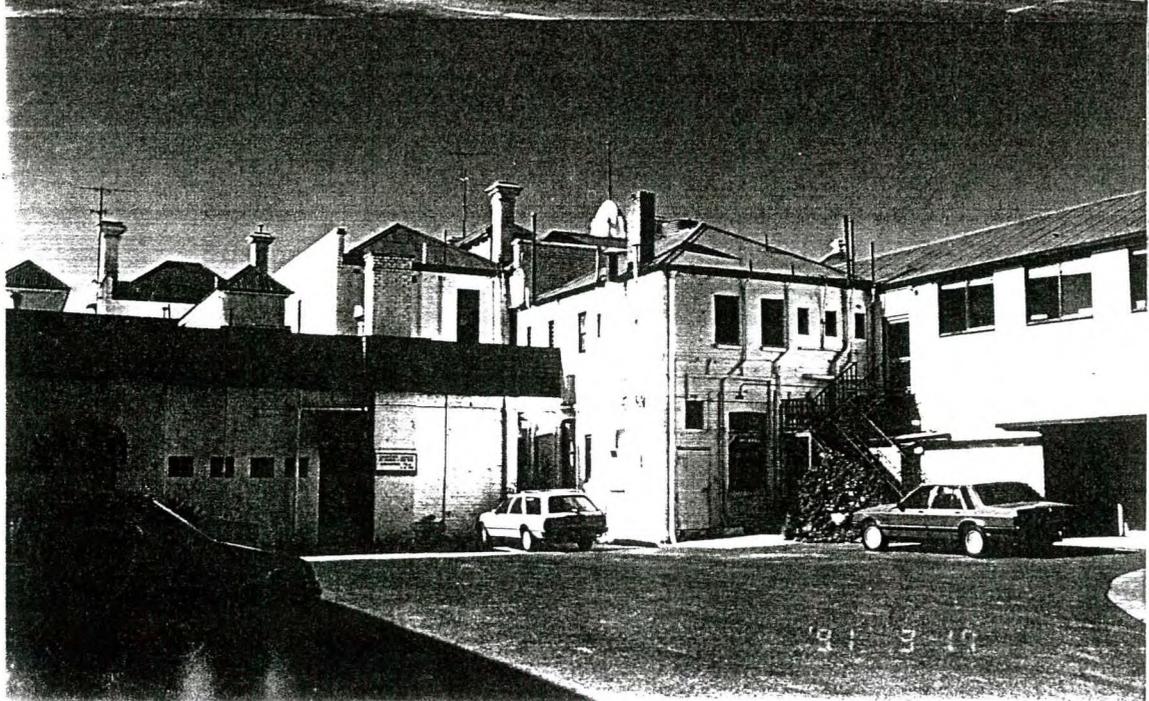
BULL AND MOUTH HOTEL,
N.W. CNR. NOLAN STREET,
117 HIGH STREET,
MARYBOROUGH.

Features are the flag pole capped corner circular turret and flanking gables, cantilevered balconies with their shells off and perforated balustrades, elaborate parapet to the main body, first floor window cases, smooth rusticated first floor piers and ground floor walls, the large arched bar window and the undecorated Nolan Street wing.

- Regular maintenance as necessary.
- When repainting externally use original/period paint colours and placement.
- Remove chocolate face bricks and cantilevered verandahs and return facade to its original appearance.
- Redecorate Public Bar area to relate the remainder of the building.

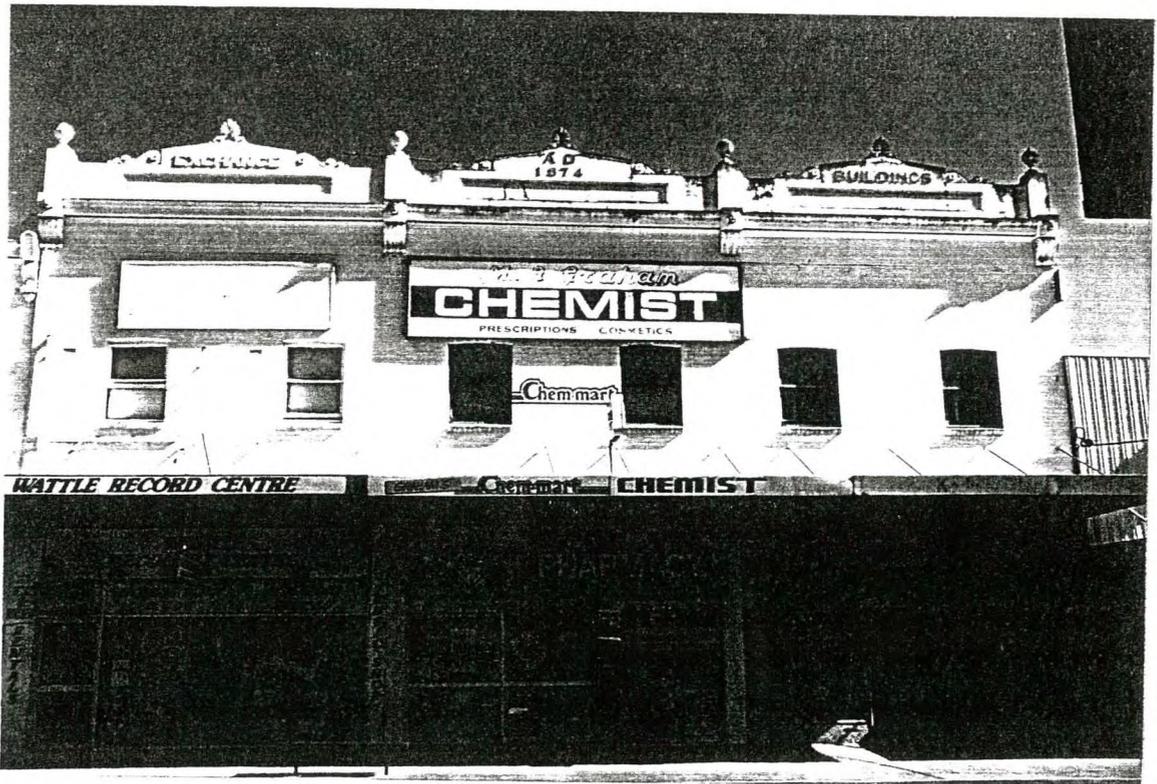
EXCHANGE BUILDINGS - THREE SHOPS,
133-137 HIGH STREET,
MARYBOROUGH.

BUILT:	1874 ¹
	RECENT TIMES REAR SECTION OF SOUTHERN SHOP
THEMES ILLUSTRATED BY THIS PLACE:	PRIVATE BUILDING - VICTORIAN
DEGREE OF SIGNIFICANCE:	LOCAL SIGNIFICANCE
EXTENT OF SIGNIFICANCE:	ENTIRE BUILDING AND SITE
RECOMMENDATIONS:	LOCAL PLANNING PROTECTION
	CONSERVATION AREA: HIGH STREET-NOLAN STREET

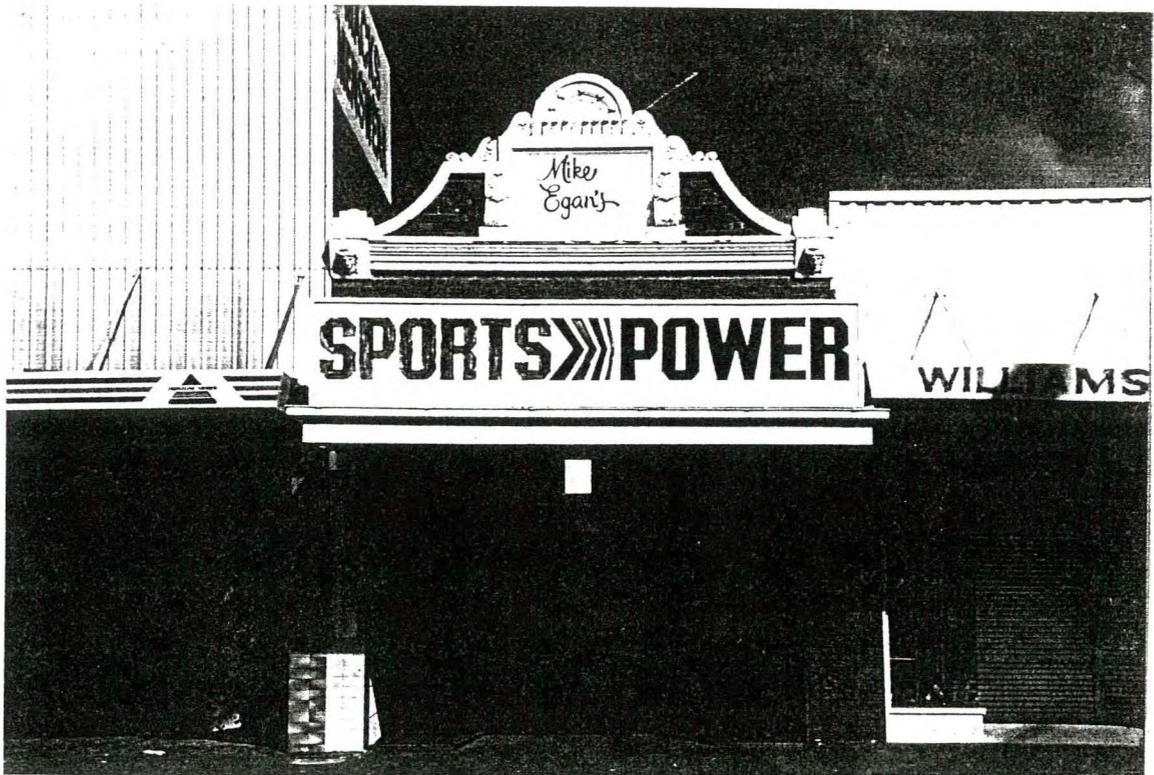
FACE BRICK SHOP,
158 HIGH STREET,
MARYBOROUGH.

BUILT:	1900S? RECENT TIMES SHOPFRONT AND CANTILEVERED VERANDAH
THEMES ILLUSTRATED BY THIS PLACE:	PRIVATE BUILDING - VICTORIAN
DEGREE OF SIGNIFICANCE:	LOCAL SIGNIFICANCE
EXTENT OF SIGNIFICANCE:	ENTIRE BUILDING AND SITE
RECOMMENDATIONS:	LOCAL PLANNING PROTECTION CONSERVATION AREA: HIGH STREET-NOLAN STREET

Regular maintenance as necessary.

Use appropriate signage.
