central Goldfields Shire

Heritage Study 1992

BOOK 3 - Havelock - High

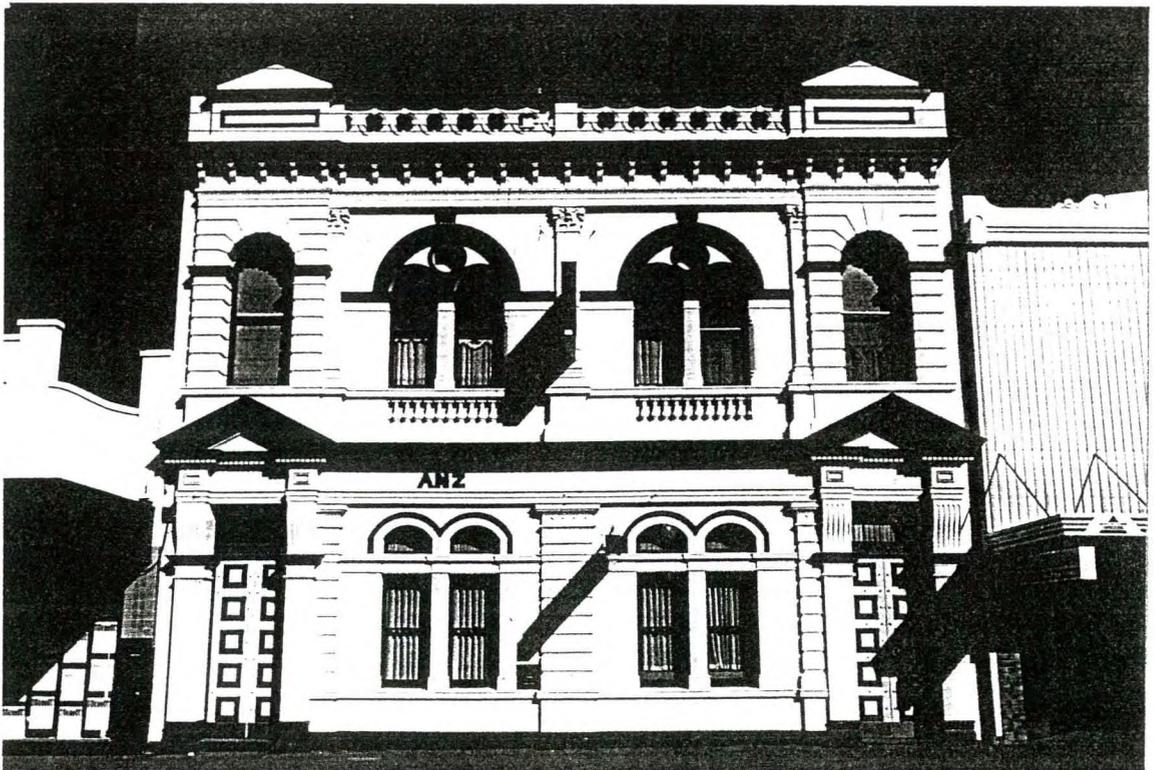
A.N.Z. BANK,
ORIGINALLY UNION BANK,
162 HIGH STREET,
MARYBOROUGH.

BUILT:	C.1889 ¹
THEMES ILLUSTRATED BY THIS PLACE:	PRIVATE BUILDING - LATE VICTORIAN
DEGREE OF SIGNIFICANCE:	REGIONAL SIGNIFICANCE
EXTENT OF SIGNIFICANCE:	ENTIRE BUILDING AND SITE
RECOMMENDATIONS:	LOCAL PLANNING PROTECTION
	CONSERVATION AREA: HIGH STREET-NOLAN STREET

Regular maintenance as necessary.
When repainting use original/period paint colours and placement.
Conserve surviving original fabric internally and reverse
unsympathetic ground floor changes where possible.

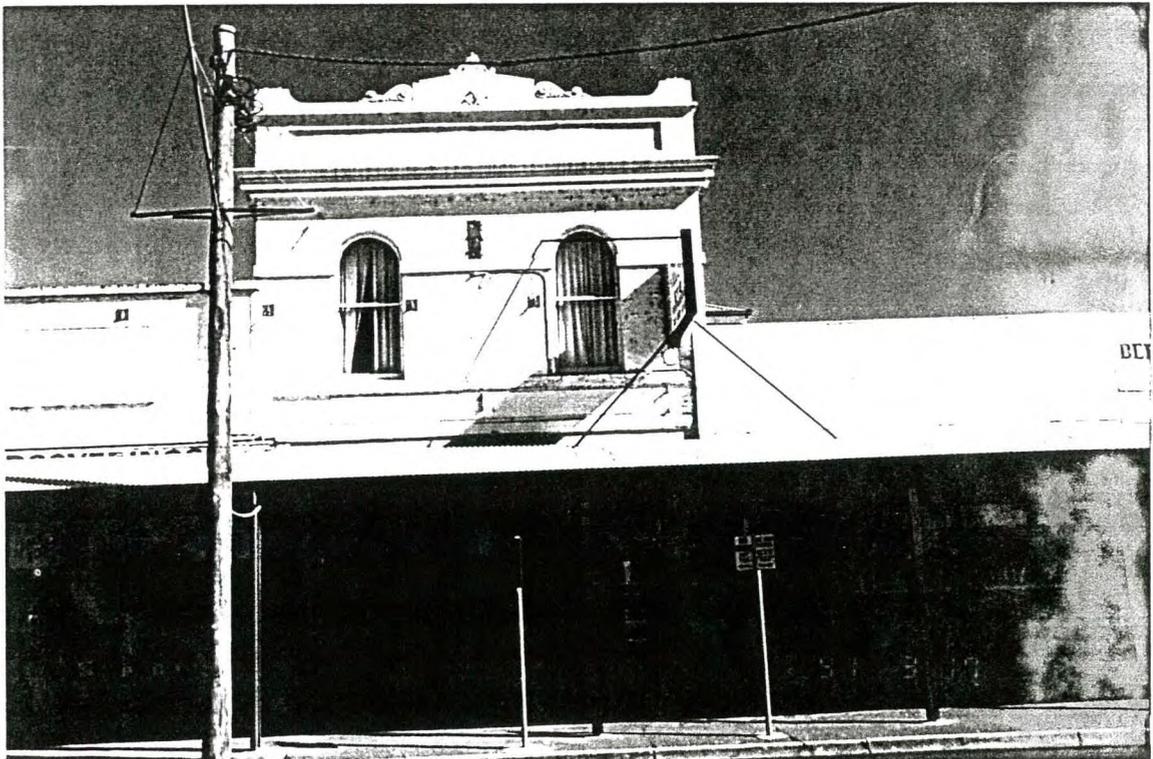
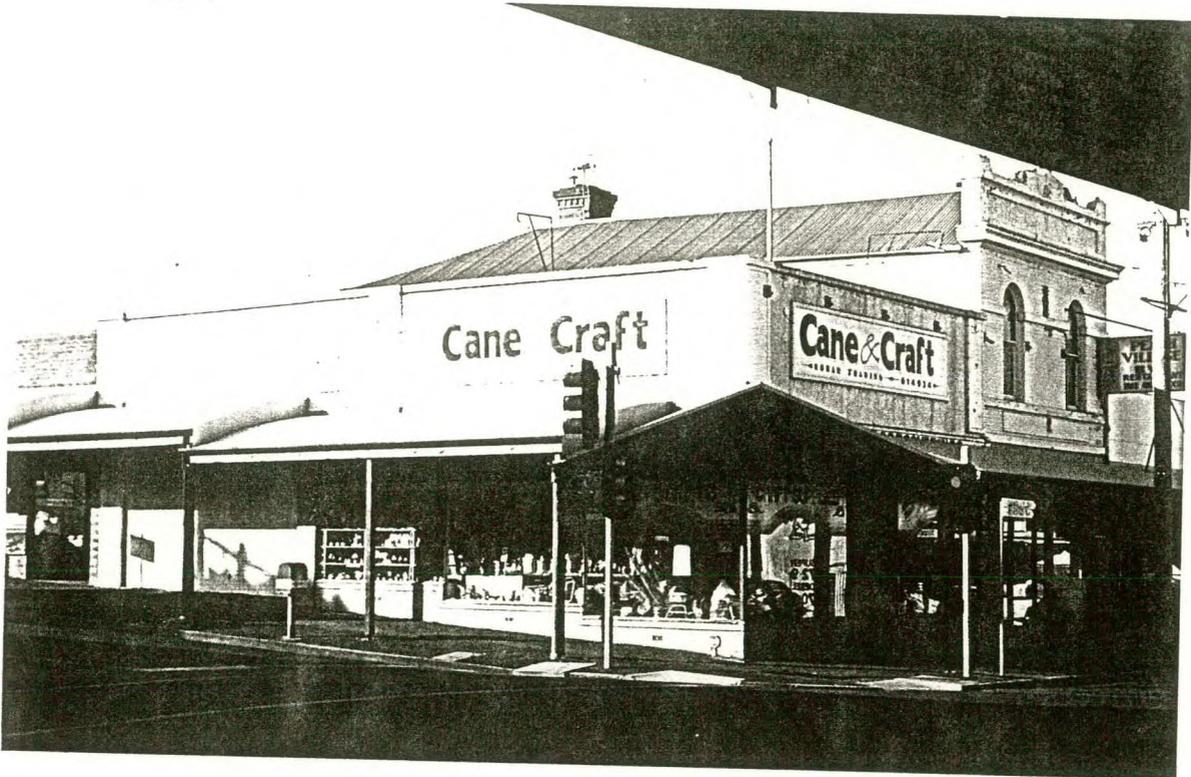
TWO STOREY FACE BRICK SHOP,
169 HIGH STREET,
MARYBOROUGH.

BUILT:	LATE 19TH CENTURY/ 1880S/1890S/1900S
THEMES ILLUSTRATED BY THIS PLACE:	PRIVATE BUILDING - VICTORIAN/EDWARDIAN
DEGREE OF SIGNIFICANCE:	LOCAL SIGNIFICANCE
EXTENT OF SIGNIFICANCE:	ENTIRE BUILDING AND SITE
RECOMMENDATIONS:	LOCAL PLANNING PROTECTION
	CONSERVATION AREA: HIGH STREET-NOLAN STREET

Regular maintenance as necessary.
Keep intact.
Chemical removal of all paint on the face brick walls would improve the appearance of this building in the streetscape. The exposed face brickwork beneath the removed wall plate in the centre of the upper facade suggests that the facade was first painted only in comparatively recent times.
Over time replace the shopfront with a more appropriate one, such as a replica of the original one or a period one.
When built this shop most probably had its own verandah; over time the replication of the original verandah, if sufficient evidence survives, is desirable. The present verandah, which is shared with all of the other shops in this block, ignores the individuality and very different form and date of construction of each shop, though providing a beneficial general streetscape function.

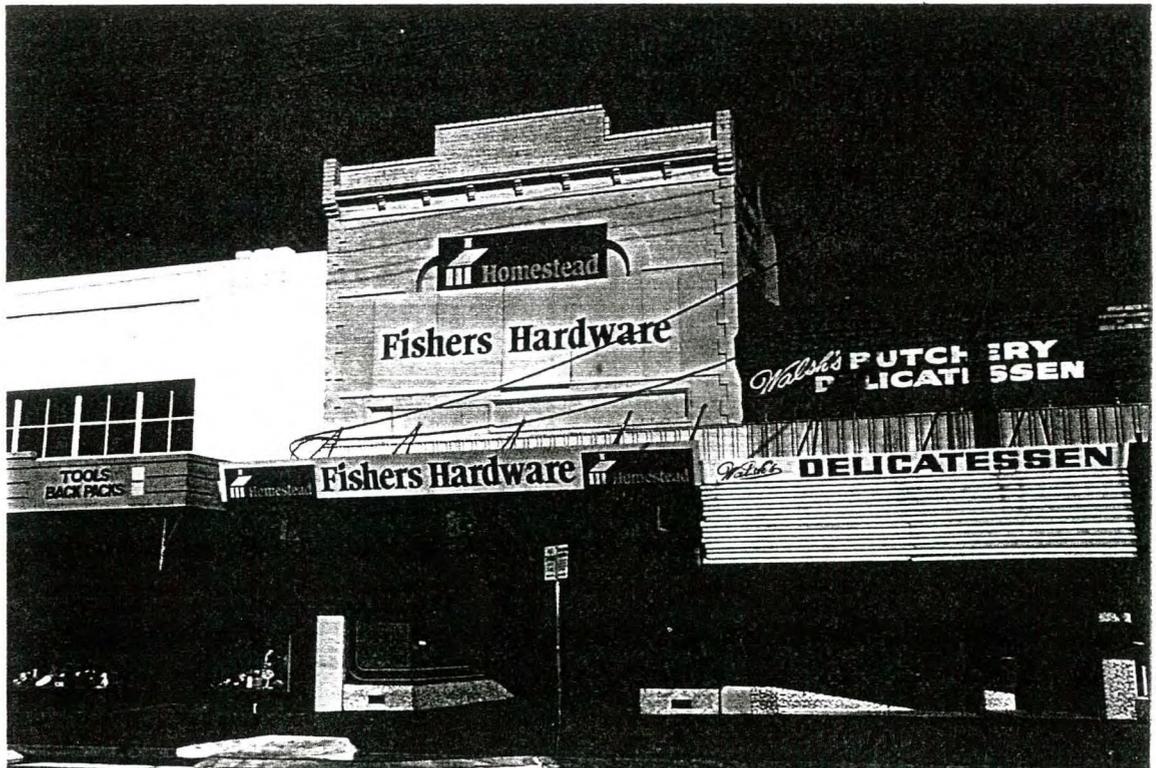
TWO STOREY SHOP,
176 HIGH STREET,
MARYBOROUGH.

BUILT:	1870S/1880S
	MID 20TH CENTURY UNSYMPATHETIC SHOPFRONT AND VERANDAH
THEMES ILLUSTRATED BY THIS PLACE:	PRIVATE BUILDING - VICTORIAN
DEGREE OF SIGNIFICANCE:	LOCAL SIGNIFICANCE
EXTENT OF SIGNIFICANCE:	ENTIRE BUILDING AND SITE
RECOMMENDATIONS:	LOCAL PLANNING PROTECTION
	CONSERVATION AREA: HIGH STREET-NOLAN STREET

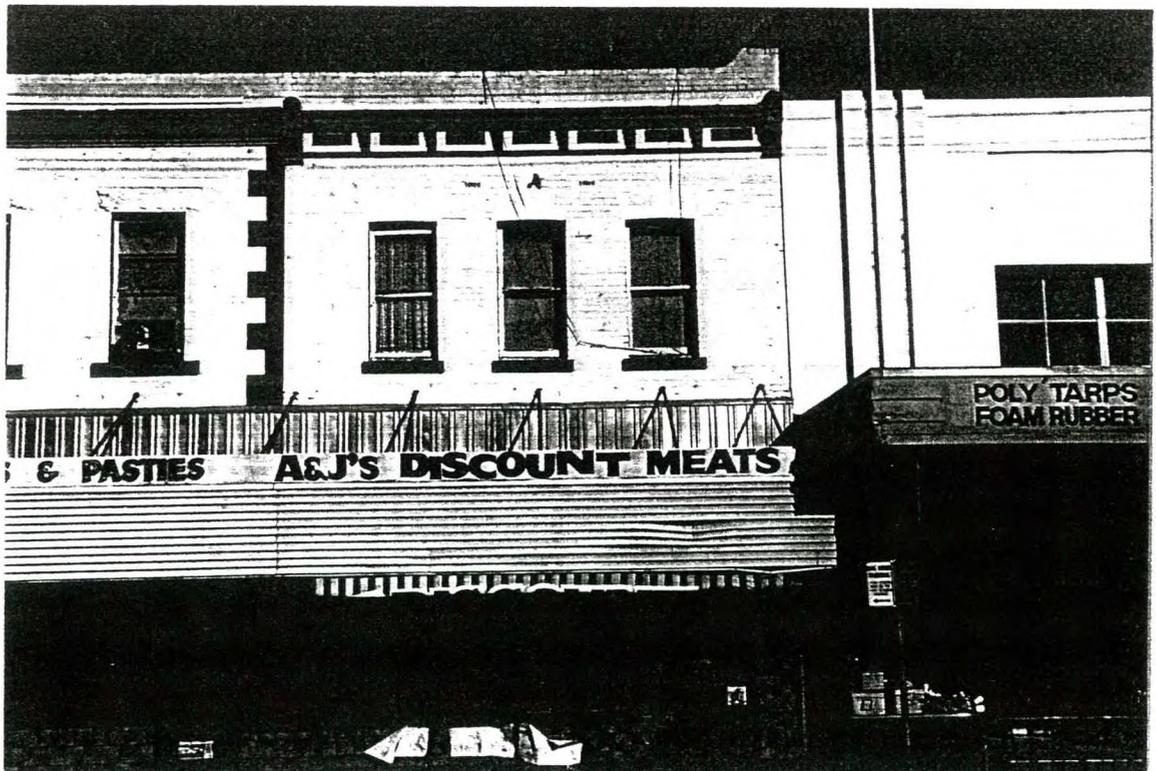
TWO STOREYED FACE BRICK SHOP,
182 HIGH STREET,
MARYBOROUGH.

BUILT:	PRE 1885 ¹
	RECENT TIMES UNSYMPATHETIC SHOPFRONT AND VERANDAH
THEMES ILLUSTRATED BY THIS PLACE:	PRIVATE BUILDING - VICTORIAN
DEGREE OF SIGNIFICANCE:	LOCAL SIGNIFICANCE
EXTENT OF SIGNIFICANCE:	ENTIRE BUILDING AND SITE
RECOMMENDATIONS:	LOCAL PLANNING PROTECTION
	CONSERVATION AREA: HIGH STREET-NOLAN STREET

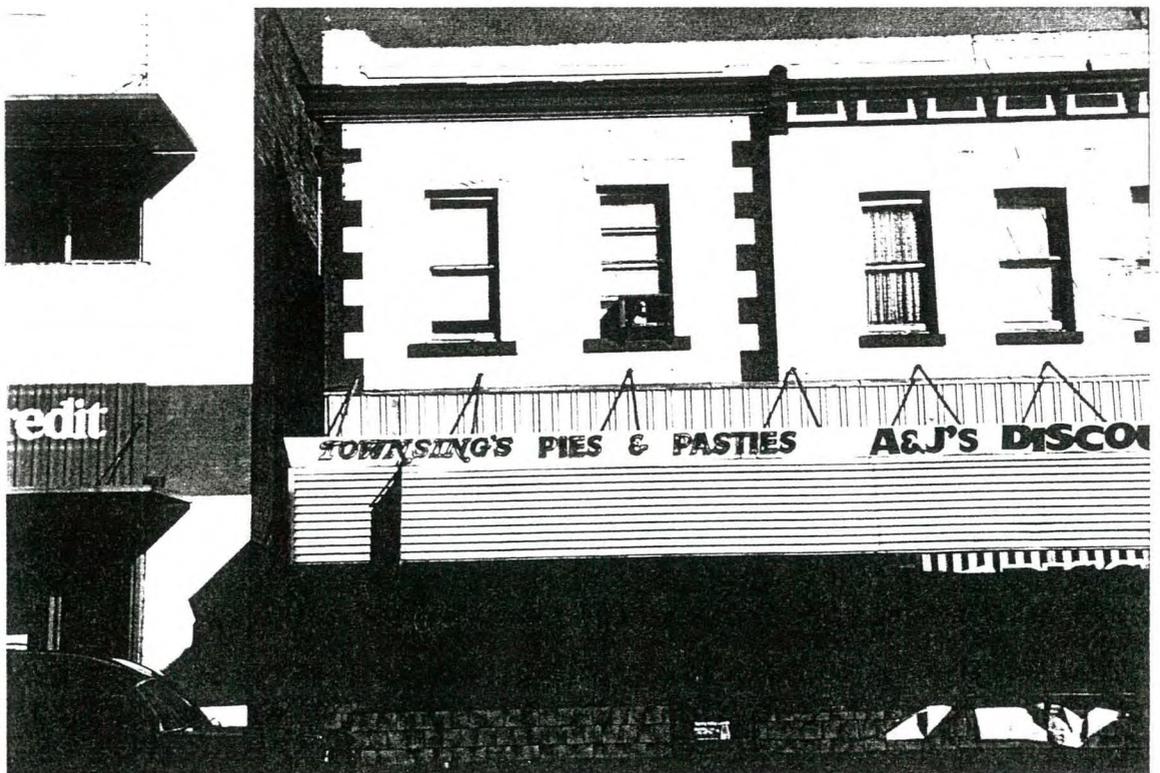
Part of the streetscape and group of significant shops here, this building is also of interest for its design, which features rusticated stone block lintels, an unusual detail found in a few other buildings in Maryborough (one being the Supreme Court House in Clarendon Street). This building is one of the oldest surviving shops in Maryborough and comes from the period when the transient gold mining settlement became a permanent town. There are only a small number of double storeyed shops in the City and most are at this oldest end of the commercial area.

Chemically remove paint from facade to return to most probable original appearance.
Replace present cantilevered verandah with reconstructed/replica post-supported one.
Remove iron/aluminium sheet from facade above present verandah.
Replace shopfront with a replica of the original or one based on those used at the time that this shop was built.
Ensure that all roof and ground-water is collected and carried well away from the building.
Regular maintenance as necessary.

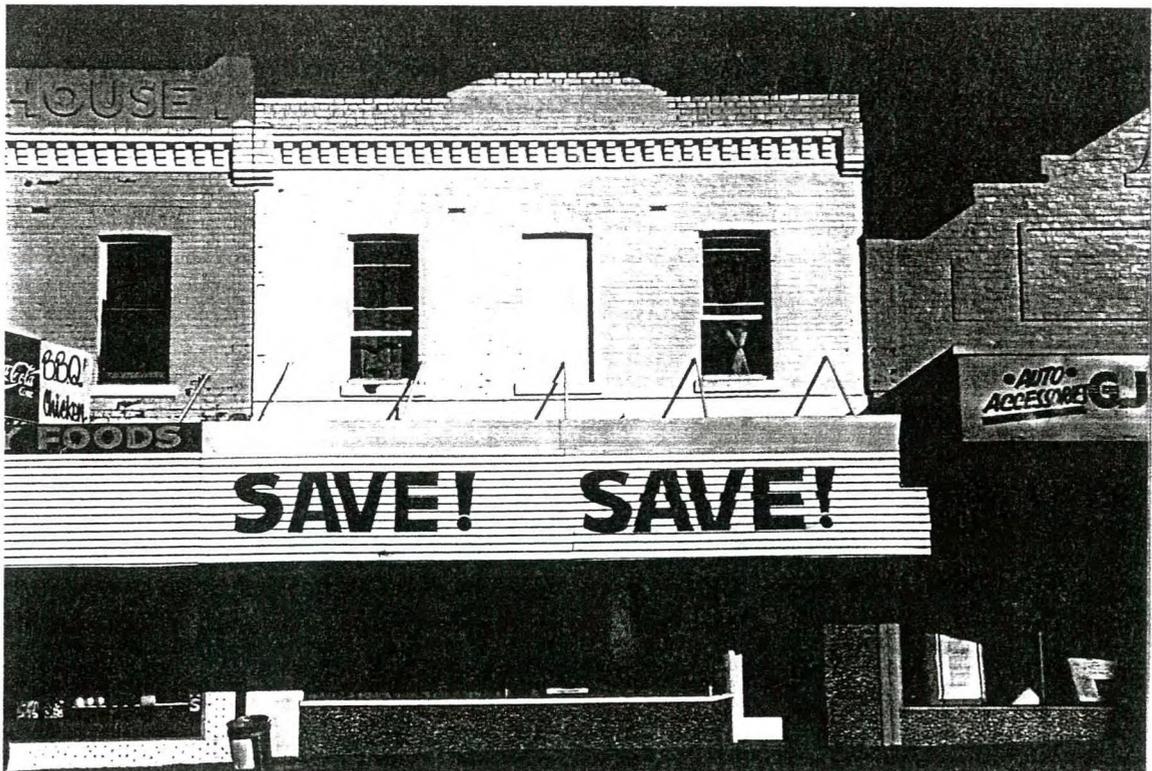
TWO STOREY FACE BRICK SHOP,
194 HIGH STREET,
MARYBOROUGH.

BUILT:	PRE 1885 ¹
	MID 20TH CENTURY SHOPFRONT AND VERANDAH
THEMES ILLUSTRATED BY THIS PLACE:	PRIVATE BUILDING - VICTORIAN
DEGREE OF SIGNIFICANCE:	LOCAL SIGNIFICANCE
EXTENT OF SIGNIFICANCE:	ENTIRE BUILDING AND SITE
RECOMMENDATIONS:	LOCAL PLANNING PROTECTION
	CONSERVATION AREA: HIGH STREET-NOLAN STREET

Chemically remove paint from facade to return to most probable original appearance.
Remove cantilevered verandah and replace with post-supported one.

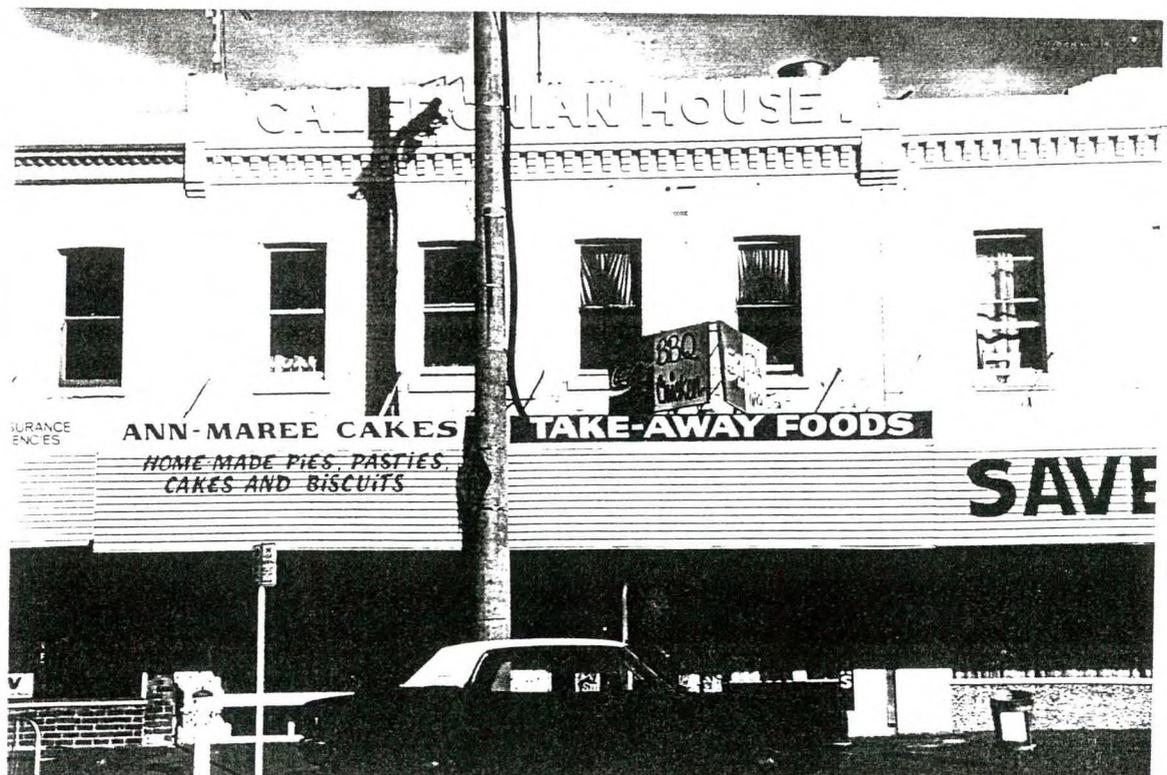
CALEDONIAN HOUSE - TWO STOREY
FACE BRICK SHOPS,
196-198 HIGH STREET,
MARYBOROUGH.

BUILT:	PRE 1885 ¹
	MID 20TH CENTURY CANTILEVERED VERANDAH
	RECENT TIMES UNSYMPATHETIC SHOPFRONT
THEMES ILLUSTRATED BY THIS PLACE:	PRIVATE BUILDING - VICTORIAN
DEGREE OF SIGNIFICANCE:	LOCAL SIGNIFICANCE
EXTENT OF SIGNIFICANCE:	ENTIRE BUILDING AND SITE
RECOMMENDATIONS:	LOCAL PLANNING PROTECTION
	CONSERVATION AREA: HIGH STREET-NOLAN STREET

Chemically remove paint from face brick walls - the present topcoat appears to be the only one.
Remove cantilevered verandah and erect a post-supported one.
Install reconstructed/replica shopfront to replace existing.
Repaint joinery and other originally painted elements in original/period paint colours and placement.
Collect all roof and ground-water and carry well away from the building.
Regular maintenance as necessary.

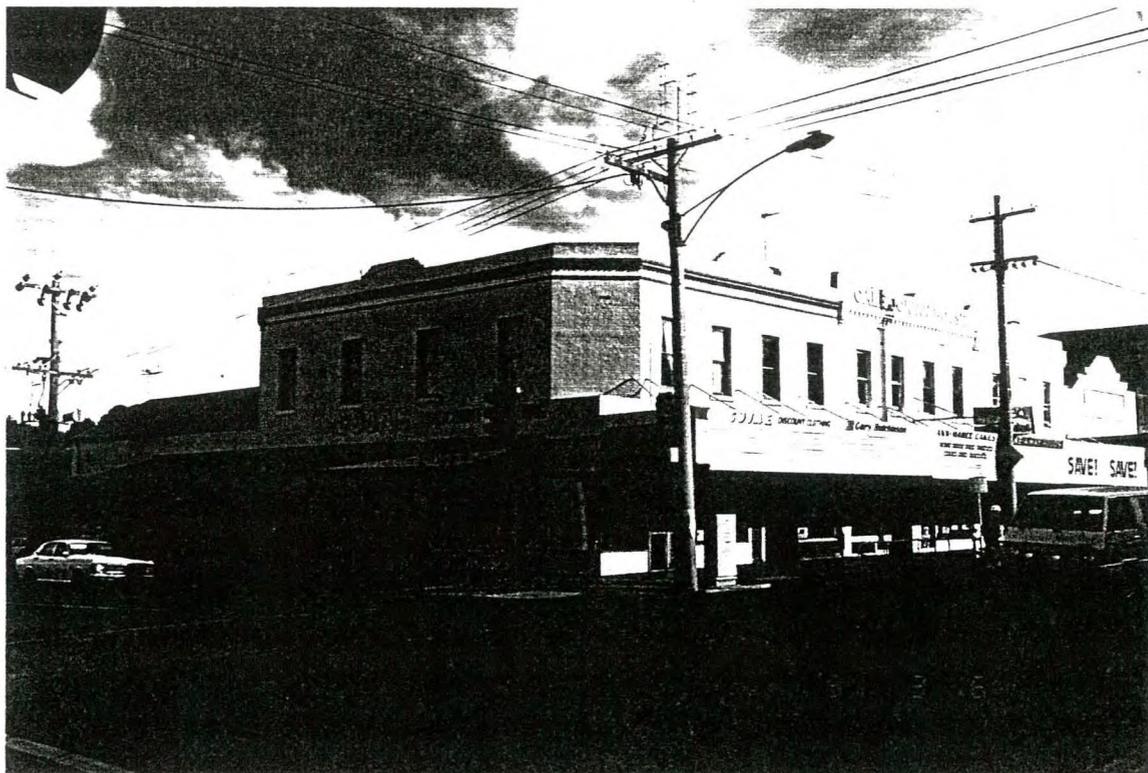
TWO STOREY FACE BRICK SHOP,
S.E. CNR. TUAGGRA STREET,
200 HIGH STREET,
MARYBOROUGH.

BUILT:	19TH CENTURY
THEMES ILLUSTRATED BY THIS PLACE:	PRIVATE BUILDING - VICTORIAN
DEGREE OF SIGNIFICANCE:	LOCAL SIGNIFICANCE
EXTENT OF SIGNIFICANCE:	ENTIRE BUILDING AND SITE
RECOMMENDATIONS:	LOCAL PLANNING PROTECTION
	CONSERVATION AREA: HIGH STREET-NOLAN STREET

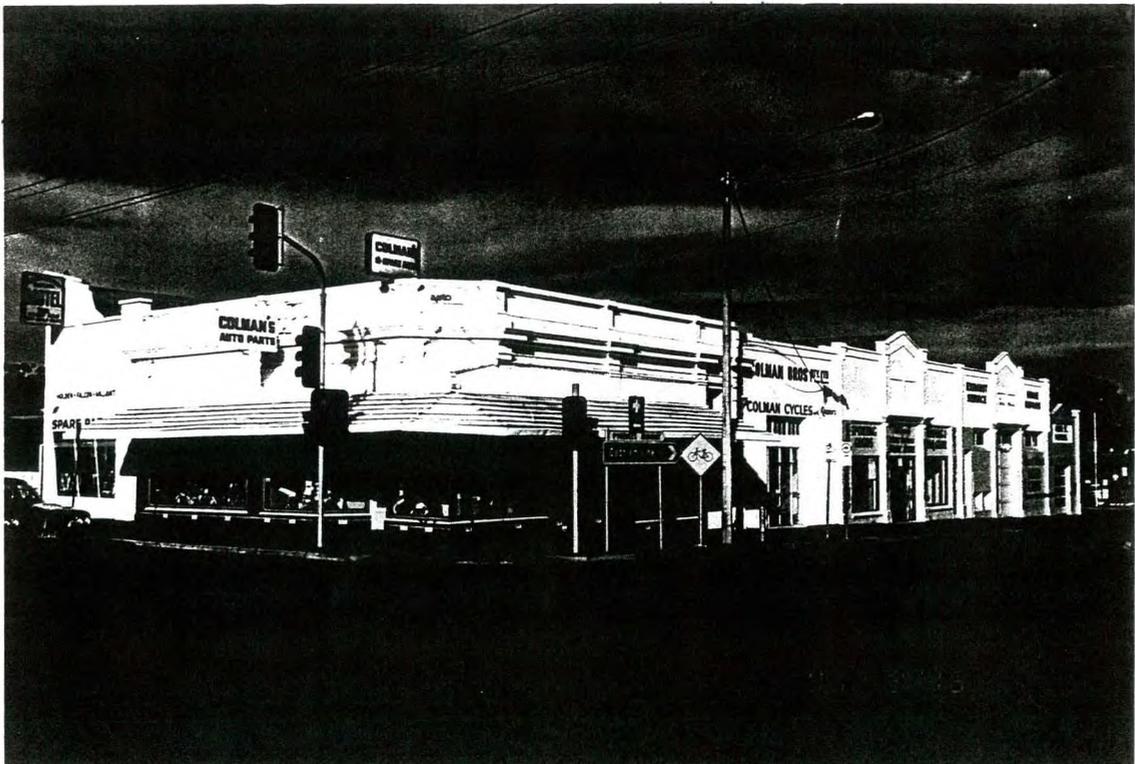
CEMENT RENDERED SHOP AND FACE BRICK
COMMERCIAL PREMISES - COLMAN'S,
N.E. CNR. TUAGGRA STREET,
204-208 HIGH STREET,
MARYBOROUGH.

BUILT:	1882
	EARLY 1930S NORTH END AND SHOPFRONTS
	? NORTH END PART DEMOLISHED AND REBUILT
THEMES ILLUSTRATED BY THIS PLACE:	PRIVATE BUILDING - VICTORIAN
DEGREE OF SIGNIFICANCE:	LOCAL SIGNIFICANCE
EXTENT OF SIGNIFICANCE:	ENTIRE BUILDING AND SITE
RECOMMENDATIONS:	LOCAL PLANNING PROTECTION
	CONSERVATION AREA: HIGH STREET - NOLAN STREET

- Remove present awning and reconstruct original post-supported verandah.
- Chemically remove paint from cement rendered facade or repaint in original?/early/period paint colours.
- Ensure all roof and ground-water is collected and carried well away from the building.
- Regular maintenance as necessary.

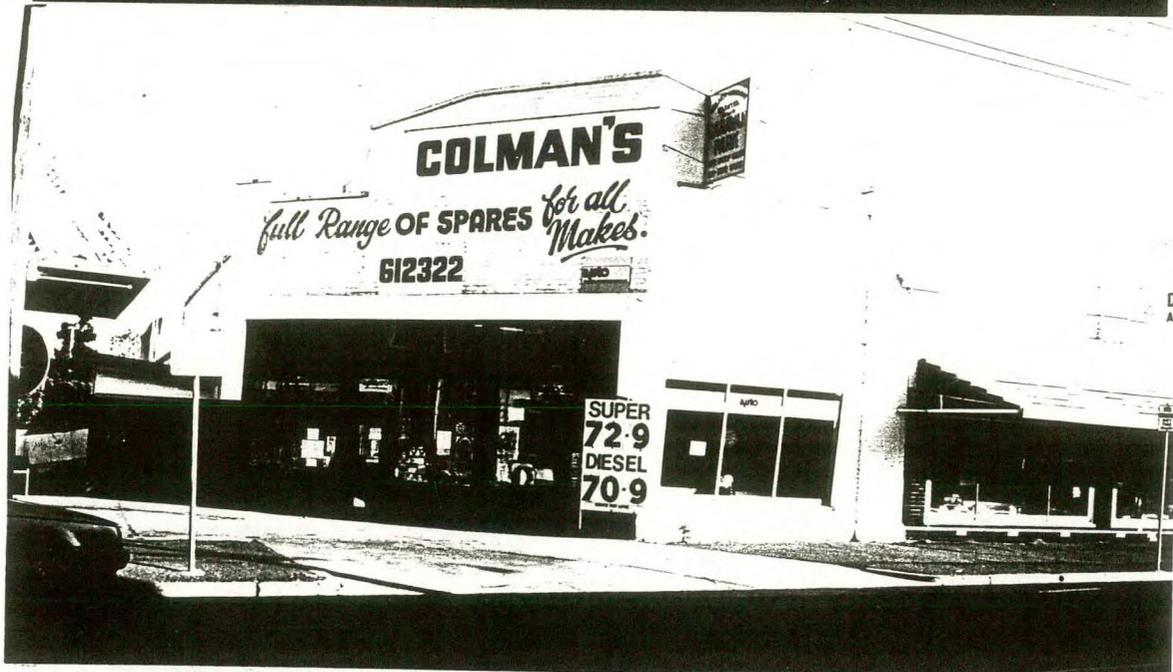
THE CORNER OF THIS BUILDING HAS BEEN CUT OFF FOR THE SERVICE STATION AREA; THIS END OF THE FACADE POSTDATES THE MAIN BODY ON THE STREET CORNER

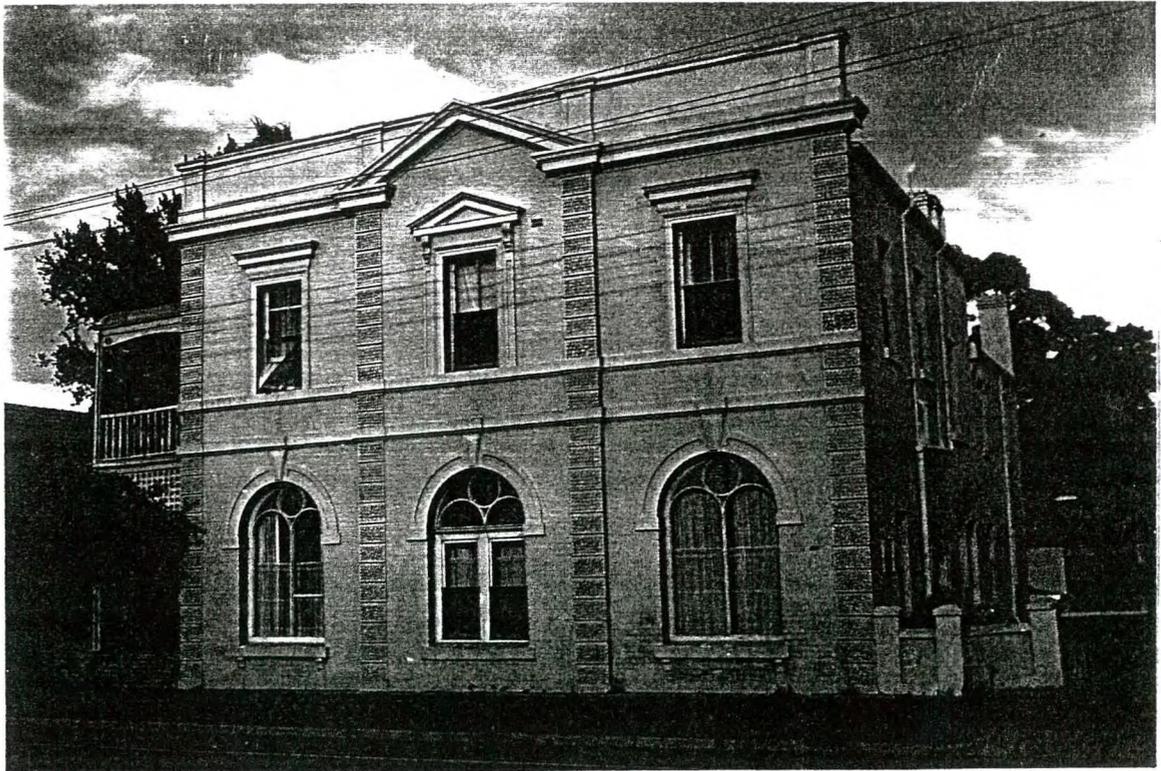
BRICK AND CEMENT RENDER BUILDING,
MATURE PALM TREE,
238 HIGH STREET,
MARYBOROUGH.

BUILT:	1880S?
THEMES ILLUSTRATED BY THIS PLACE:	PRIVATE BUILDING - VICTORIAN
DEGREE OF SIGNIFICANCE:	LOCAL SIGNIFICANCE
EXTENT OF SIGNIFICANCE:	ENTIRE BUILDING, MATURE PALM TREE AND ALL OF SITE.
RECOMMENDATIONS:	LOCAL PLANNING PROTECTION CONSERVATION AREA: HIGH STREET-NOLAN STREET

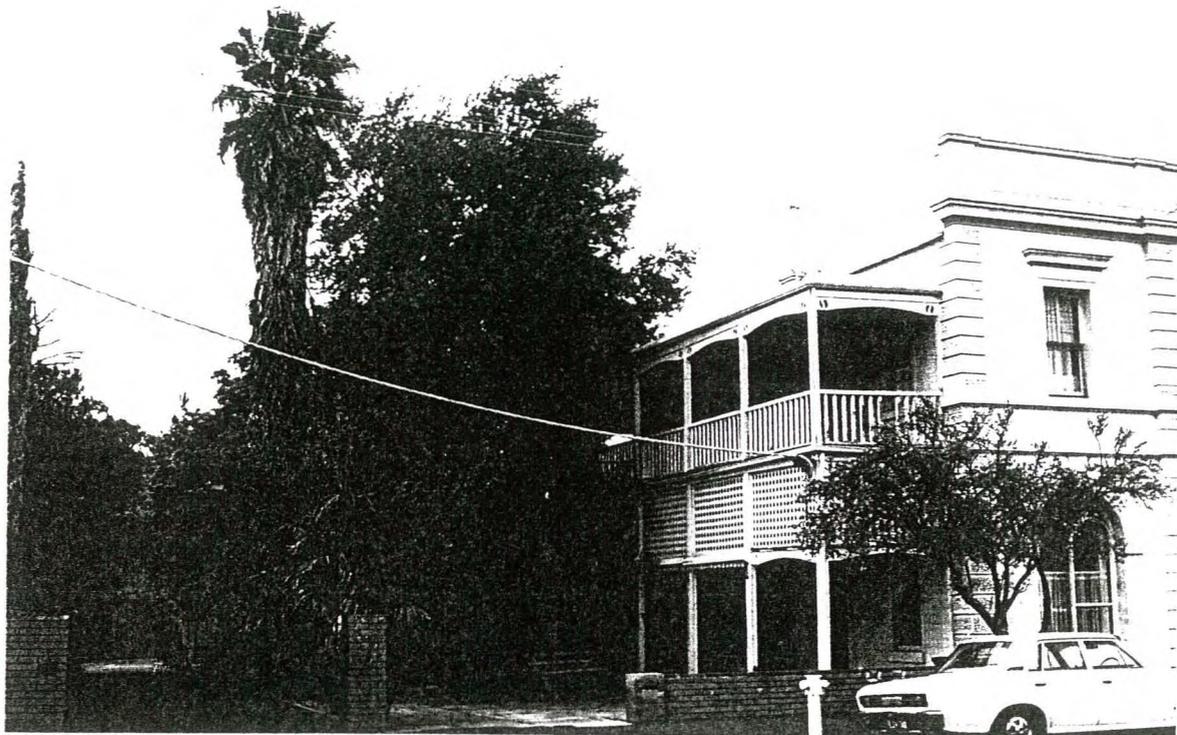
Washingtonia filifera (x2),
REAR 238 HIGH STREET,
MARYBOROUGH.

Two fine characteristic landscape trees augmenting an attractive building. They make a most effective contribution to the skyline especially when viewed from Princes Park.

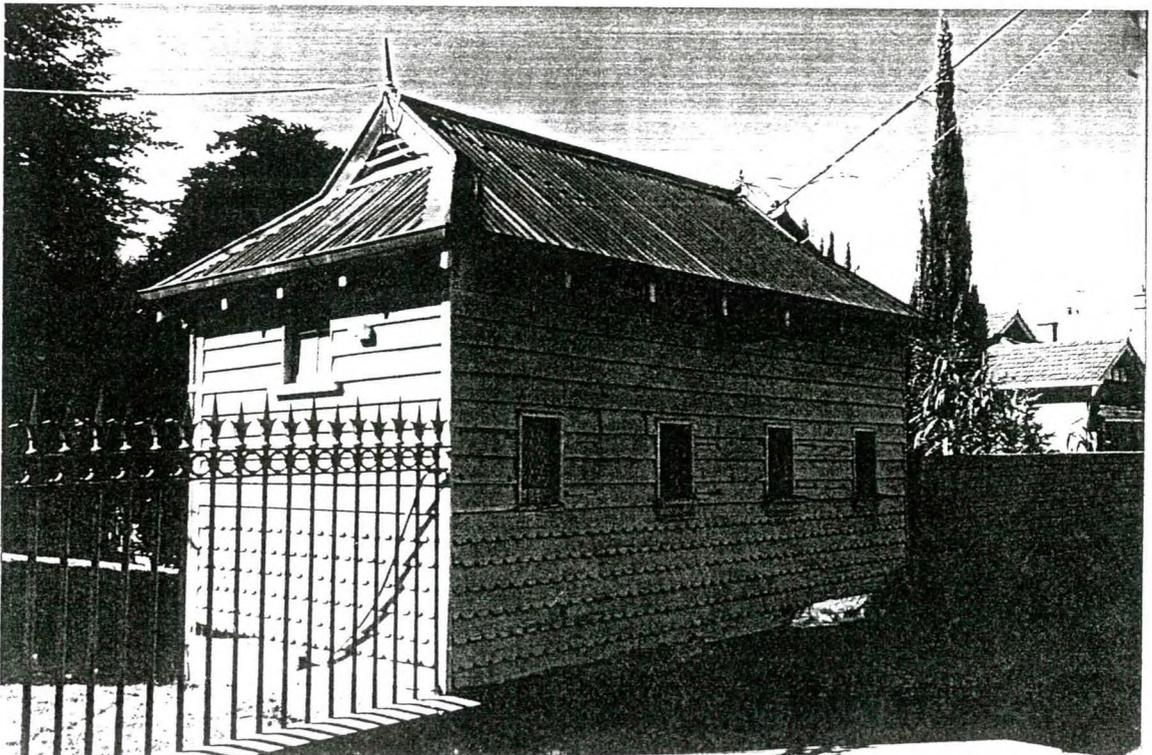
Timber Ticket Box Cont.

Various repairs required.

Repainting is required to ensure this building's conservation - the present colours are very appropriate.

Ensure that roof rainwater is taken well away from this building and the cast iron palisade fence.

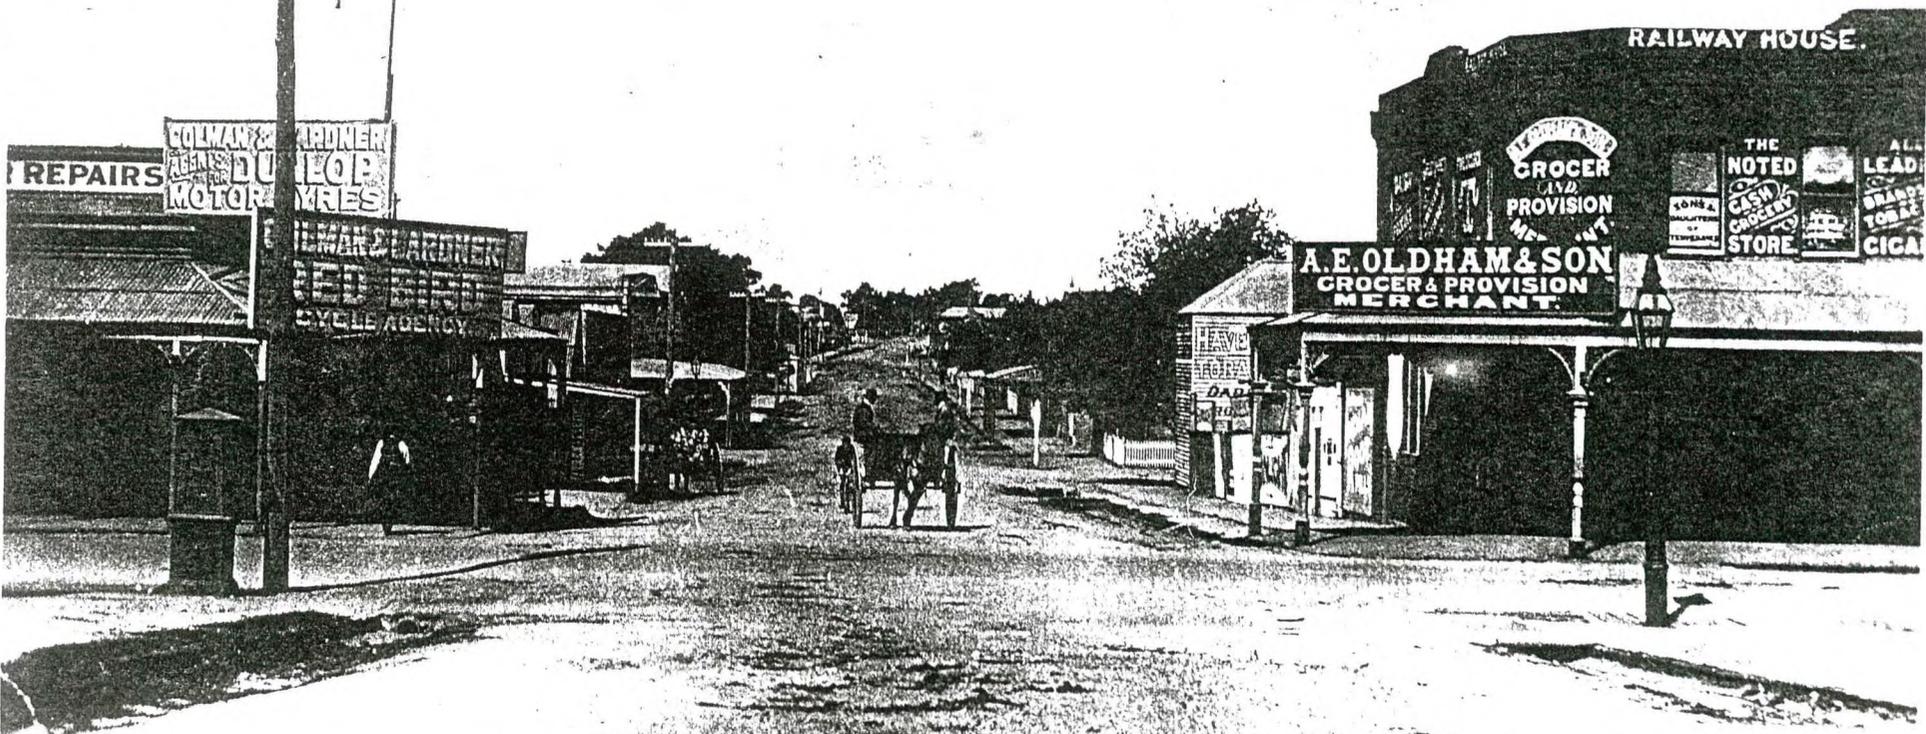
LOOKING EAST ALONG TUAGGRA STREET CIRCA 1900: NO. 200 ON THE RIGHT
HAND SIDE AND NO. 204 TO THE LEFT - NOTE THE VERANDAHS
COLLECTION OF WARREN TATTERSALL, DALE TATTERSALL STUDIOS, MARYBOROUGH
